## Howard County Traffic Signal Inspection Summary Report:

**Signal Number:** 053  
**Location:** Frederick Rd. at Plumtree Rd.  
**Inspection Date:** June 6, 2018

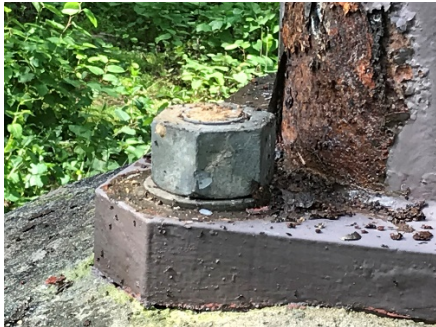
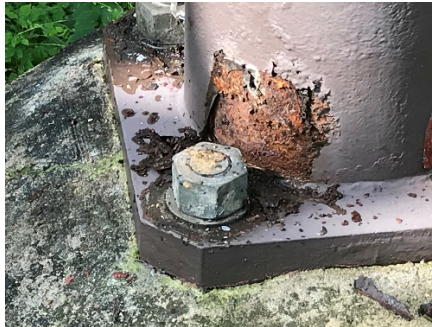
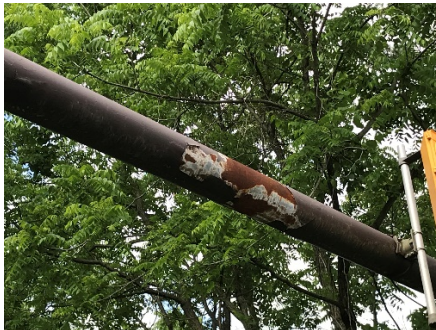
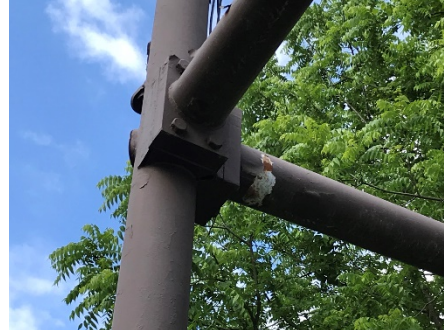
Poles are in overall fair condition. SE structure has rusting and deterioration around the base plate area. Paint coating on this structure is in poor condition with considerable rusting. Base plate area should be media blasted, prime, and re-painted.

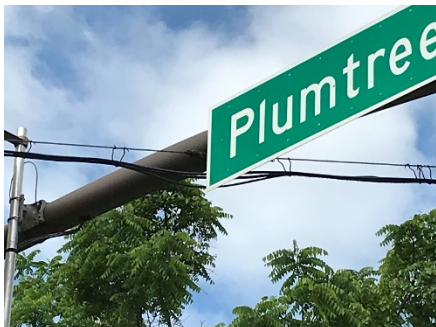
SE Corner – loose tightening nuts. Street name sign possibly rubbing against span wire.

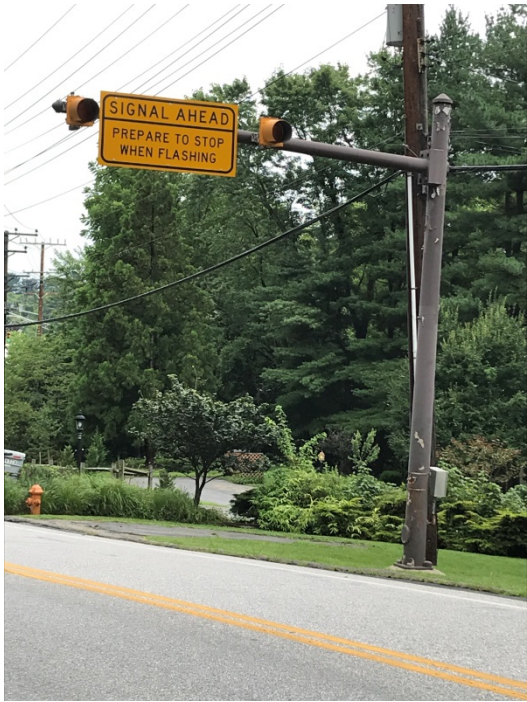
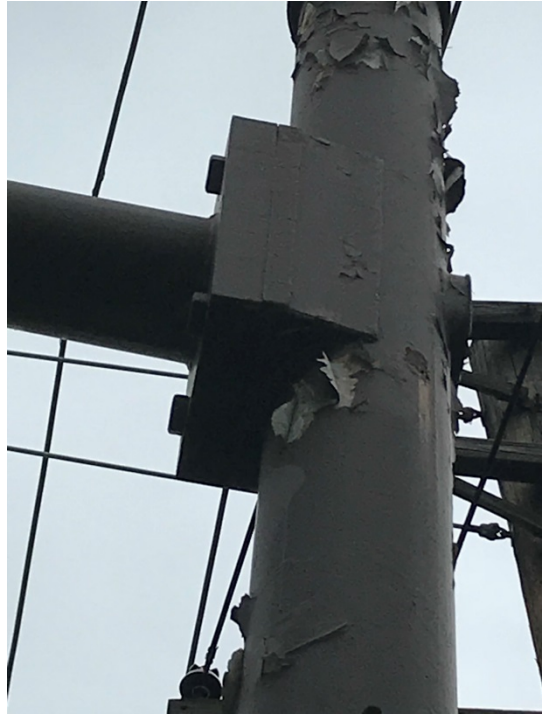
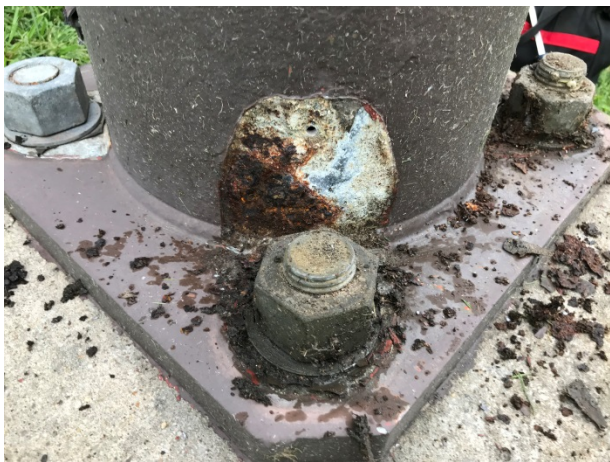
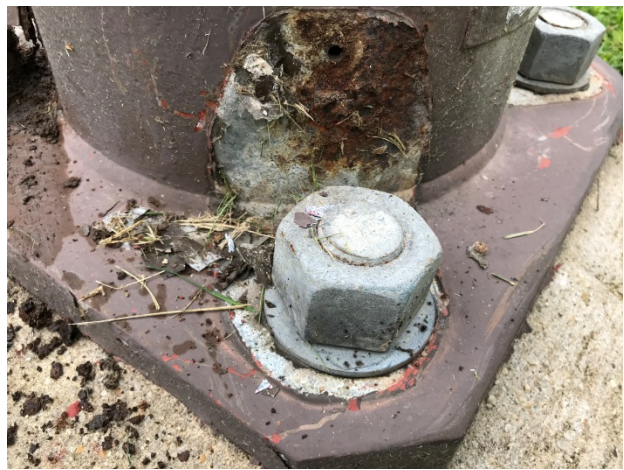
Hazard Identification Beacon:

Older HIB. Paint coating is in fair condition with considerable peeling and some surface rusting. Moderate rusting was found around the base plate weld area. The area should be cleaned, primed, and painted to prevent any further deterioration.
