HO-329, Howard Lodge No. 101 Masonic Building
5814 Main St., Elkridge
Surveyed by: Kristin Hill
April 2003

ADDENDUM

The Howard Lodge # 101 Masonic Building
Elkridge
Private

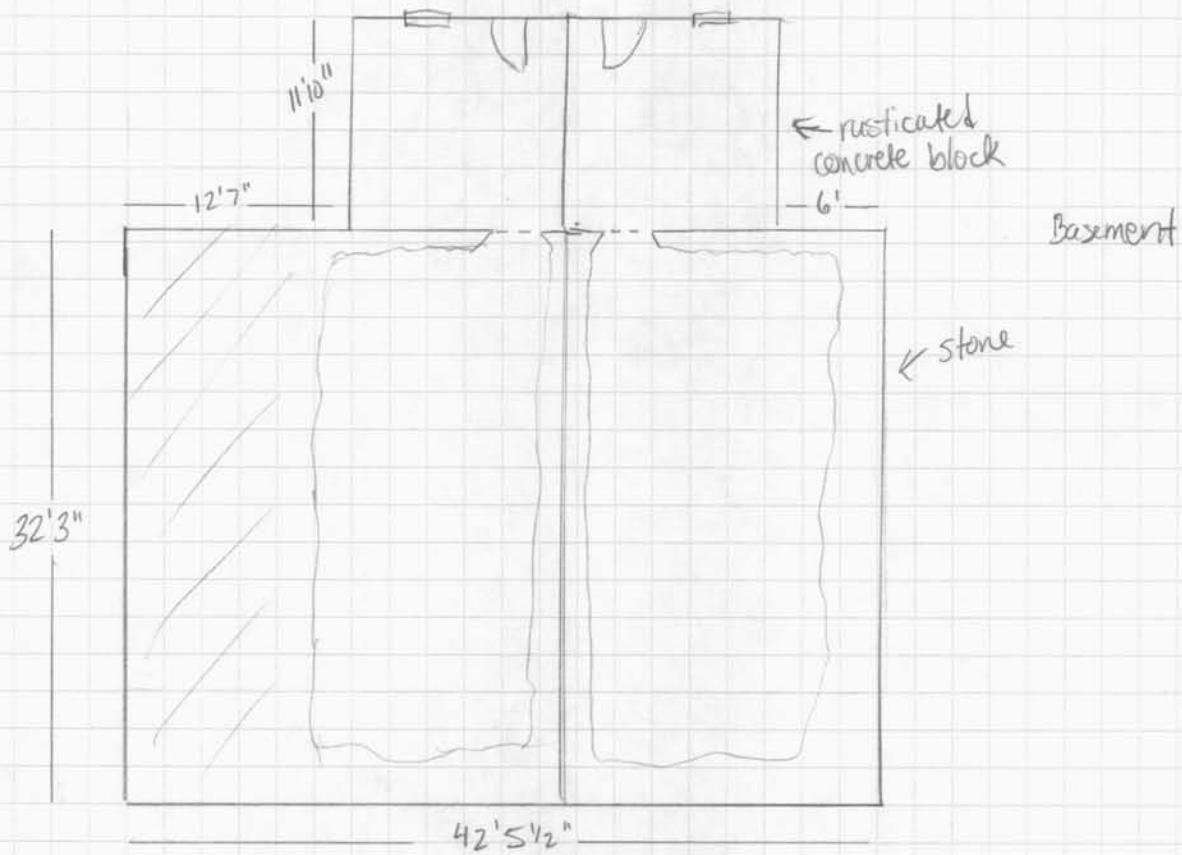
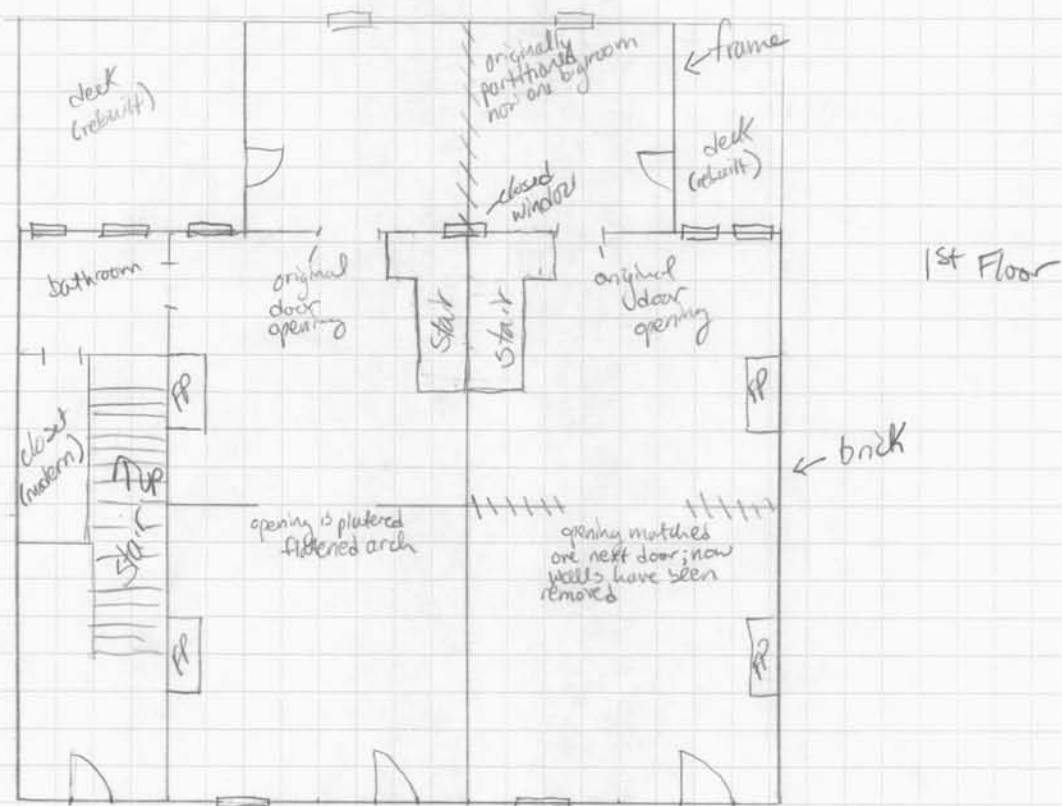
HO-329 N↑
 Howard Lodge Masonic Building
 5814 Main St., Elkridge
 Howard County
 Drawn 4/03, by Kristin Hill

Exterior dimensions drawn at 3/32 scale
 Interior dimensions/details NOT drawn to scale

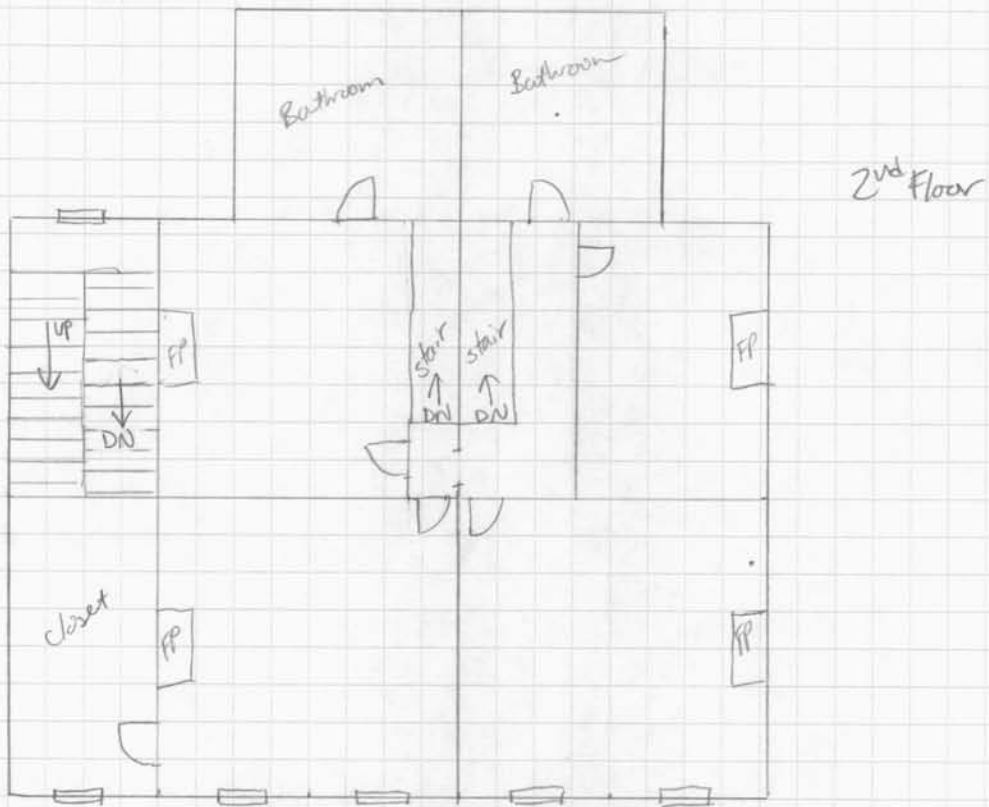
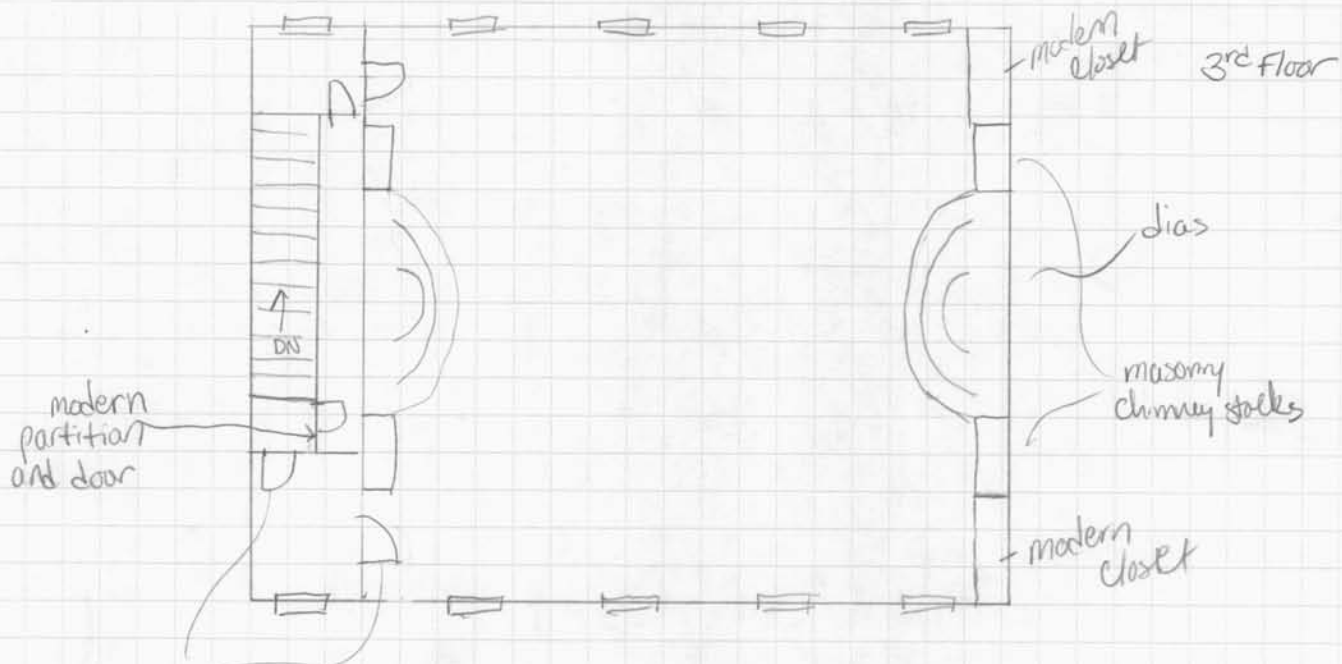
Ho-329
 Howard Lodge Masonic Building
 5814 Main St., Elkridge
 Howard County
 Drawn 4/03, by Kristin Hill

doors have hole w/ speaking tubes on exterior

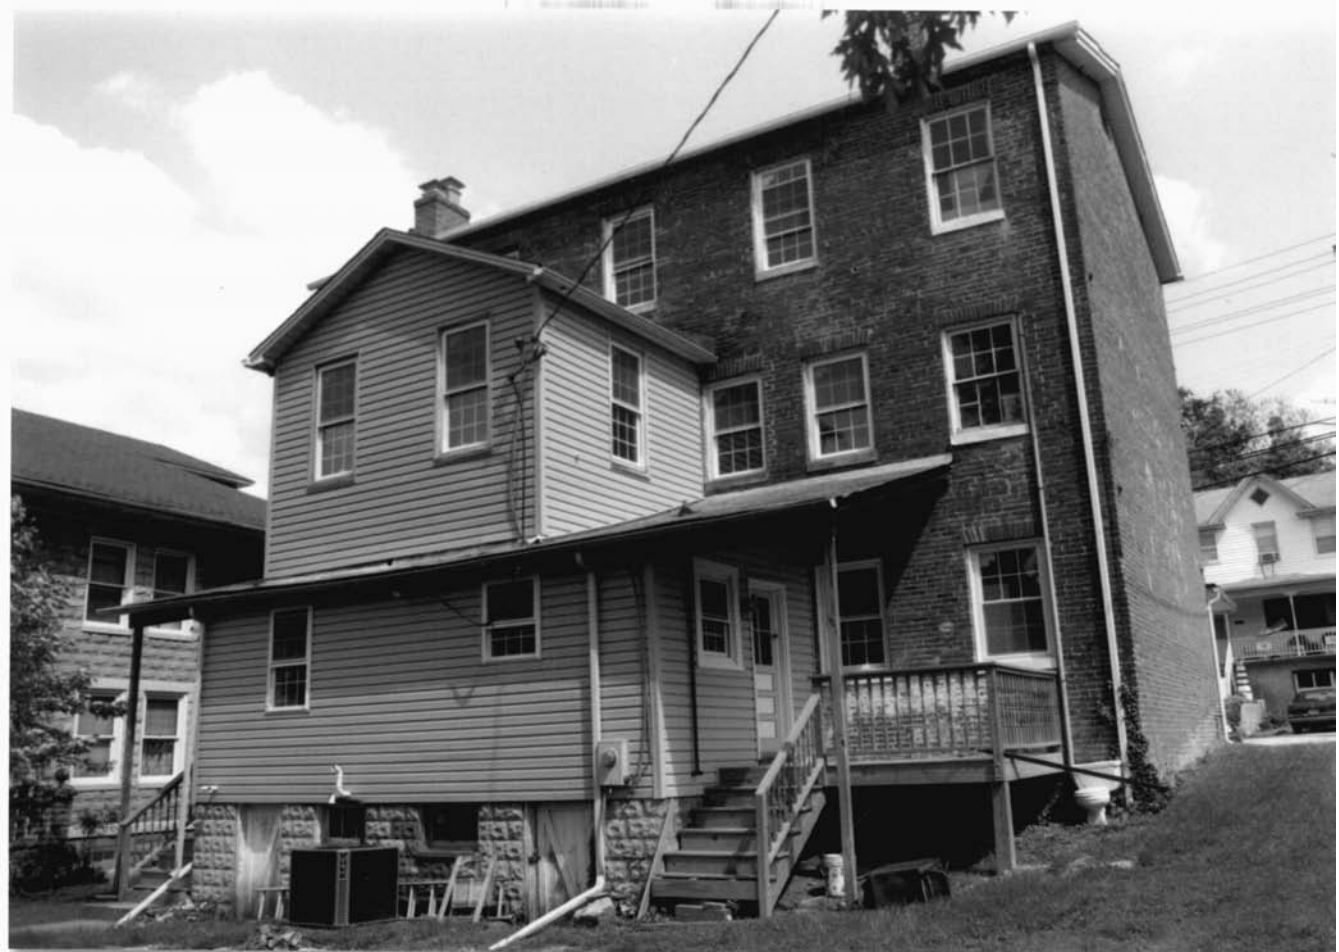
2 of 11

No. 4 (re: elevation)

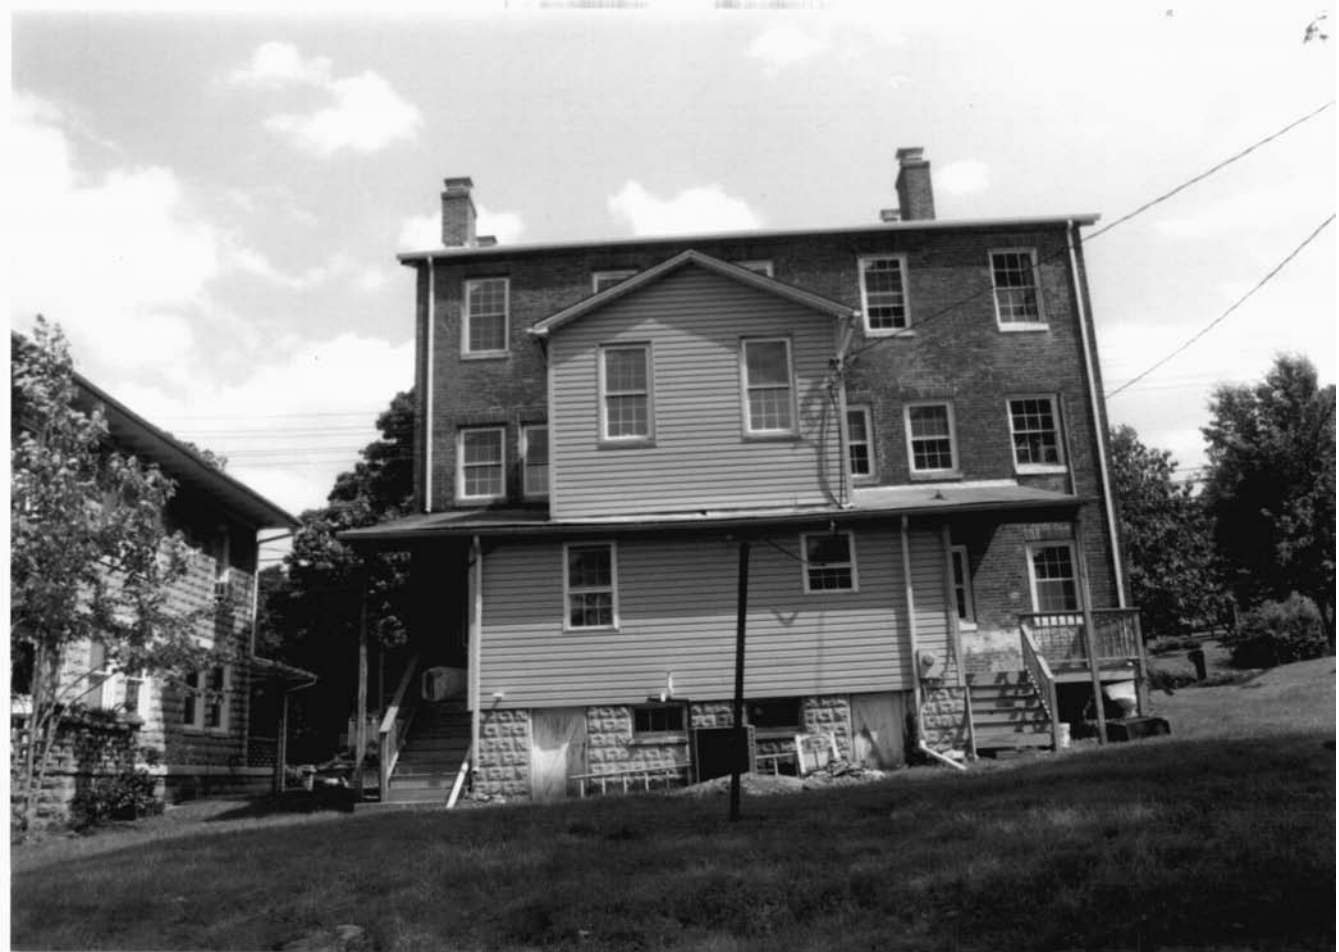
3 of 11

North (near) Deviation

The rear façade of the building probably originally closely mirrored the front façade but sometime in the early 20th century a two story two bay frame addition was made. The addition projects from what is approximately the middle of the eastern-most two thirds of the building and rests on a rusticated concrete block foundation which contains a substantial crawl space. There are two windows and two batten doors located in the north façade of the rusticated concrete block foundation. The fenestration of the rear façade of the brick part of the building was altered to accommodate the frame addition as both window openings and their accompanying jack arches were shifted to either side.

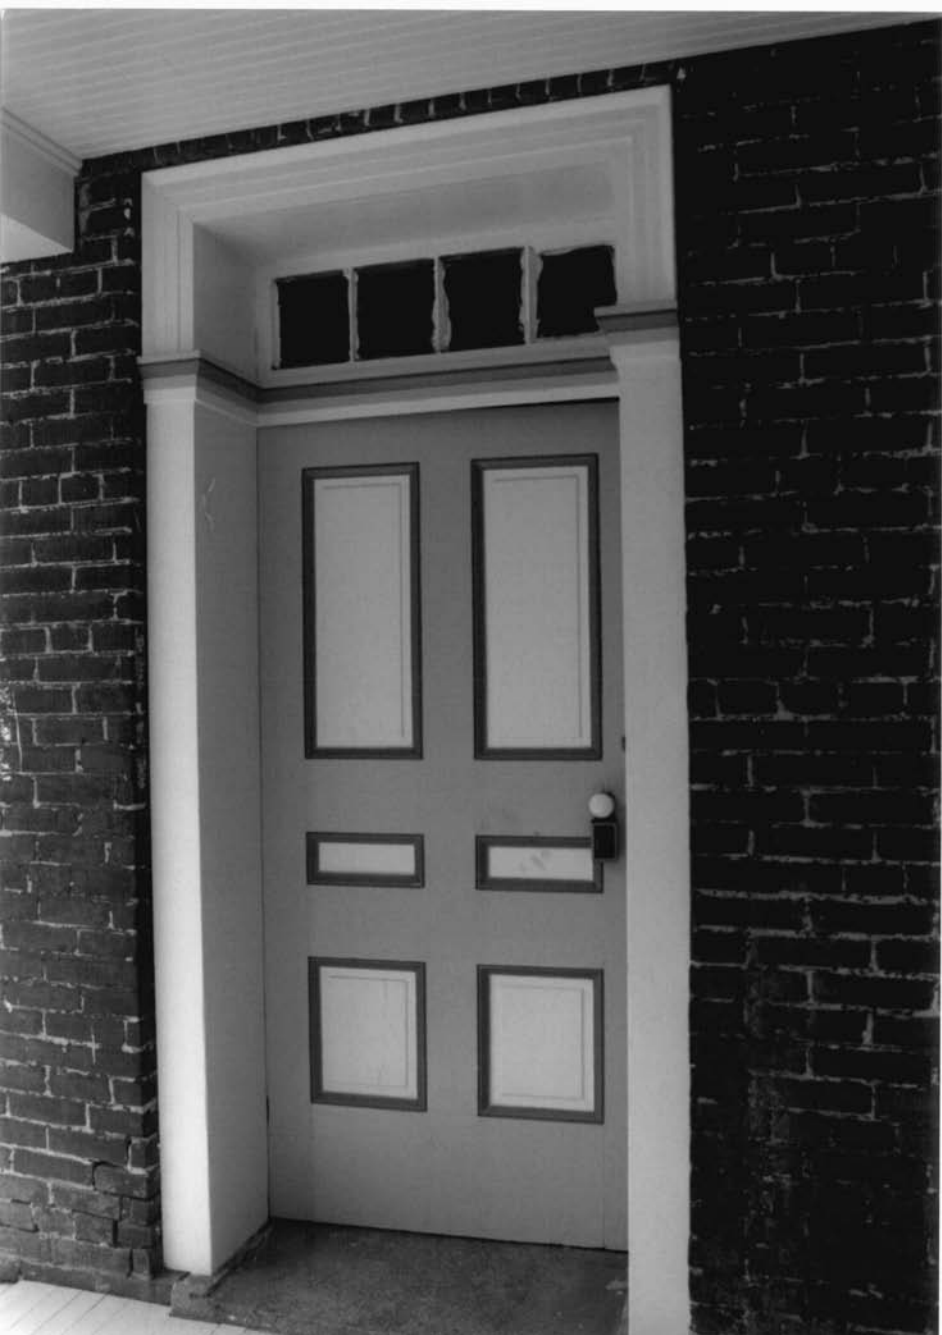
4 of 11

Nest most front door.

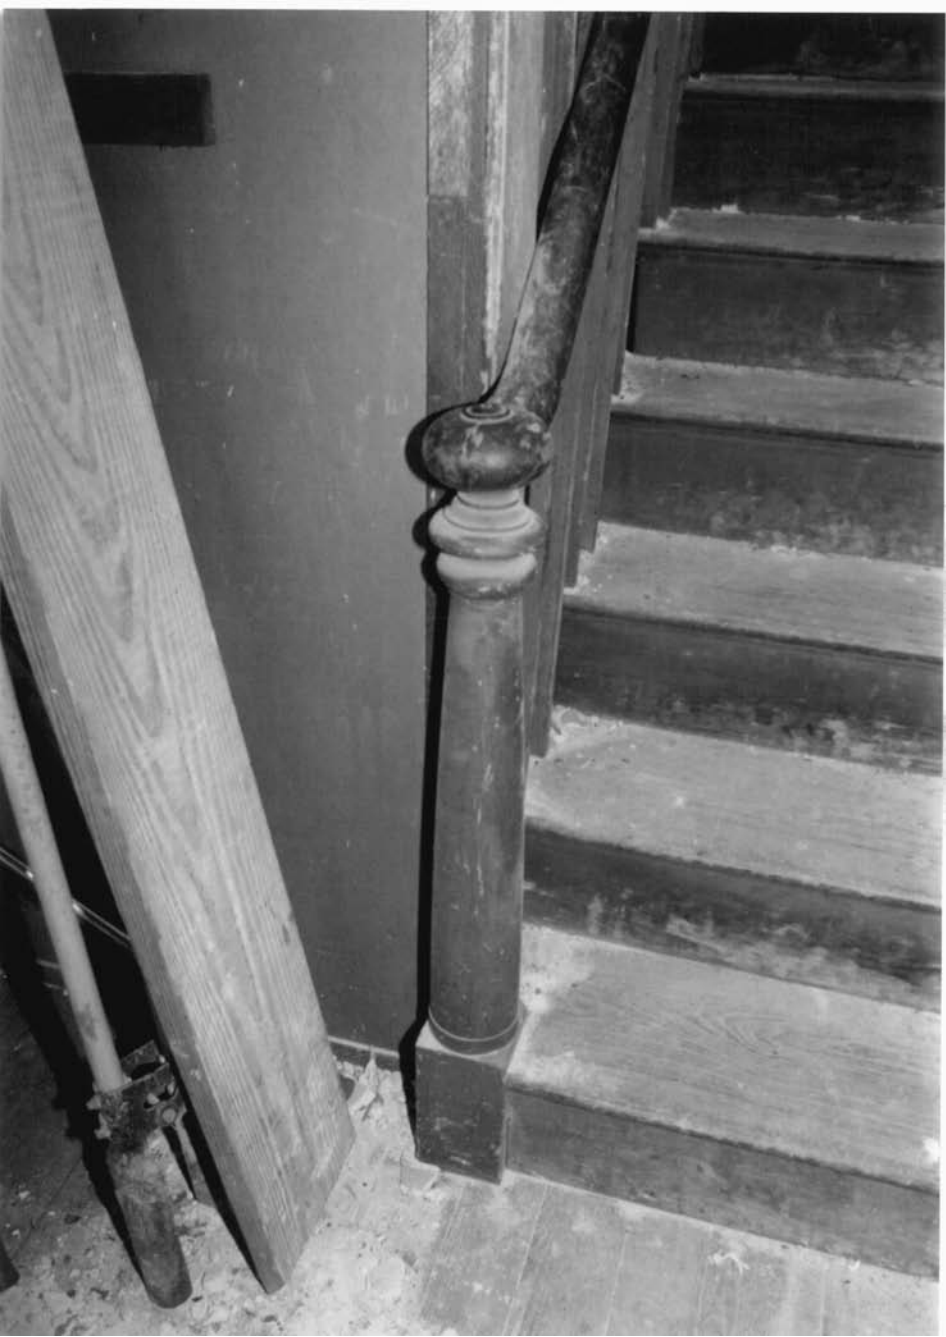
5 of 11

Newel post on 1st floor of stair to 3rd floor hall.

The stair to the third floor is located in the west bay of the building and is an excellent example of an early Greek Revival stair with a graceful turned newel post and ramped handrail. The balusters are square and arranged two to a tread. The open stringer has no stair end decoration. A closet, accessed from the rear room of the middle dwelling

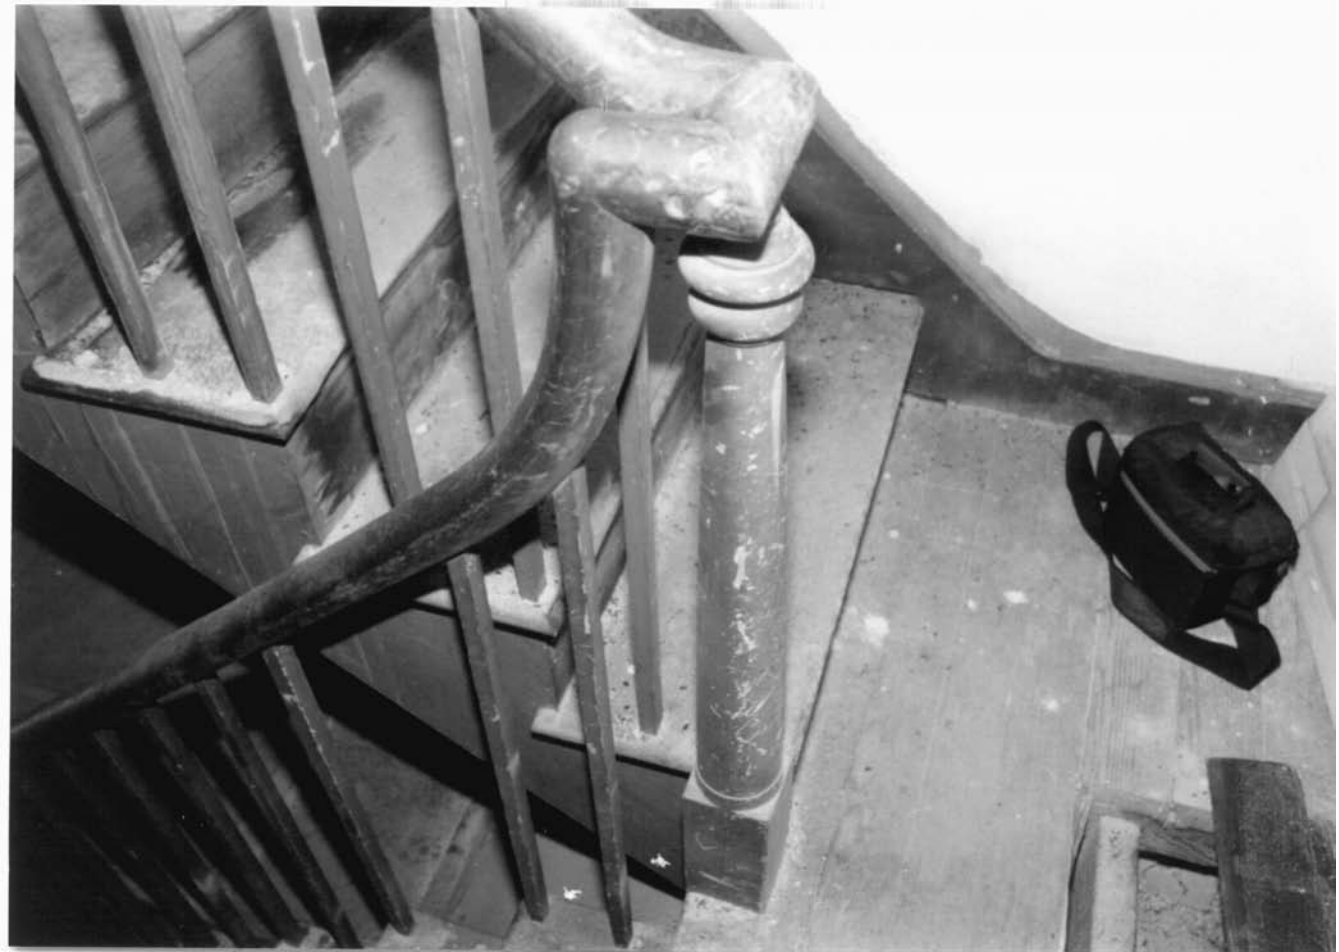
6 of 11

Newel post and ramped handrail at 2nd floor landing
of stair to the 3rd floor hall.

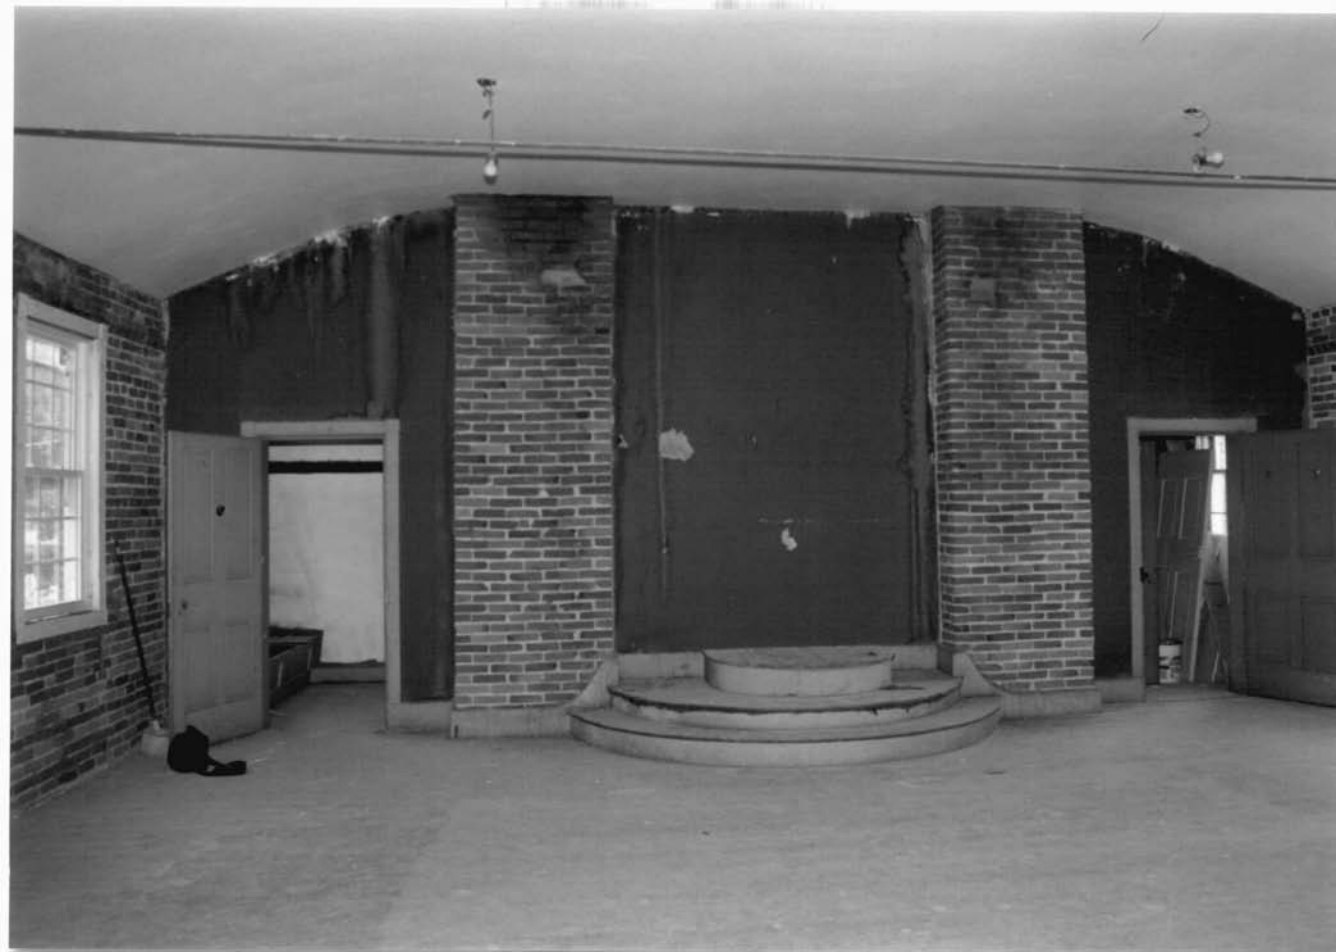
7 of 11

West end of 3rd floor rail/meeting space

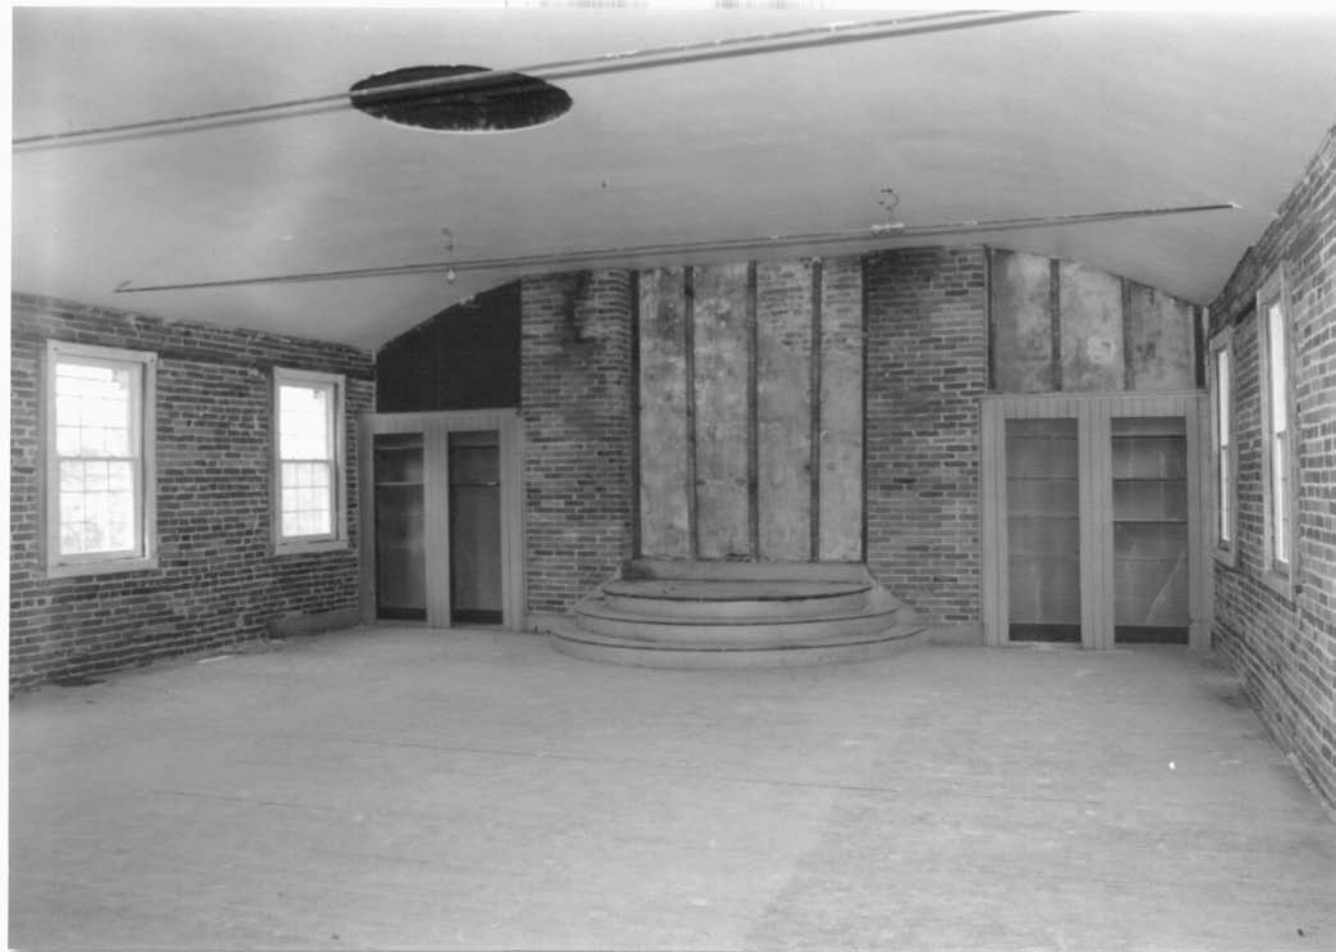
8 of 11

East end of 3rd floor hall/meeting space.

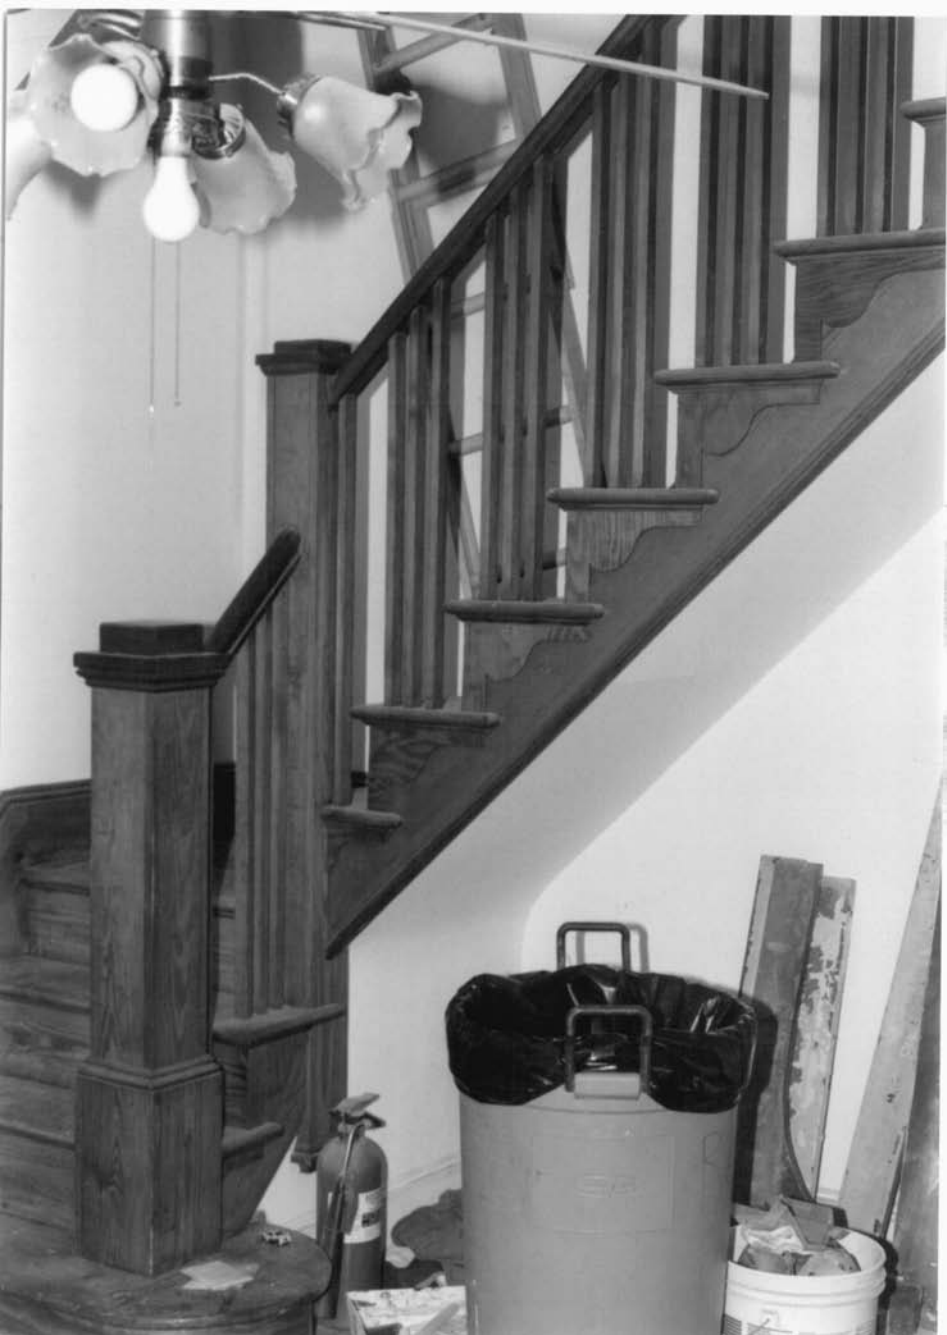
10 of 11

Stair in the center descending unit.

stair in the middle unit does have scroll decoration on the stair ends that may be original, and there is no reason to believe that the staircases themselves are not original. The other stair in the east end unit is currently lacking a balustrade and newel post, but the back of the stair has been opened up during the current renovation revealing that the boards are all sash sawn and the stair is constructed with machine headed cut nails.

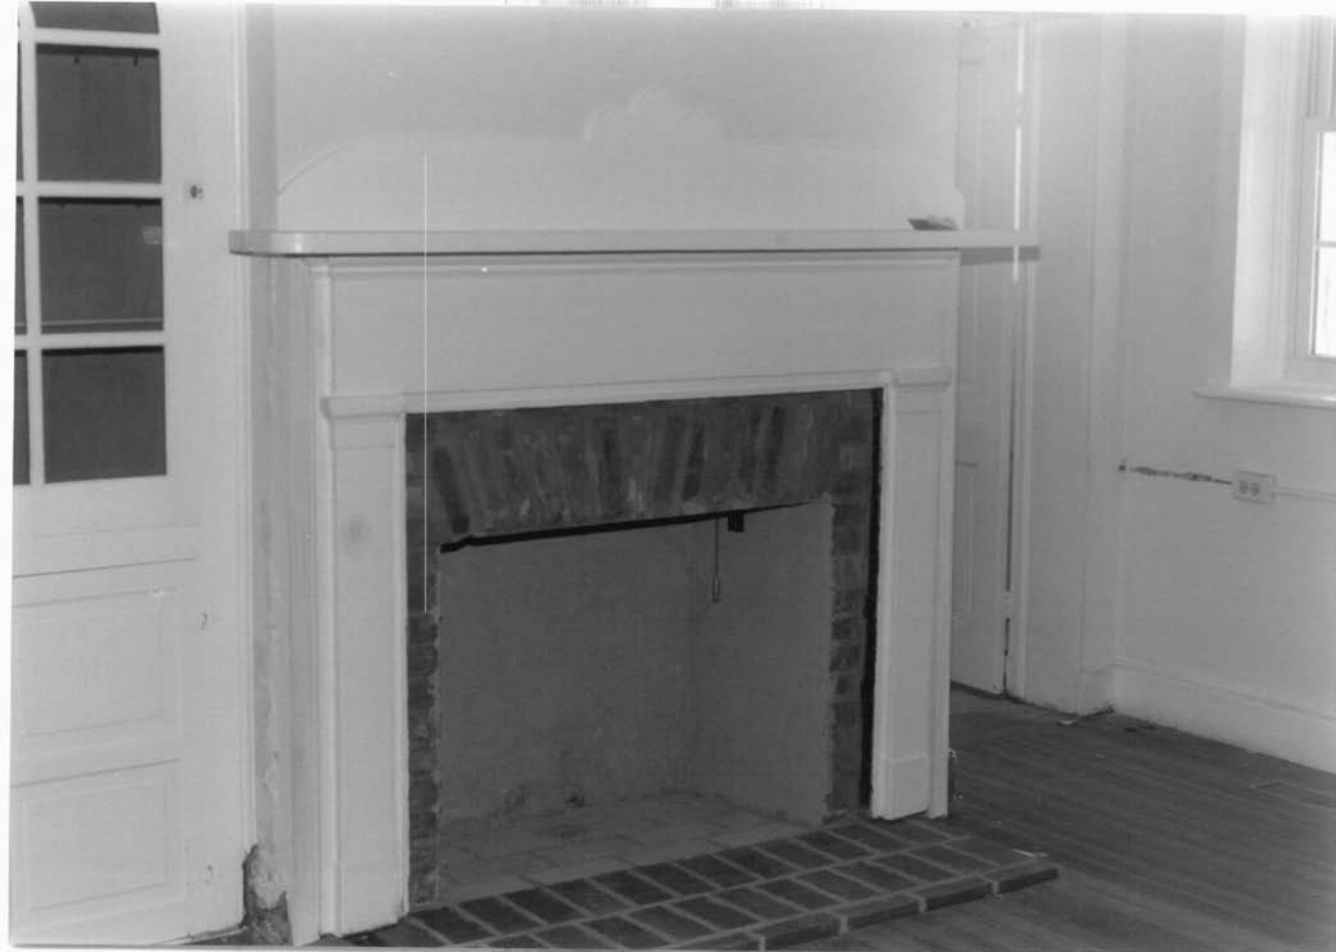
11 of 11

only remaining area of mantle with pieces added
to the top and sides

One original mantle remains in the house, though it has been altered during the current renovation. It is located in the first floor rear room in the middle unit and is a classic, simple Greek Revival wood mantle with bottom corner plinths, flat pilasters and frieze, and molded cornice. During the current renovation, reeded boards were added on either side of the original pilasters and a curved over mantle was added above the mantle shelf.
