Maryland Historical Trust State Historic Sites Inventory Form

Survey No. HO-571

historic Marlow House

city, town Highland vicinity vicinity of congressional district

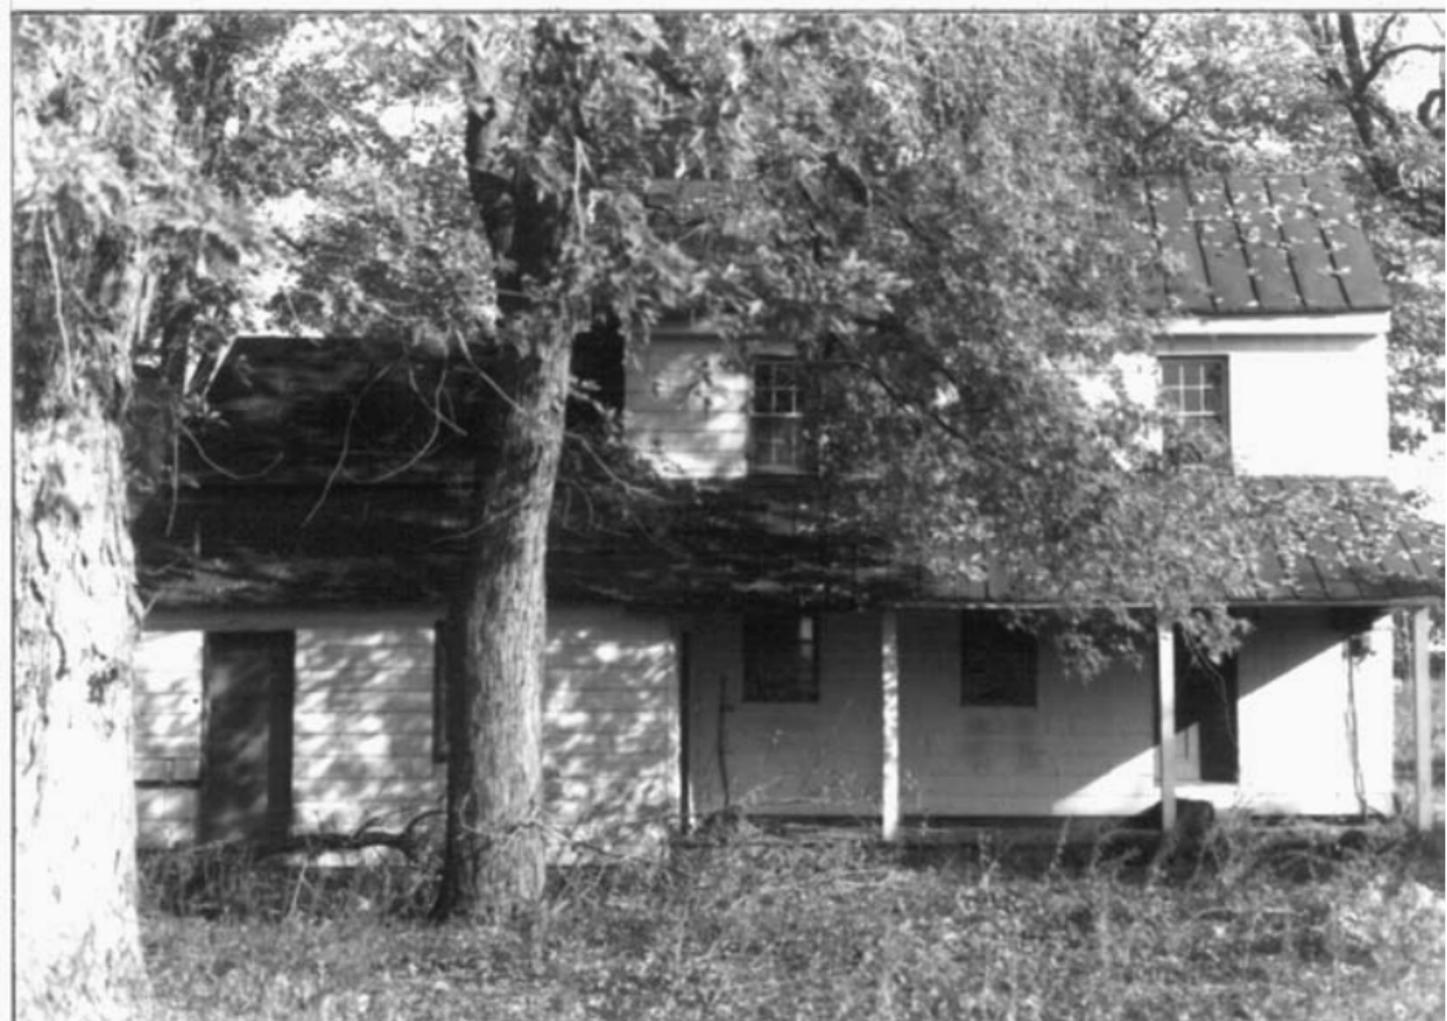
HO-571 Marlow House
Highland vicinity
Ed Shull 1981
South Facade

The south facade of the house appears to serve as the principal facade. The six-panel entrance door with three-light transom is located in the east bay, with two 6/6 windows to the west on the first story and three 6/6 windows ranged across the second story. The house rests on a stone foundation and is covered with horizontal weatherboards and a later covering of shingle siding. The eaves are enclosed with a plain box cornice; the roof is covered with standing seam metal. A one story open porch with plain posts and a standing seam metal roof extends across this facade of the main house.

JAMES MARLOW HOUSE
South View

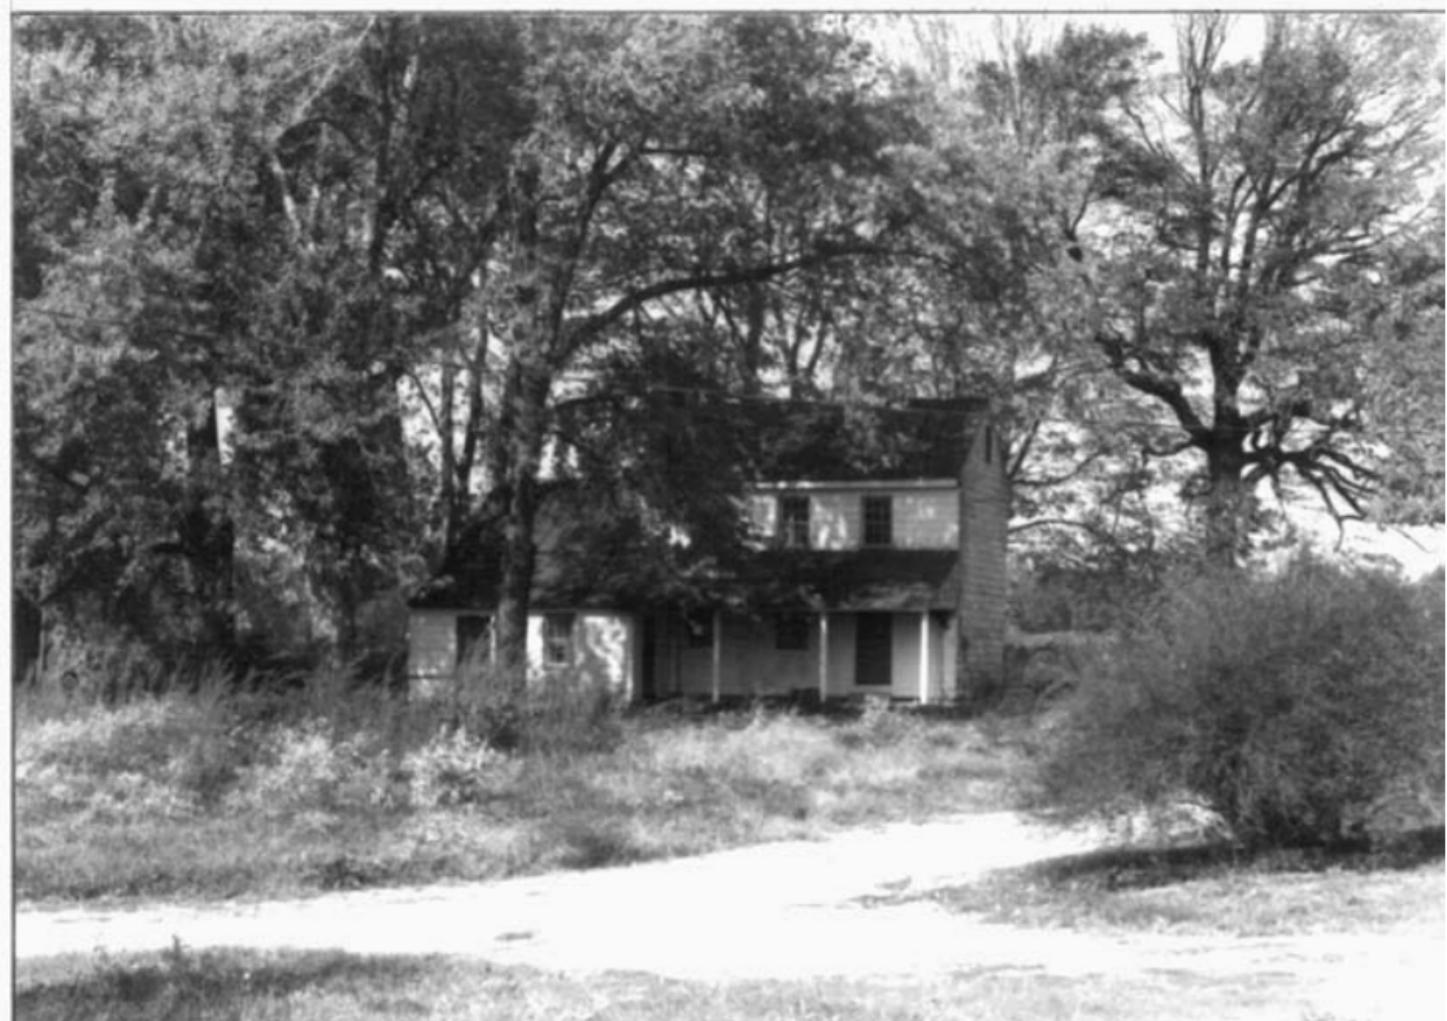
HO-571 Marlow House
Highland vicinity
Ed Shull 1981
View from South

*SOUTH FACADE -
CURRENT PRINCIPAL FACADE -
NORTH WAS ORIGINAL
PRINCIPAL FACADE
1. SYMMETRICAL PLANTING
OF ORNAMENTAL TREES
2. SHOWS OFF STAIRS
BETTER
3. SOUTH YARD CONTAINS
SERVICE ELEMENTS,
IE PUMP
BARN, CONC. 115 ETC.*

JAMES MARLOW HOUSE
South Elevation

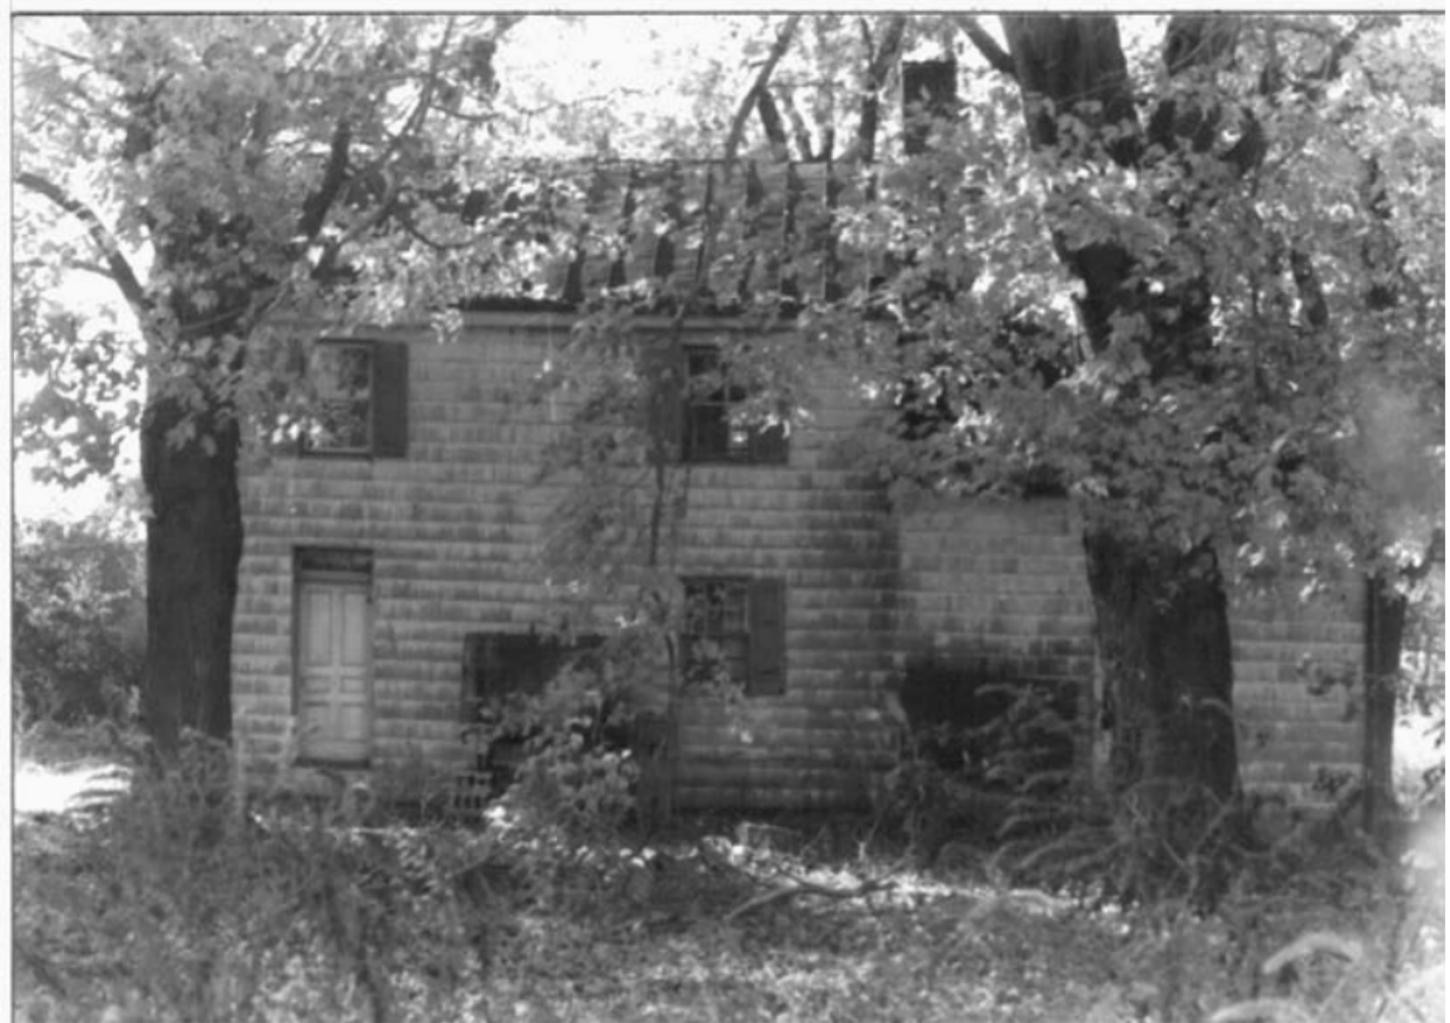
H0-571 Marlow House
Highland vicinity
Ed Shull 1981
North facade

On the north facade, there is a six-panel door with three-light transom in the east bay and one 6/6 window in the west bay of the first story; single 6/6 windows are located in the east and west bay of the second story.

JAMES MARLOW HOUSE
North Elevation

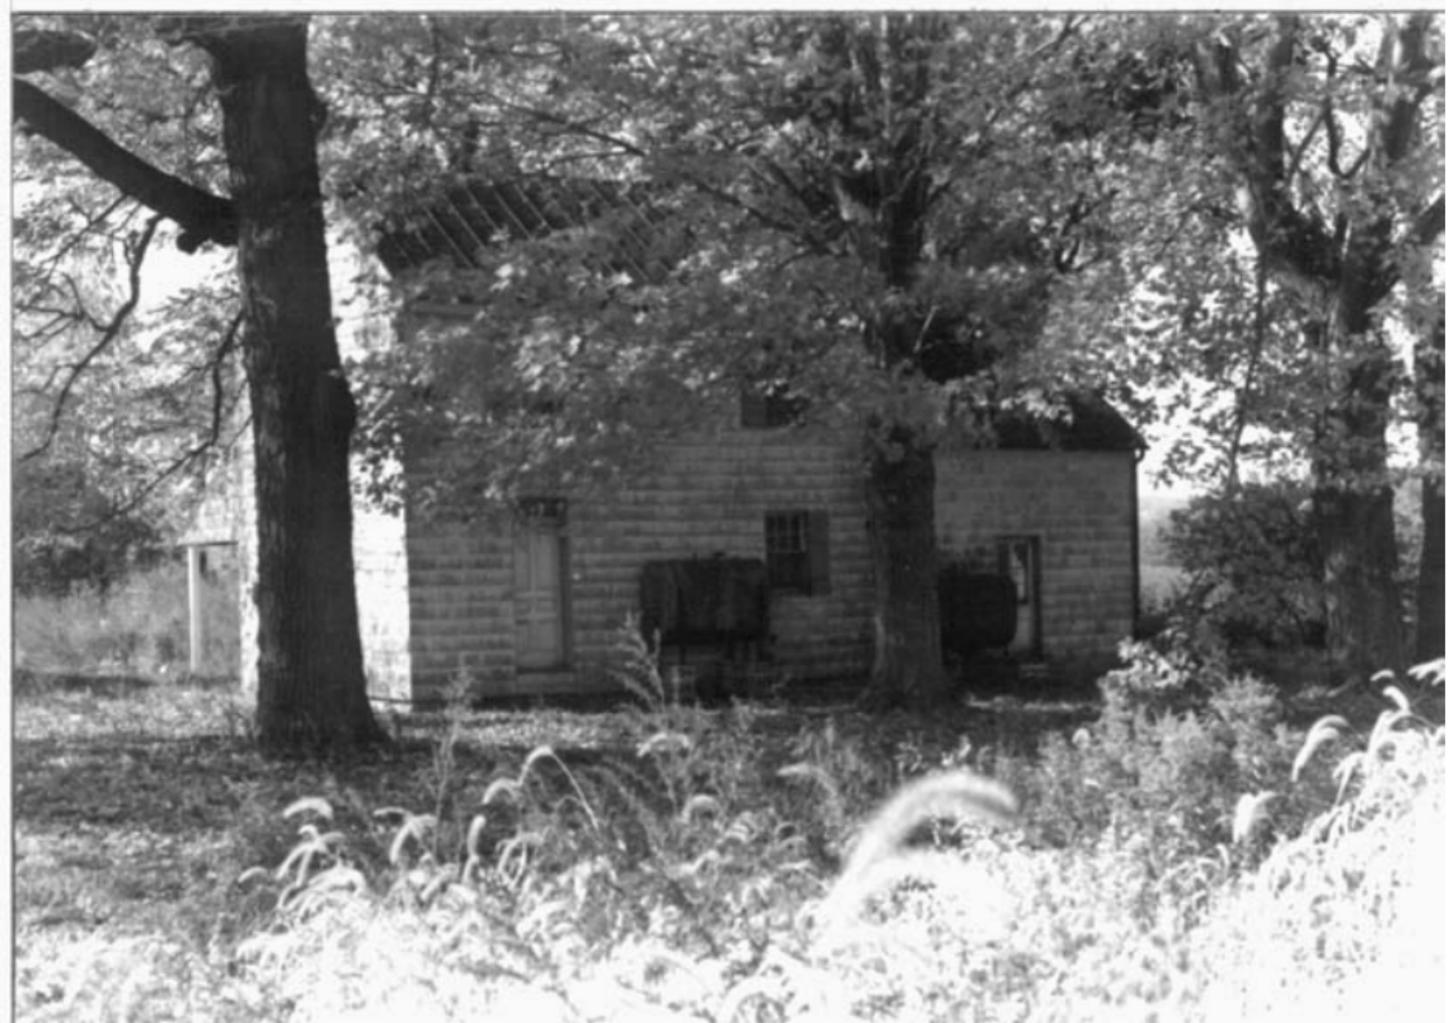
MARKLOW HOUSE

NORTH FACADE

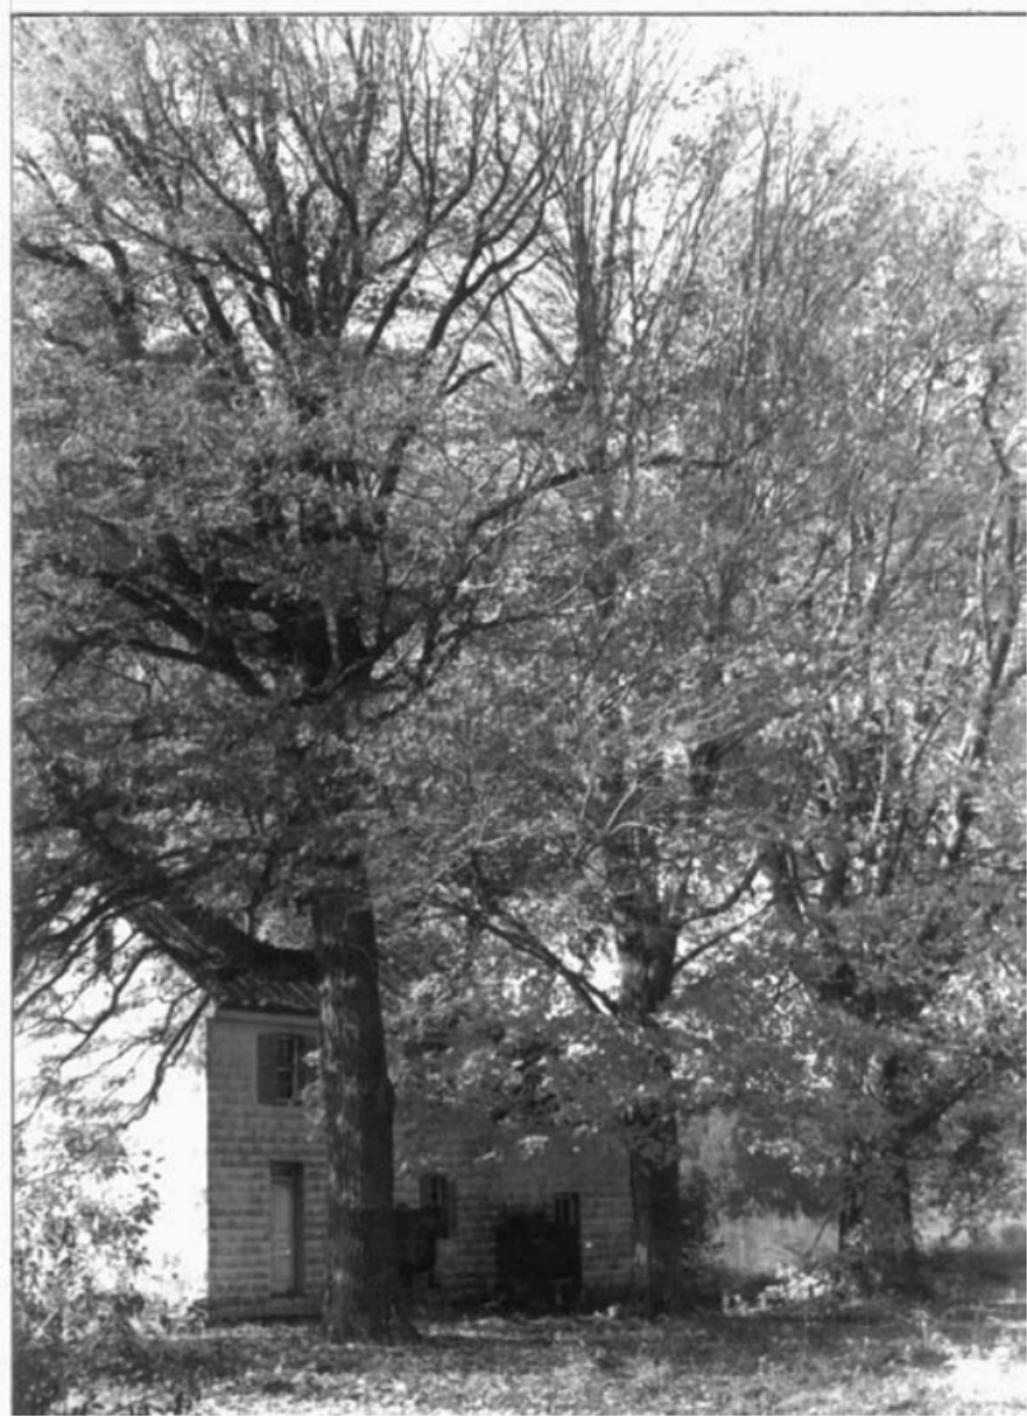
H0-571 Marlow House
Highland vicinity
Ed Shull 1981
View from Northeast

Note: Trees left to right

1. Tupelo
 2. Sugar maple
 3. Sugar maple
- } not native

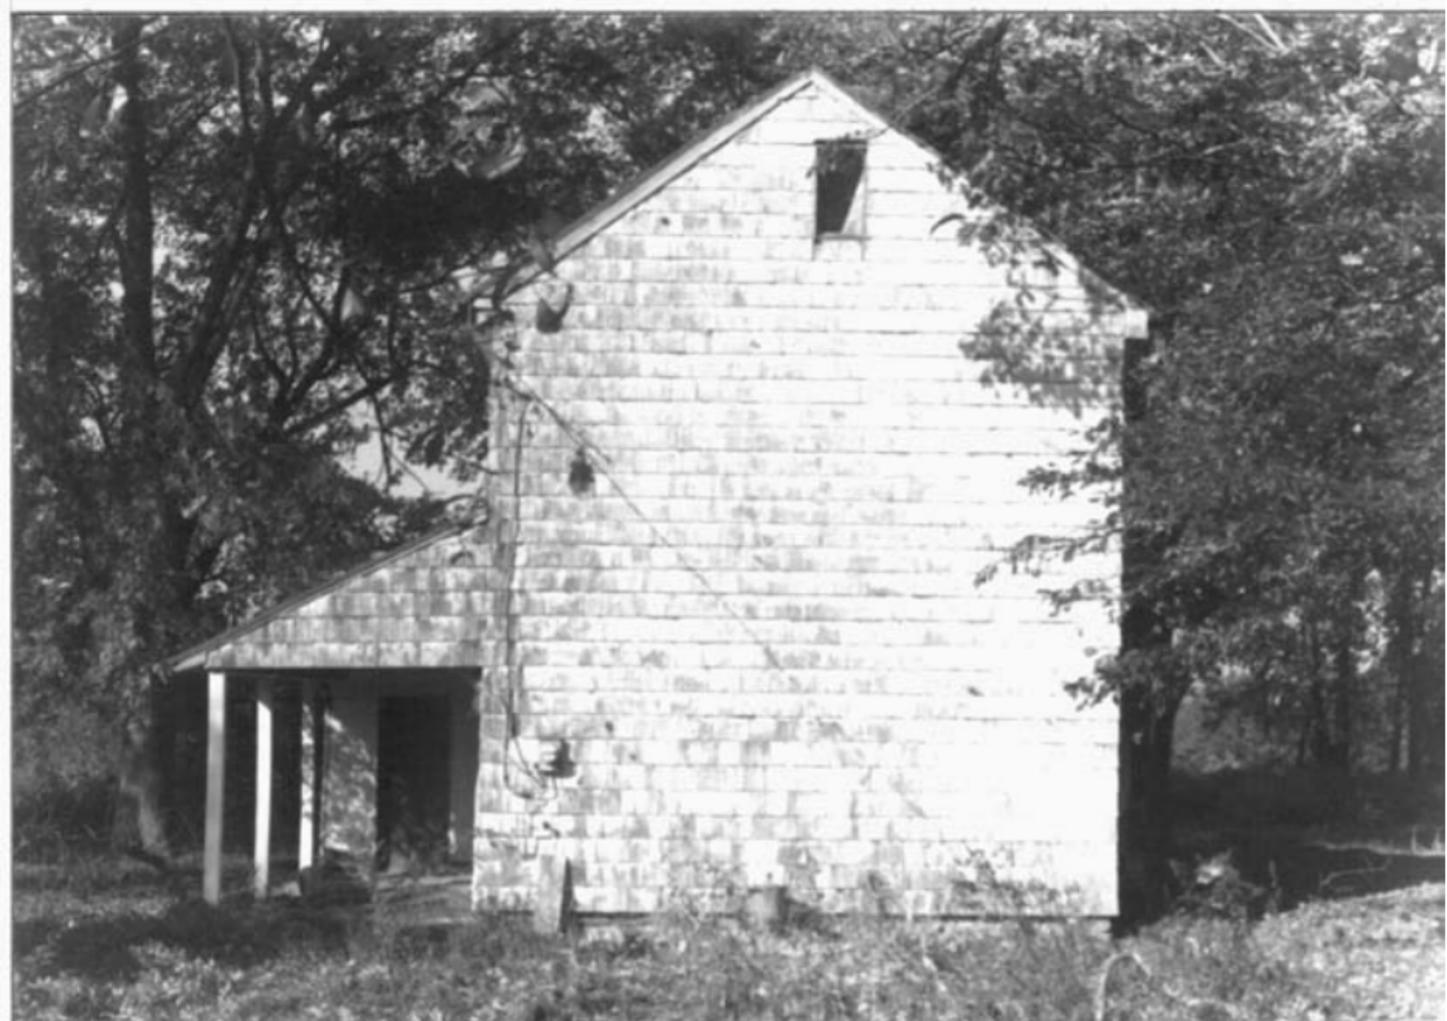
HO-571 Marlow House
Highland vicinity
Ed Shull 1981
East Gable

A small window offset to right of center in the upper gable is the only opening in the east gable wall. The stone foundation and wood shingle siding match the south facade; the rake-boards are plain.

JAMES MARLOW HOUSE
East Elevation

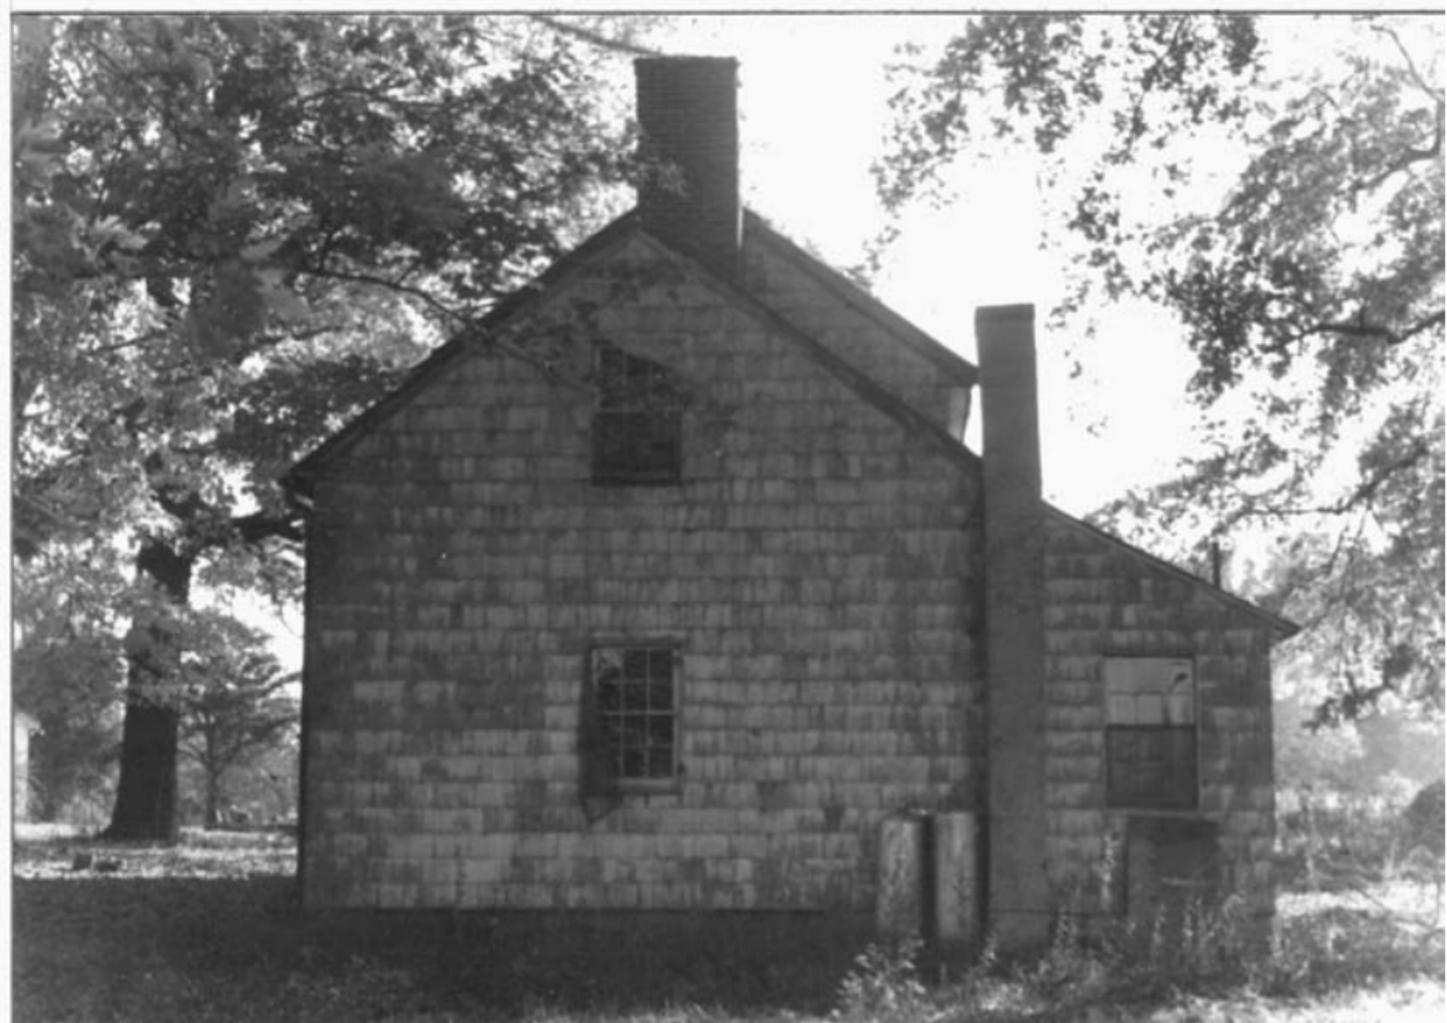
H0-571 Marlow House
Highland vicinity
Ed Shull 1981
West gable of wing

Single 6/6 windows are centered on the first and second story of the west gable wall of the wing and a 6/6 window pierces this end of the lean-to.

JAMES MARLOW HOUSE
West Elevation

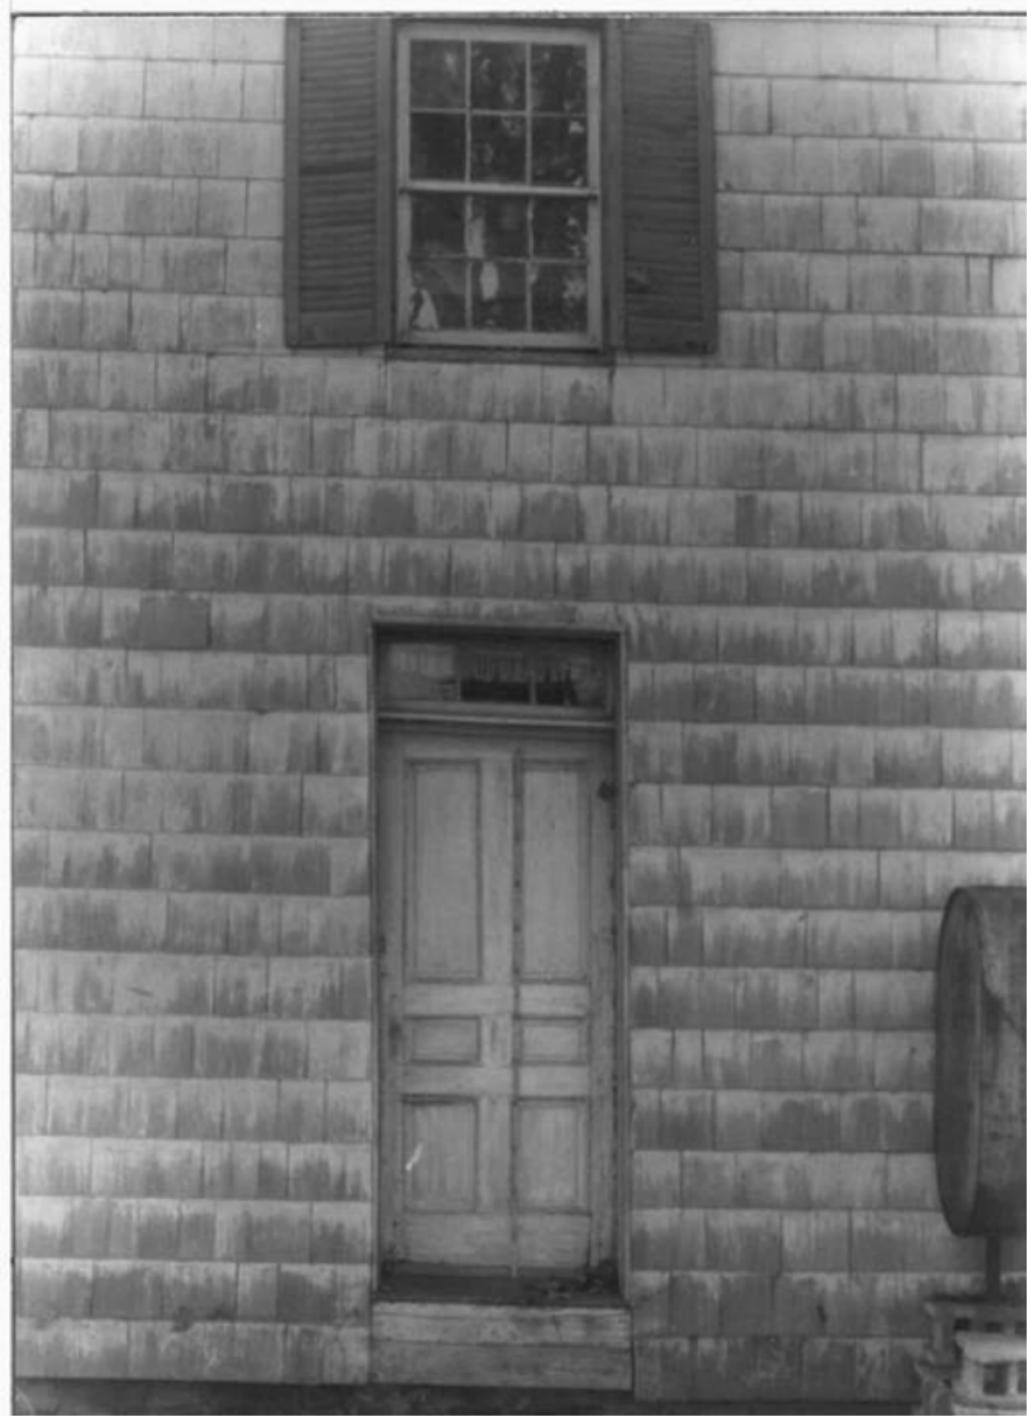
Marlow House
Highland vicinity
Ed Shull 1981
North Door

North Elevation

Door - 4 Window - 9

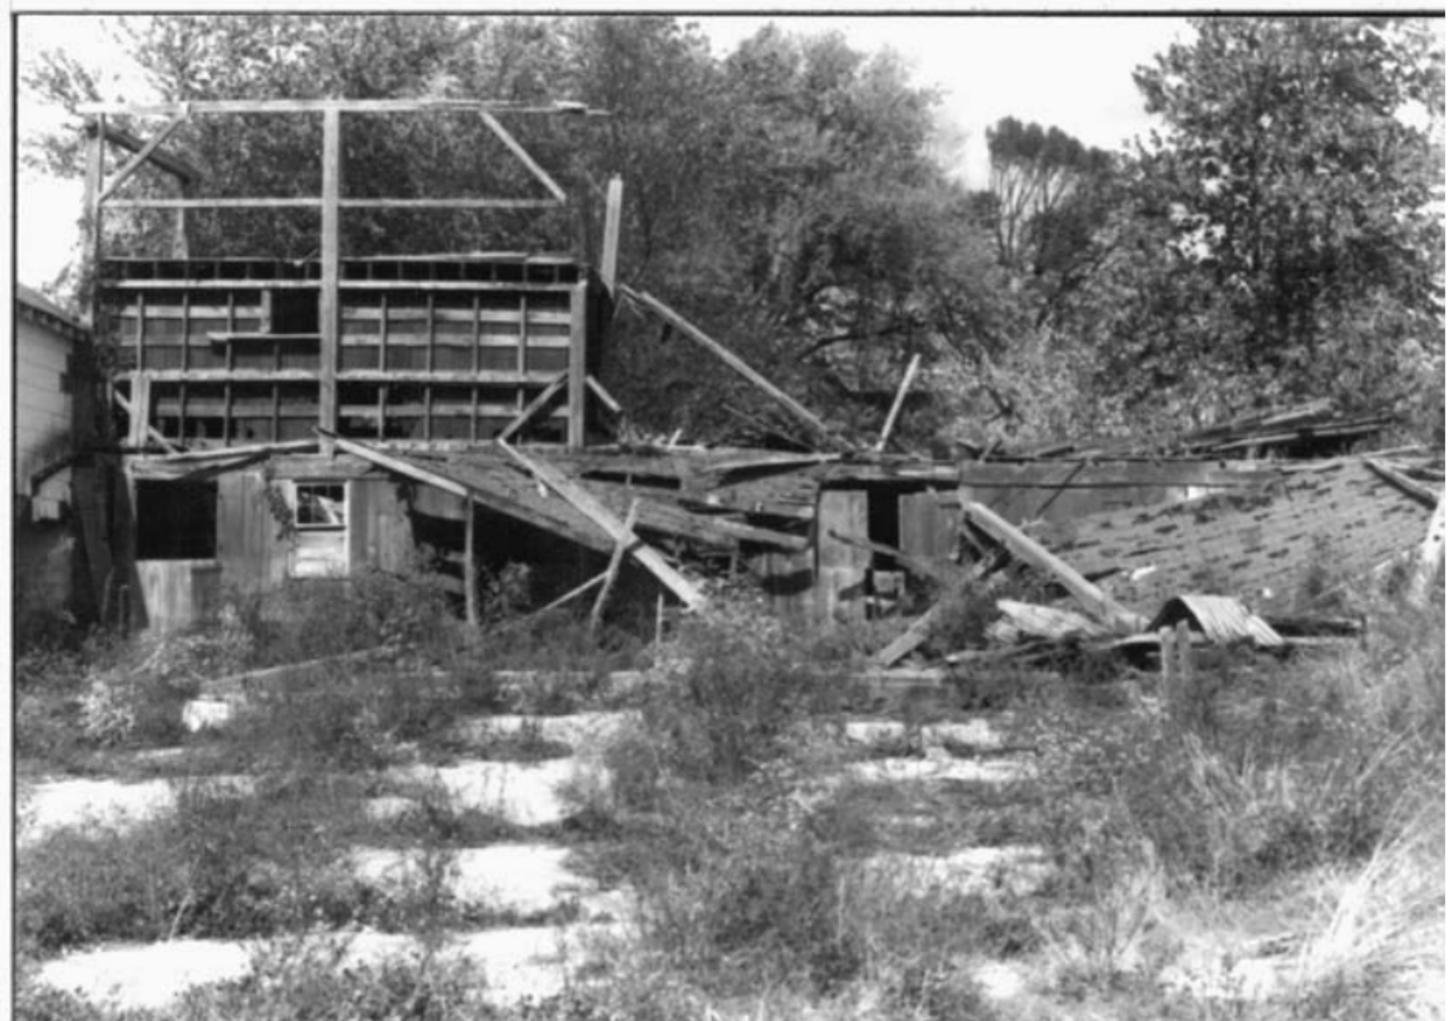
HO-571 Marlow House
Highland vicinity
Ed Shull 1981
Ruins of Barn

The house is sited on high ground along the south side of Hall Shop Road and is oriented on an east-west axis. A complex of late 19th and 20th century farm buildings is located to the south of the house. Most of these buildings are in very poor condition.

JAMES MARLOW HOUSE
Ruined Barn 20th C.
House Beyond

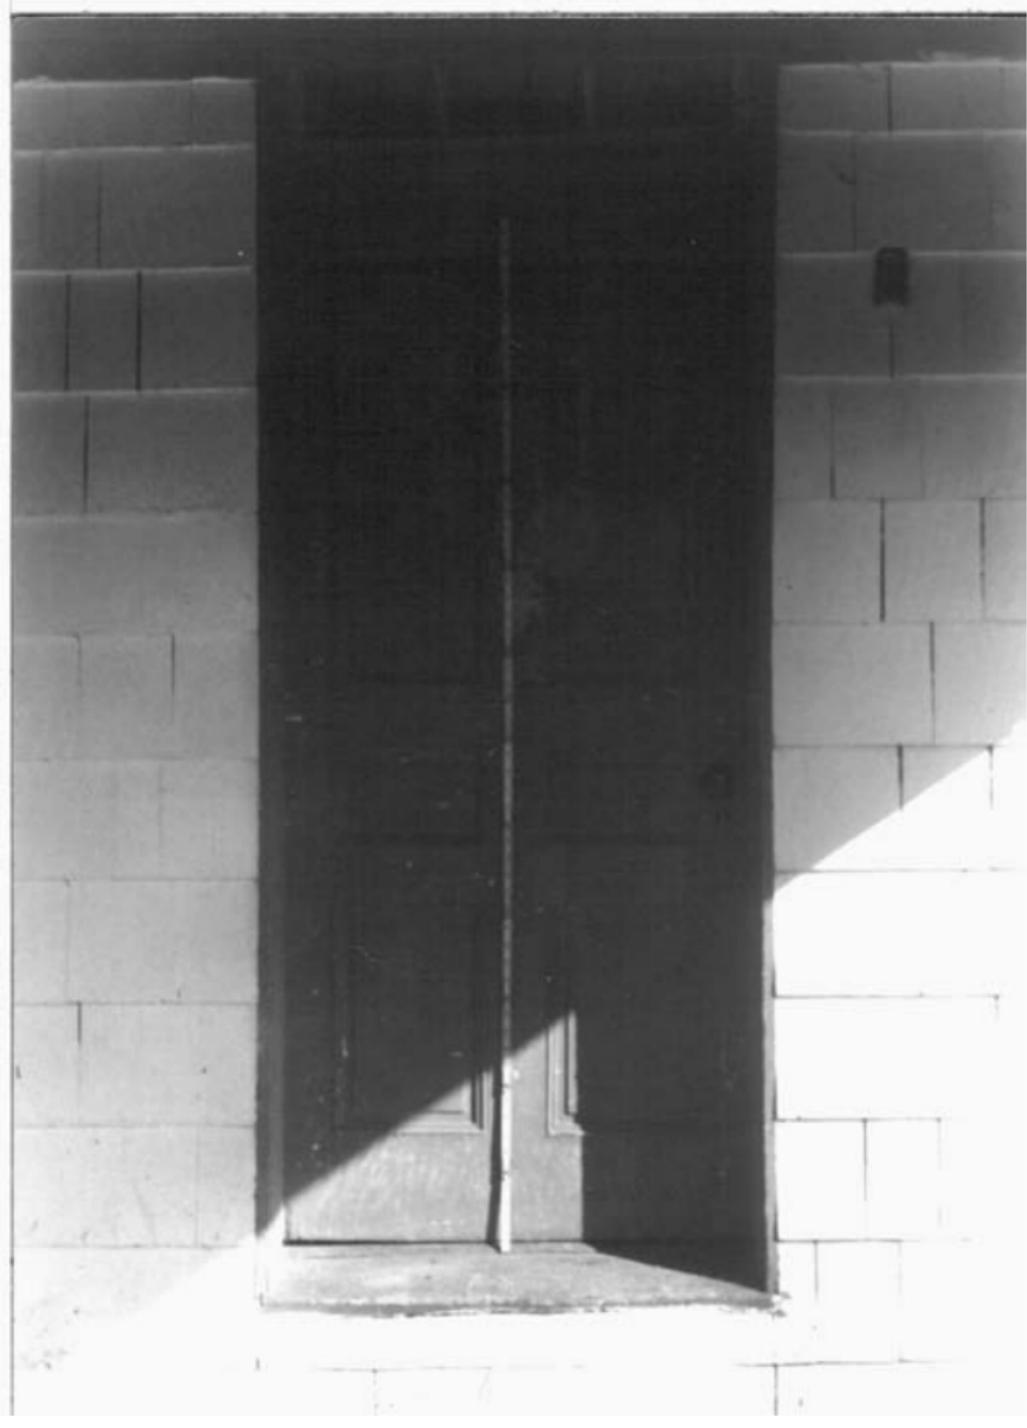
Marlow House
Highland vicinity
Ed Shull 1981
South Door

South Facade Door 2

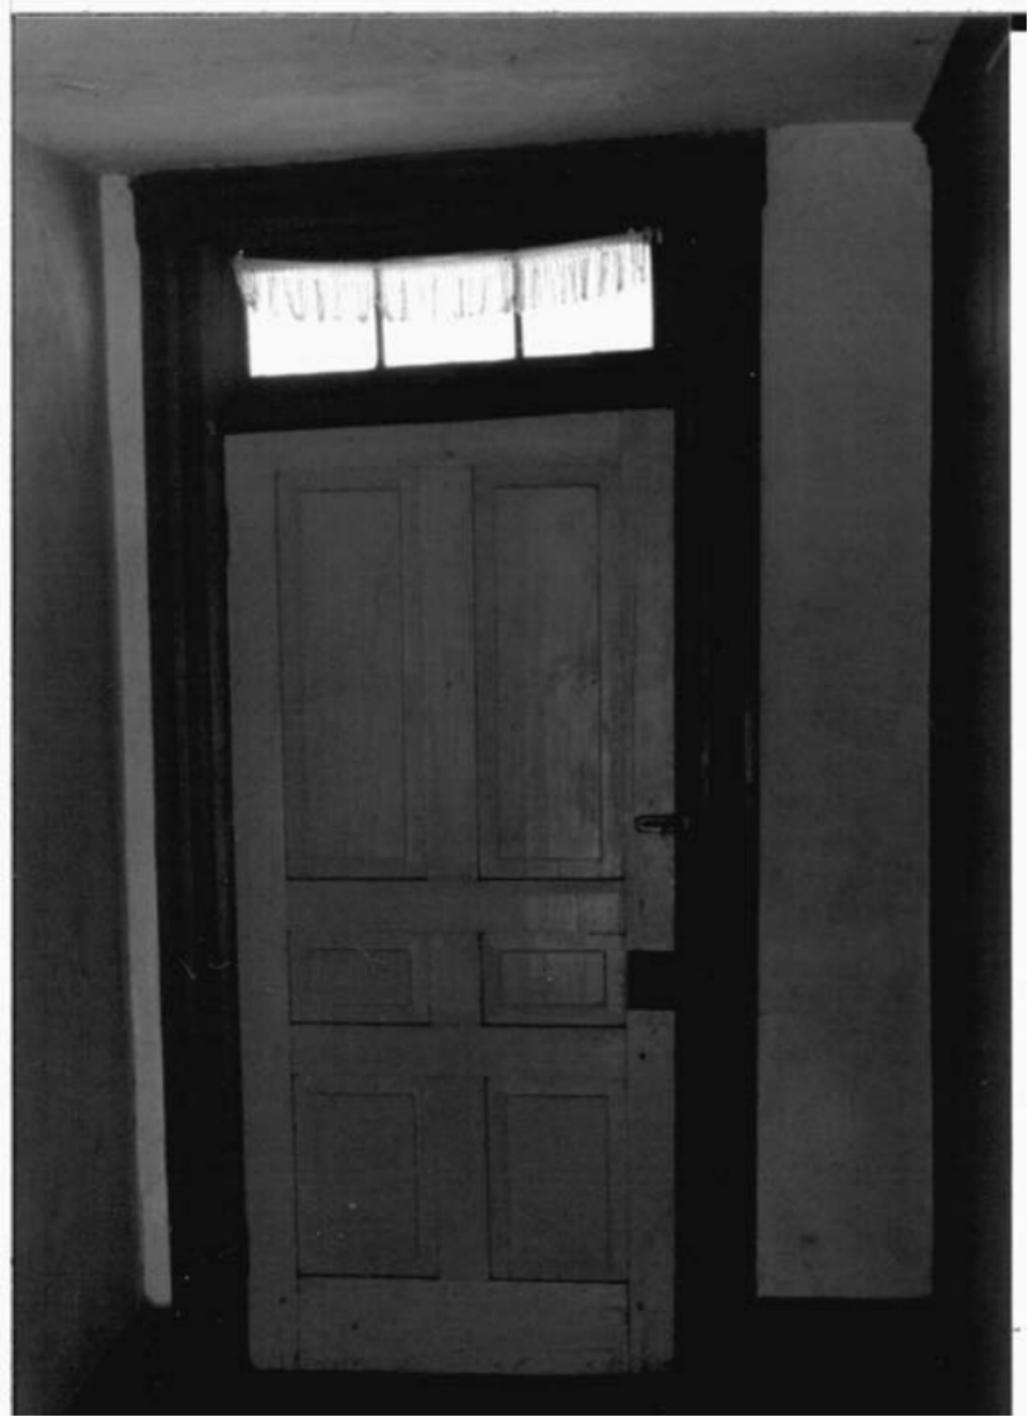
MAIN HOUSE.

FIRST FLOOR - SIDE HALL

NORTH WALL

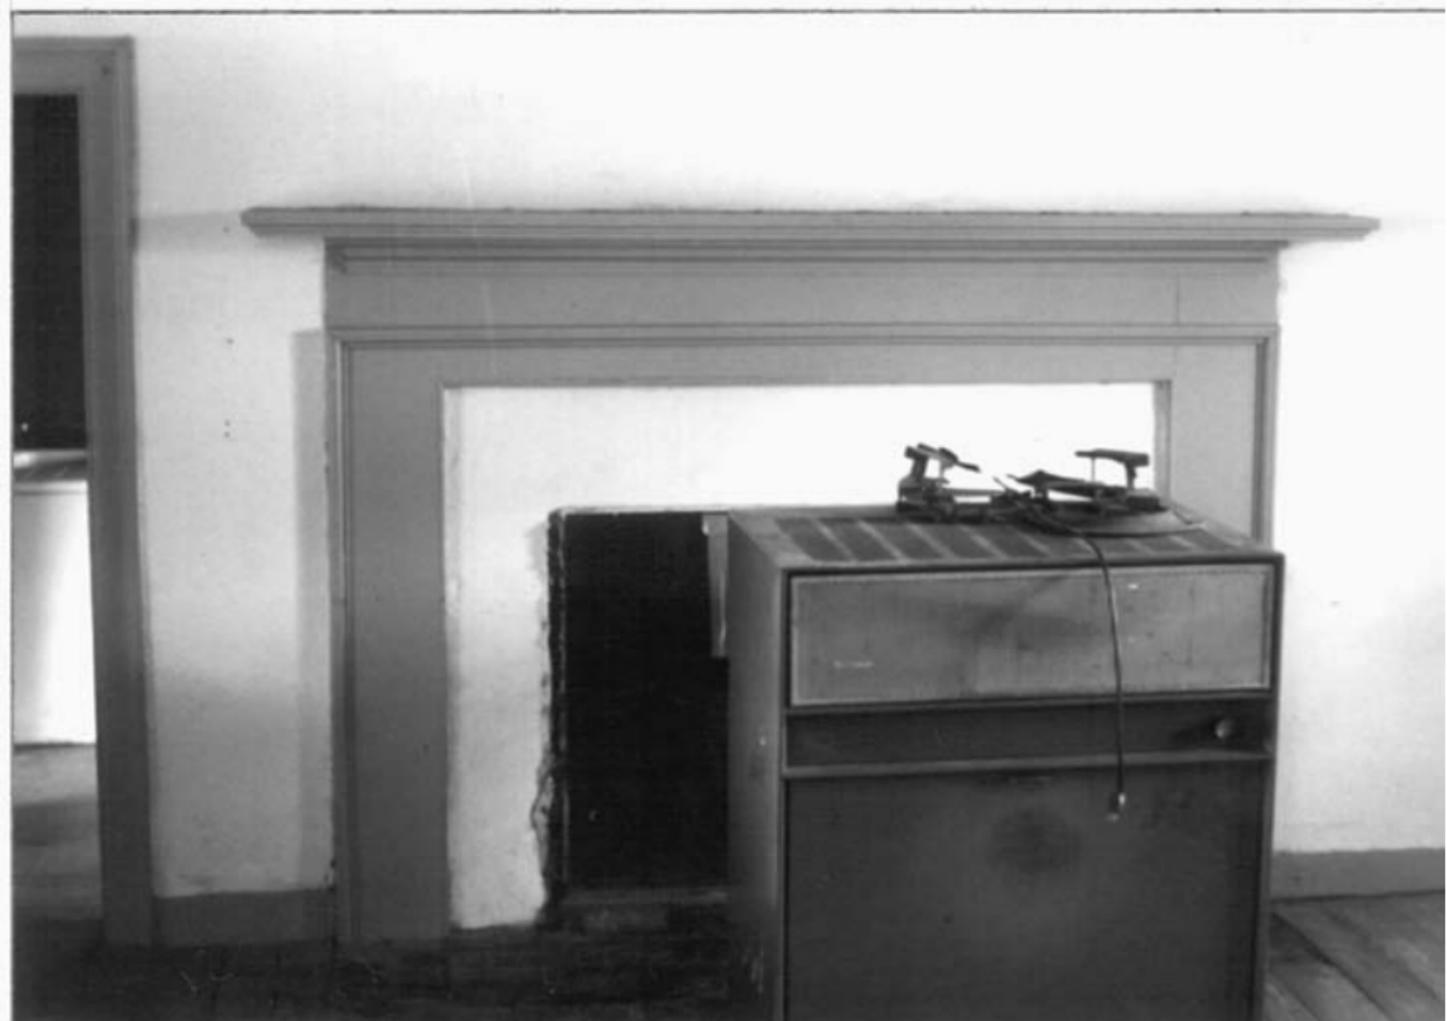
HO-571 Marlow House
Highland vicinity
Ed Shull 1981
Parlor Mantel

Marlow House is a two story example of a side passage, single parlor plan house with a true story-and-a-half kitchen wing. The main house appears to be of log construction. Significant interior details include a Greek Revival mantel and ovolo window architrave trim in the parlor, an open-string stair with grained beaded vertical board paneling in the passage, and evidence of an early cooking crane in the kitchen fireplace.

JAMES MARLOW HOUSE
Mantle in Large
Section

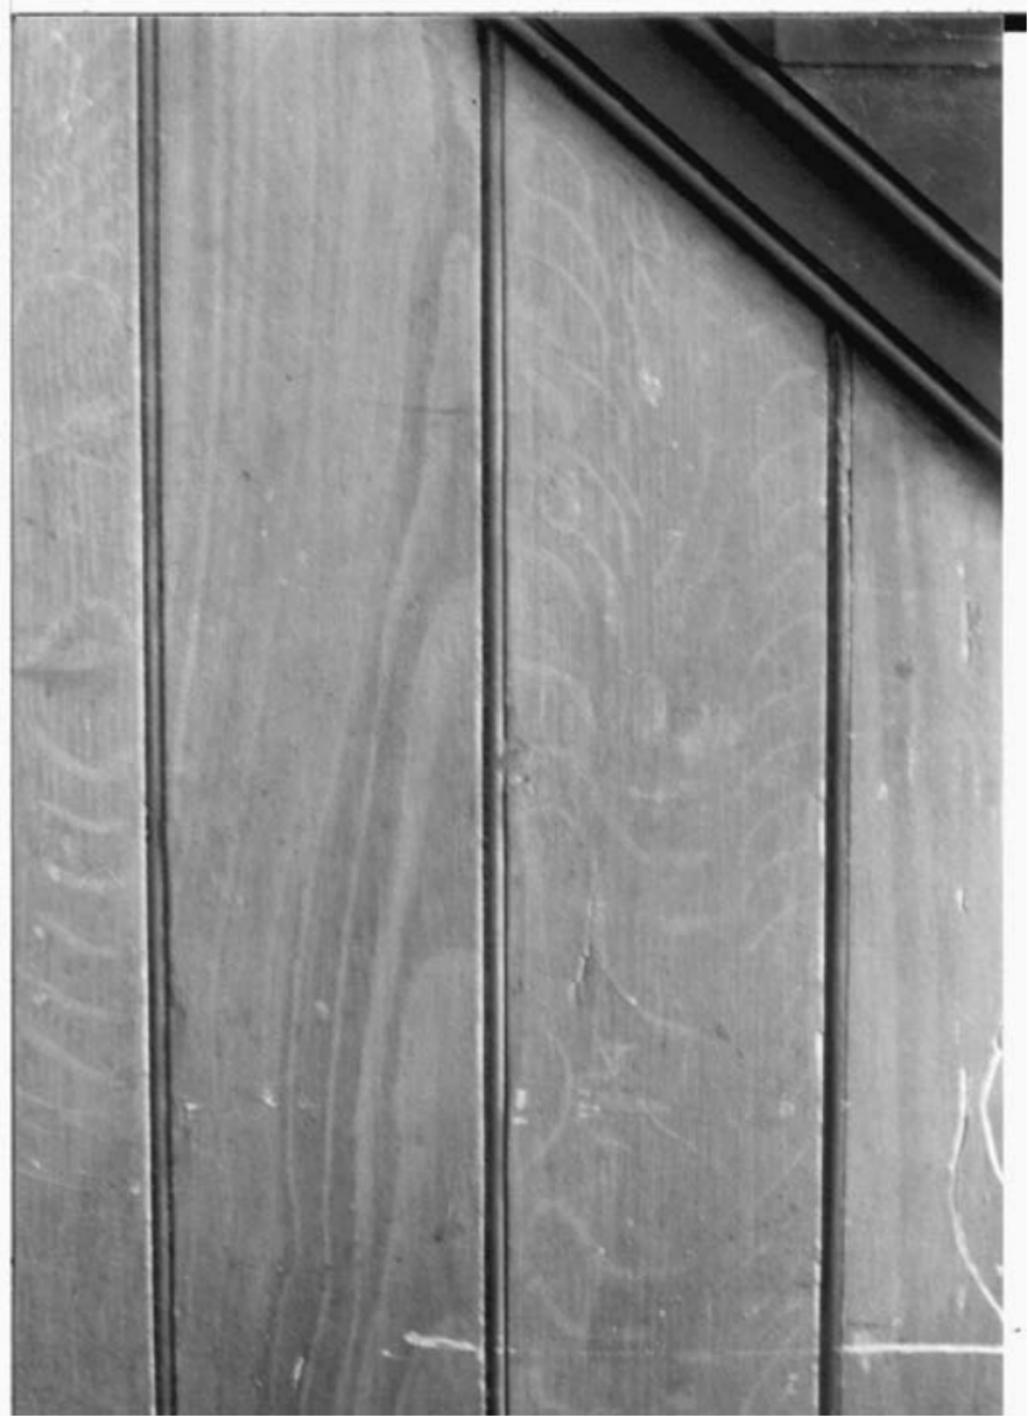
The interior of the main house consists of a side stair passage to east and a single large parlor to the west. The stair rises from the south end of the passage against the west gable wall. It is an open-string stair with square newels and balusters and a plain rail. The area below the carriage is enclosed with beaded vertical boards with ochre graining. A beaded batten door opens into a small closet under the stairs. A four-panel door opens from the passage into the parlor. The fireplace is centered on the west gable wall of the parlor. The mantel is a board surround with a molded backband framing the fireplace opening and a complex shelf with Greek Revival molding above a plain frieze. The window and door openings in the parlor are trimmed with beaded architraves with an ovolo backband more typical of the 18th or very early 19th century.

OCHK GRAINING

SIDE STAIR PASSAGE

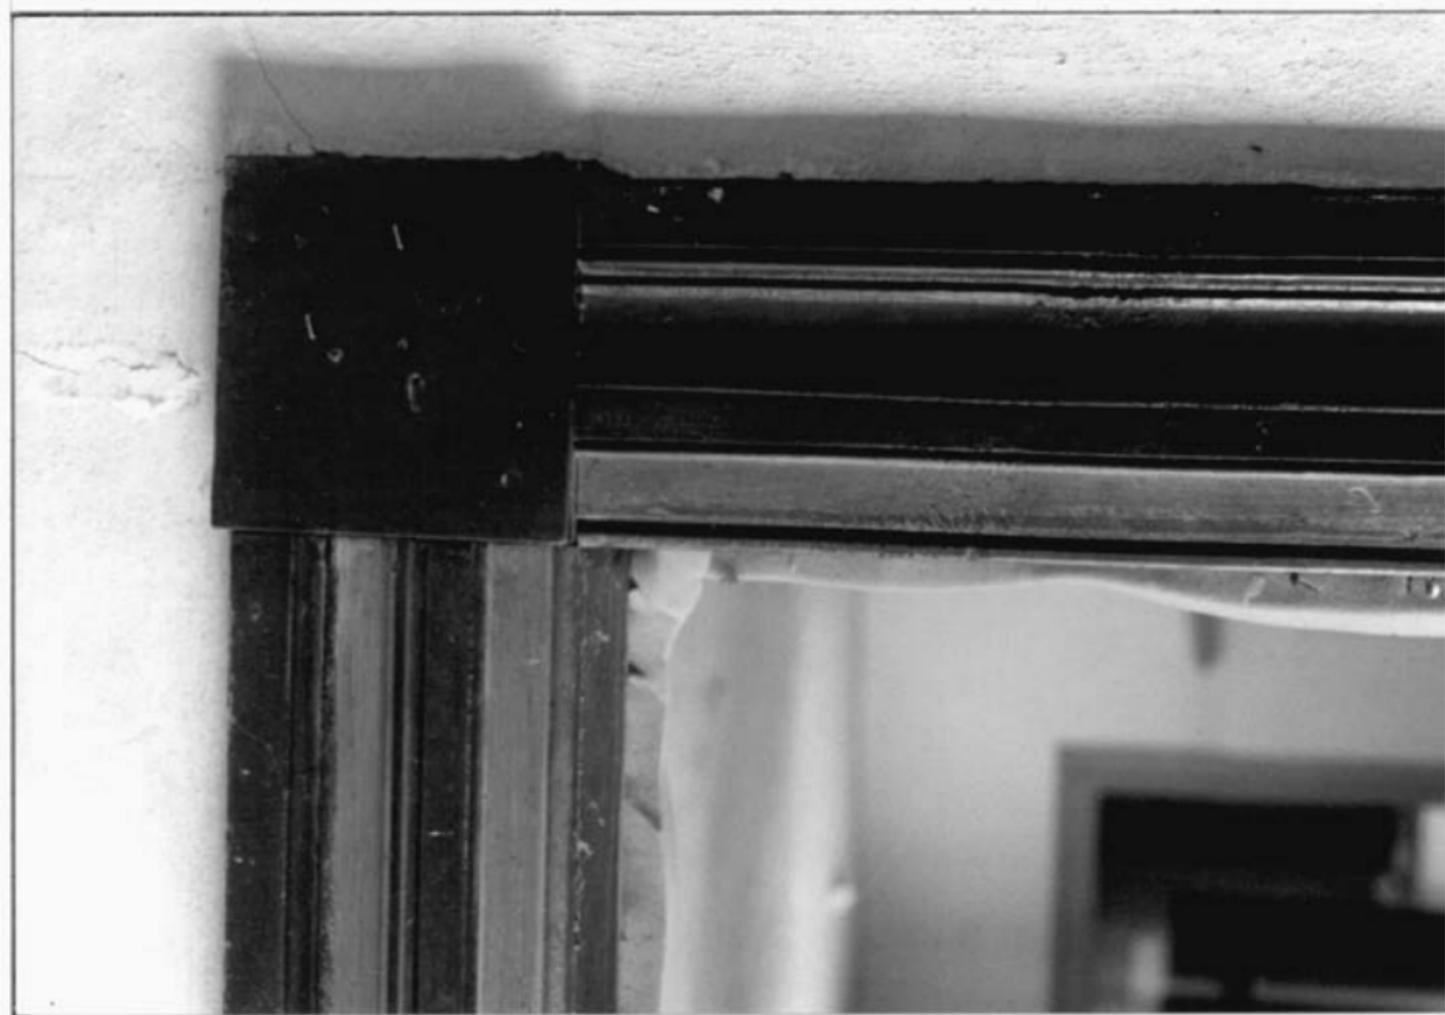
SIDE HALL - WEST WALL -

WOODWORK DETAIL

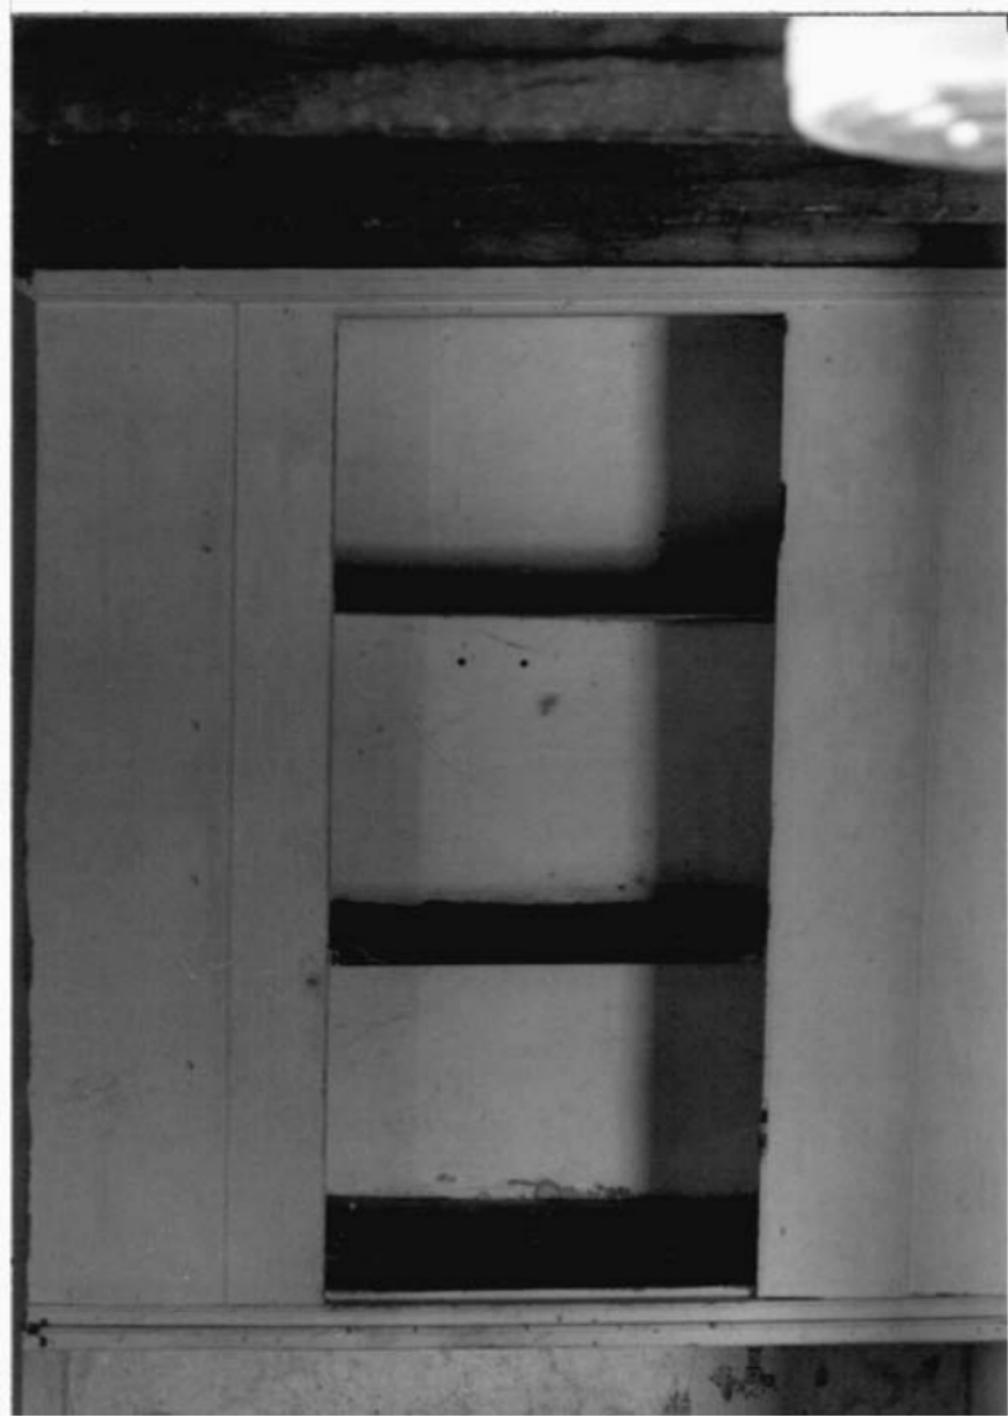
The interior of the west wing consists of a single room on each floor and one narrow room in the south lean-to. A large fireplace on the east wall of the first floor room retains the iron pintles for a fireplace cooking crane. A small built-in cupboard is located in the alcove to the left of the chimney. An enclosed winder stair is located in the northwest corner of the wing. The first floor ceiling joists remain exposed.

BUILT-IN CLIPBOARD -

WEST WING
