Maryland Historical Trust State Historic Sites Inventory Form

Survey No. HO-571

historic Marlow House

city, town Highland vicinity vicinity of congressional district

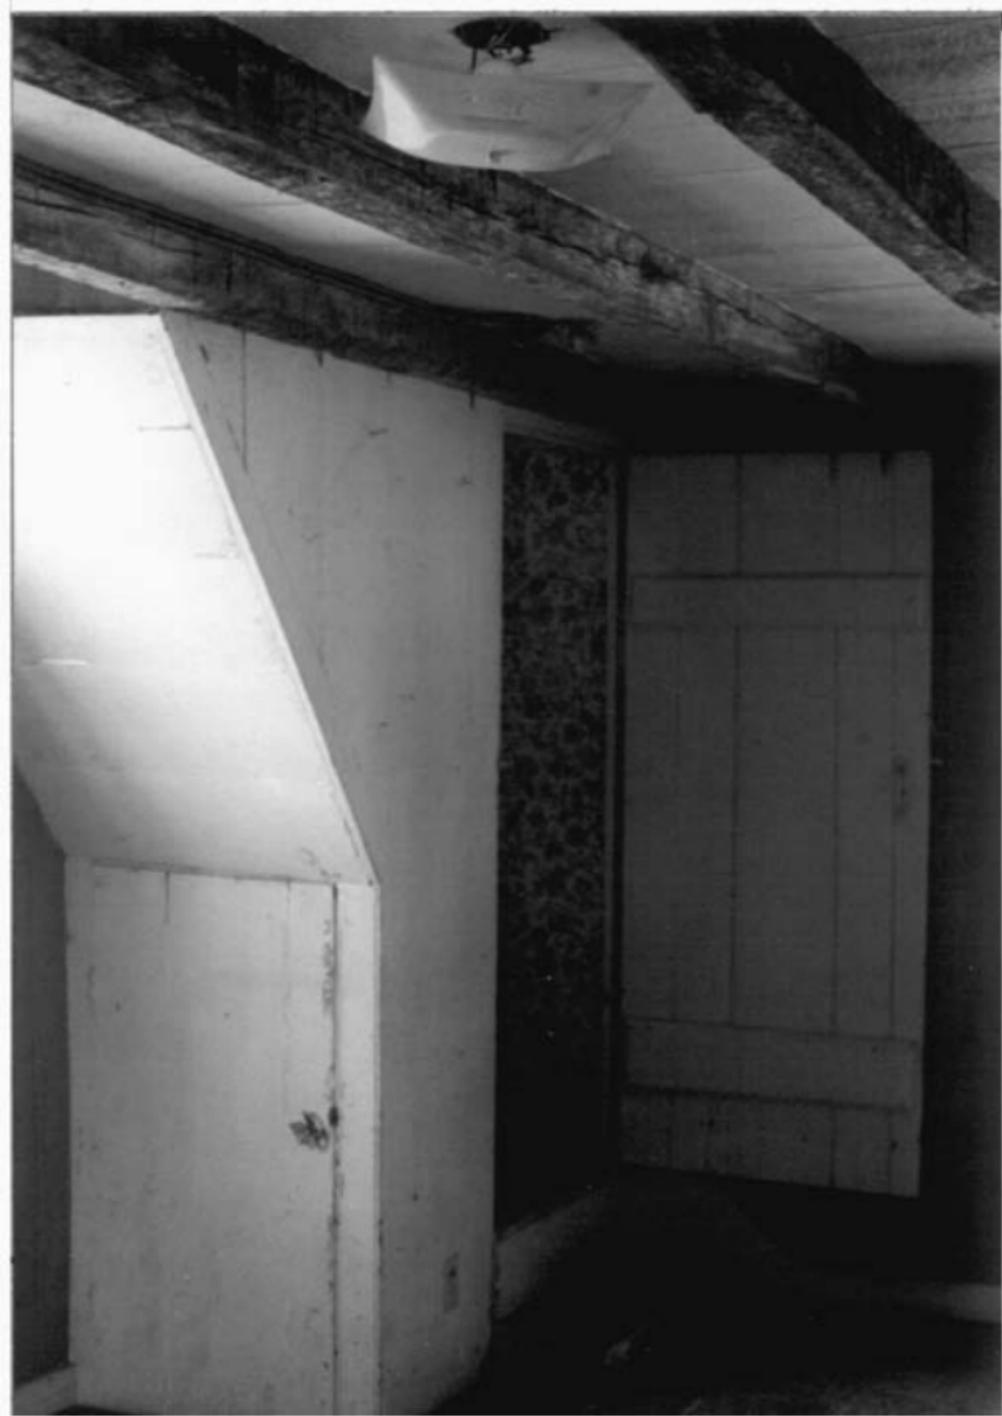
The interior of the west wing consists of a single room on each floor and one narrow room in the south lean-to. A large fireplace on the east wall of the first floor room retains the iron pintles for a fireplace cooking crane. A small built-in cupboard is located in the alcove to the left of the chimney. An enclosed winder stair is located in the northwest corner of the wing. The first floor ceiling joists remain exposed.

INTERIOR of 1¹/₂ STORY

WEST WING.
