INDIVIDUAL PROPERTY/DISTRICT  
MARYLAND HISTORICAL TRUST  
INTERNAL NR-ELIGIBILITY REVIEW FORM

Property/District Name: Edward T. Clark Farm Survey Number: HO-647

Survey No. HO-647  
Edward Talbott Clark Farm  
Buildings Complex  
Howard County, MD

# Maryland Historical Trust State Historic Sites Inventory Form

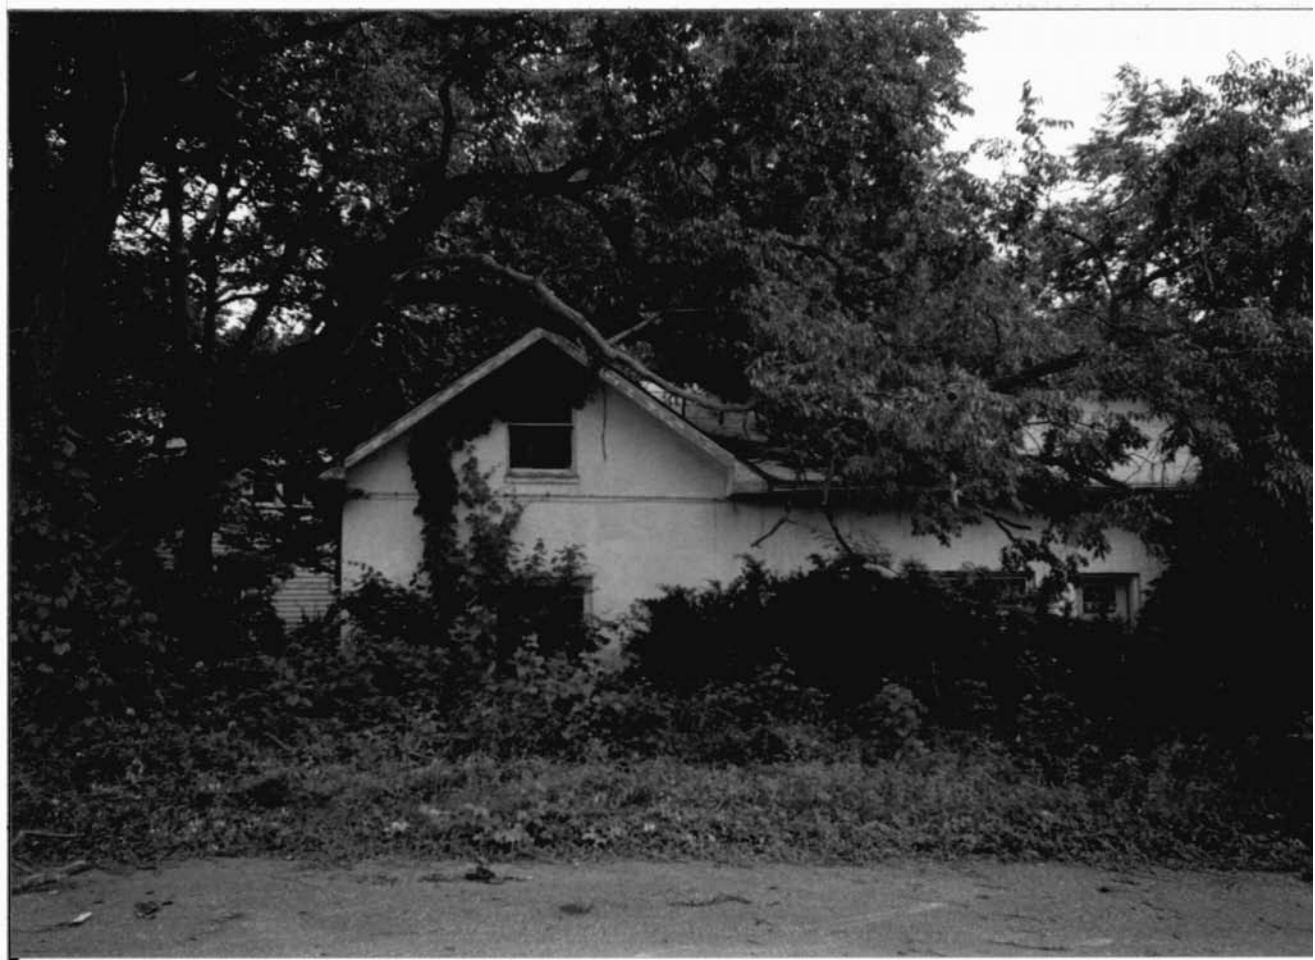
1 OF 13

This dwelling is rectangular in shape, 31 feet wide by 43 feet long. The long axis of the building is oriented along a 64 degree magnetic azimuth. This building is constructed of cement block and its exterior finish is stucco. There is a crawl space under the house. The windows are double hung, six over six. The exterior walls of the structure are in good condition. The interior of the building is deteriorated due to lack maintenance. The roof is of the gable type and is "T" shaped. Two brick chimneys extend through the roof, which is covered with asphalt shingles. The roof is severely deteriorated and partially collapsed.

STRUCTURE #1, MINIMAL TRADITIONAL STYLE  
DWELLING, FRONT ELEVATION, LOOKING S.E.

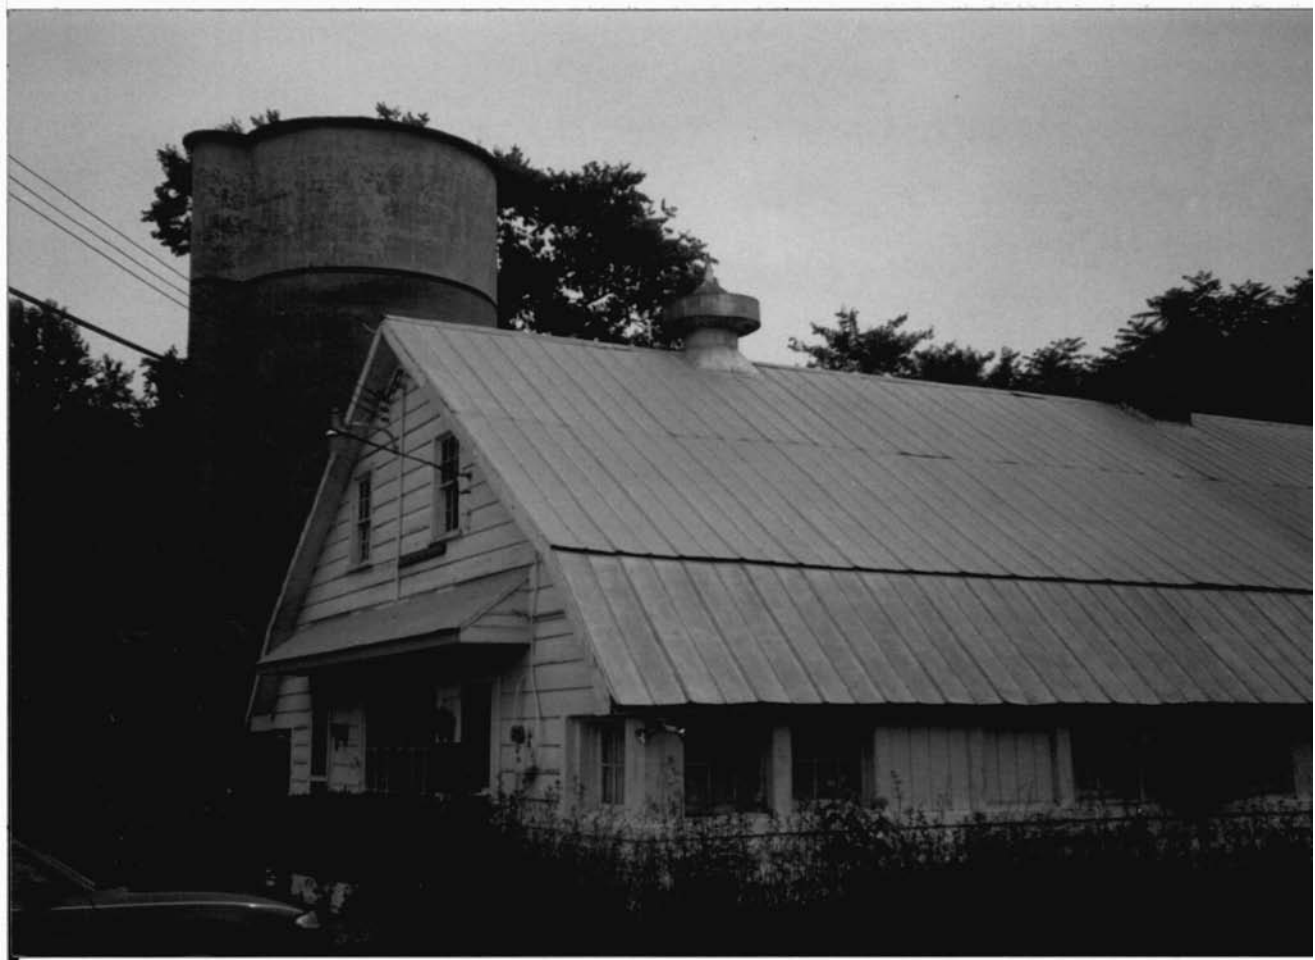
3 OF 13

The side walls of Structure # 2 are constructed of concrete masonry units (CMUs) with a 5-inch concrete cap. Above the masonry along both sides of the barn there is a nearly continuous row of six pane sash windows, each 32 inches wide by 30 inches tall. Some of the window openings have been closed off with plywood.

STRUCTURE #2, DAIRY BARN, SIDE ELEVATION,  
LOOKING S.E.

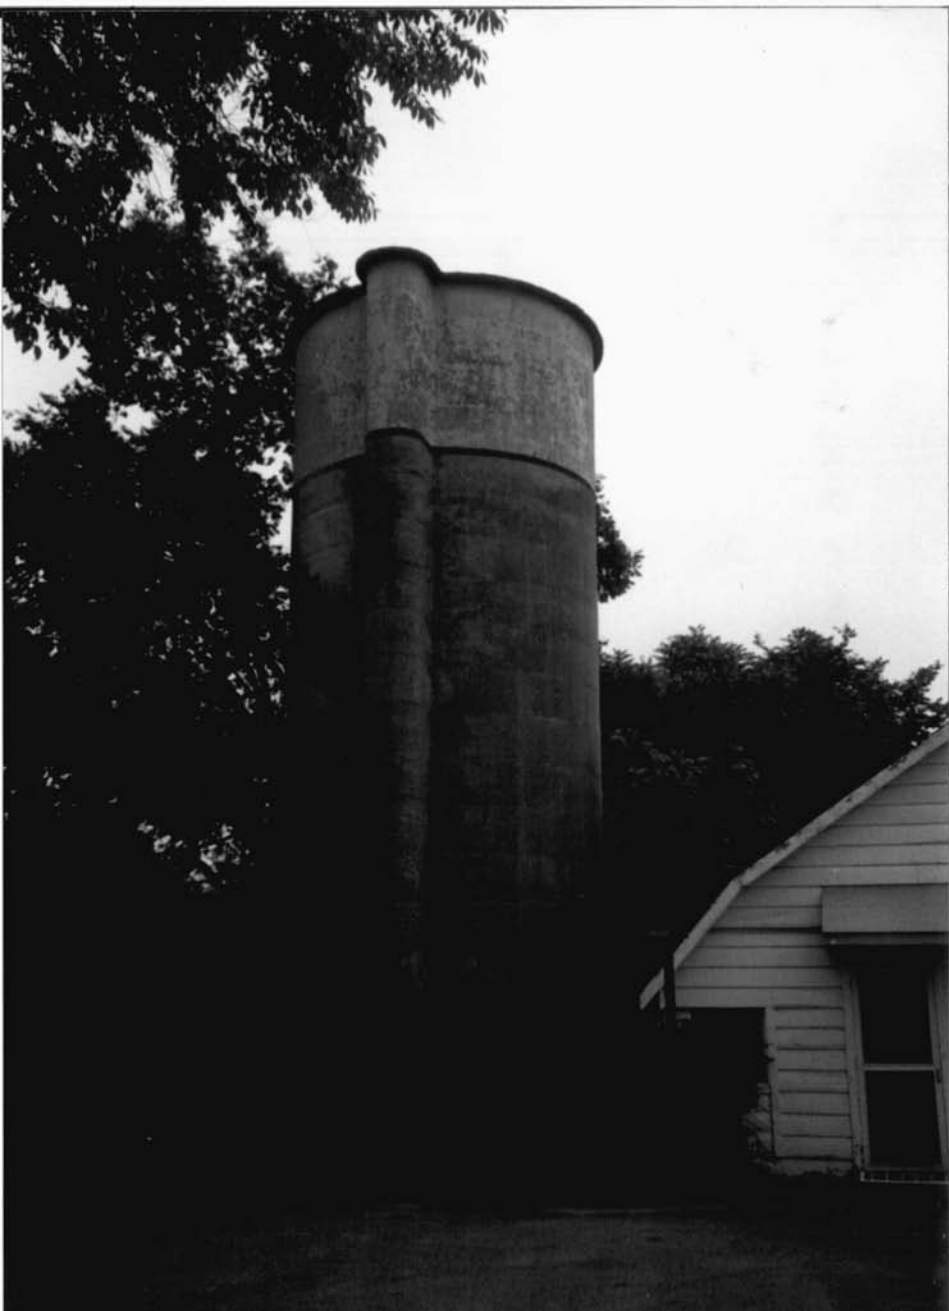
6 OF 13

Structure # 3 is located at the northeastern corner of Structure # 2 (dairy barn at 4296 Montgomery Road). It is a silo constructed of steel reinforced concrete with a concrete roof. The silo's diameter is 15 feet and its height is about 35 feet tall.

This structure appears to have been constructed circa 1945, around the same time as the adjoining barn. It is in good condition, though it has not been utilized as a silo at least since the dairy barn was converted for use as a real estate office. Due to the stoutness of its construction, the integrity of this structure is intact.

STRUCTURE #3, SILO, FRONT ELEVATION,  
JOB OF 13 STRUCTURES  
LOOKING SW.

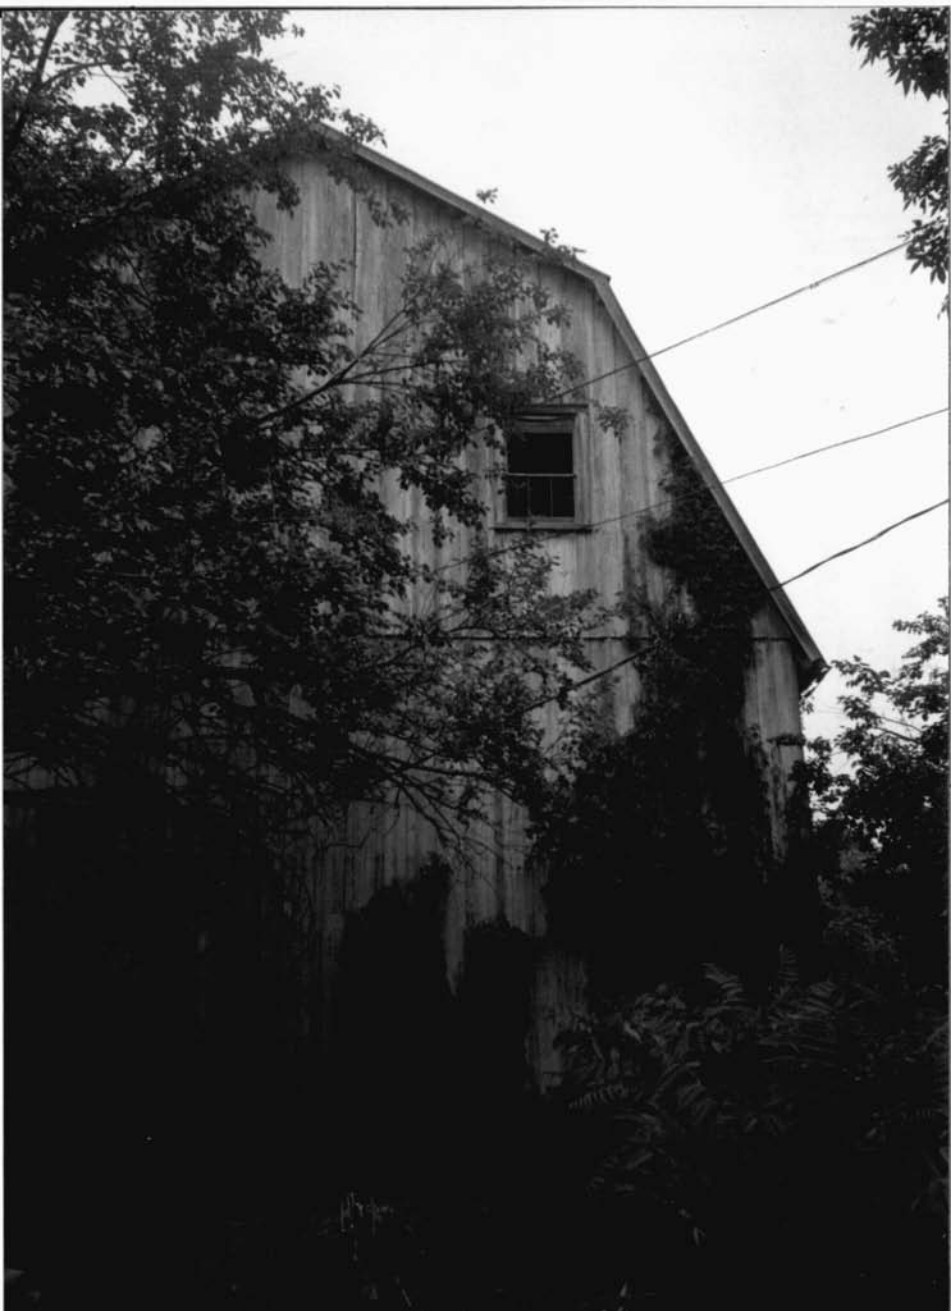
7 OF 13

ELEVATION, LOOKING EAST.

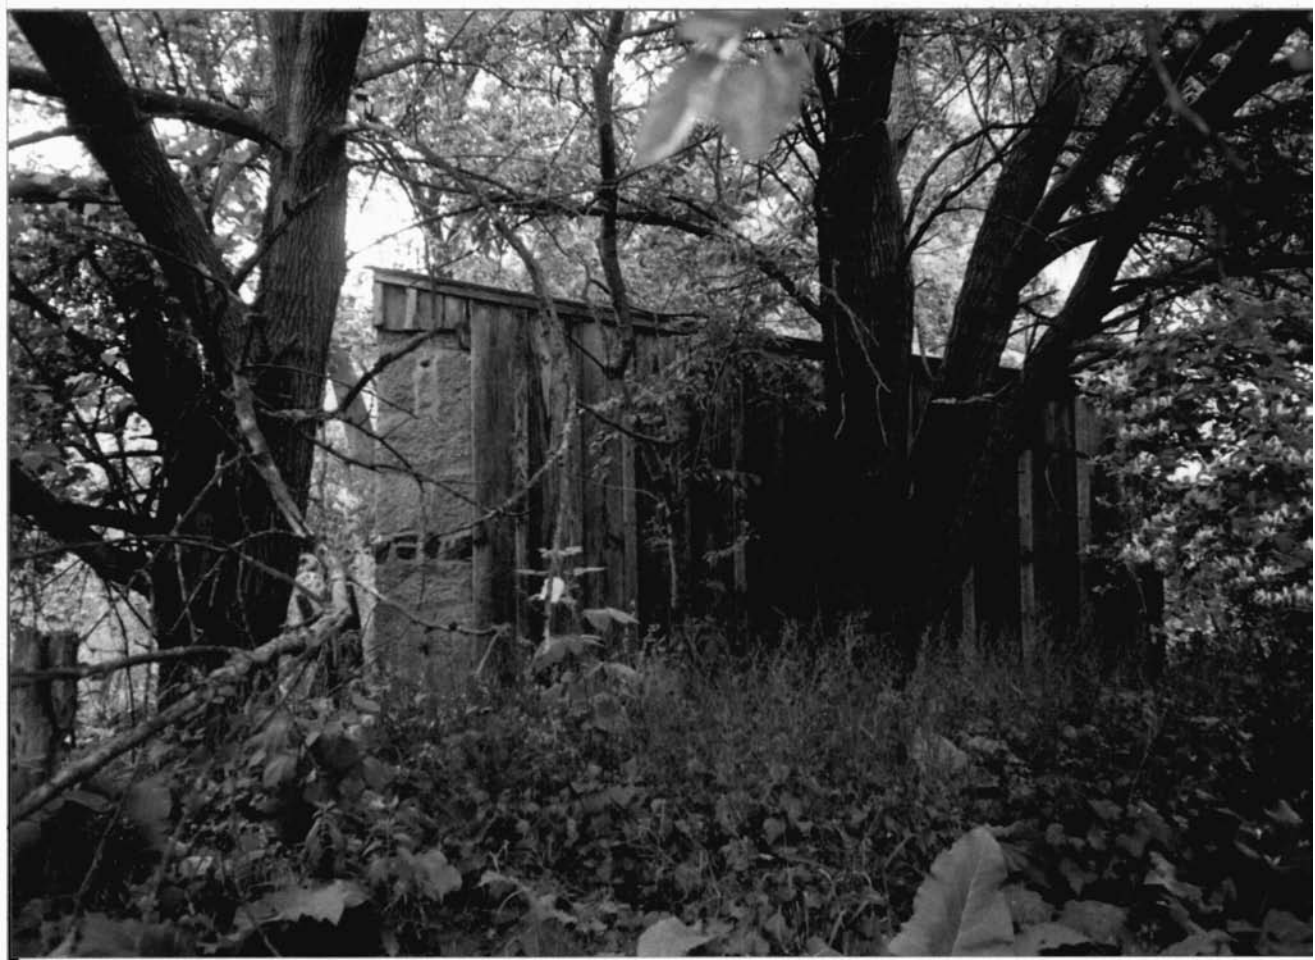
9 OF 13

STRUCTURE #5, FRAME SHED WITH STONE WALL,  
SOUTHERN END, LOOKING NORTH.

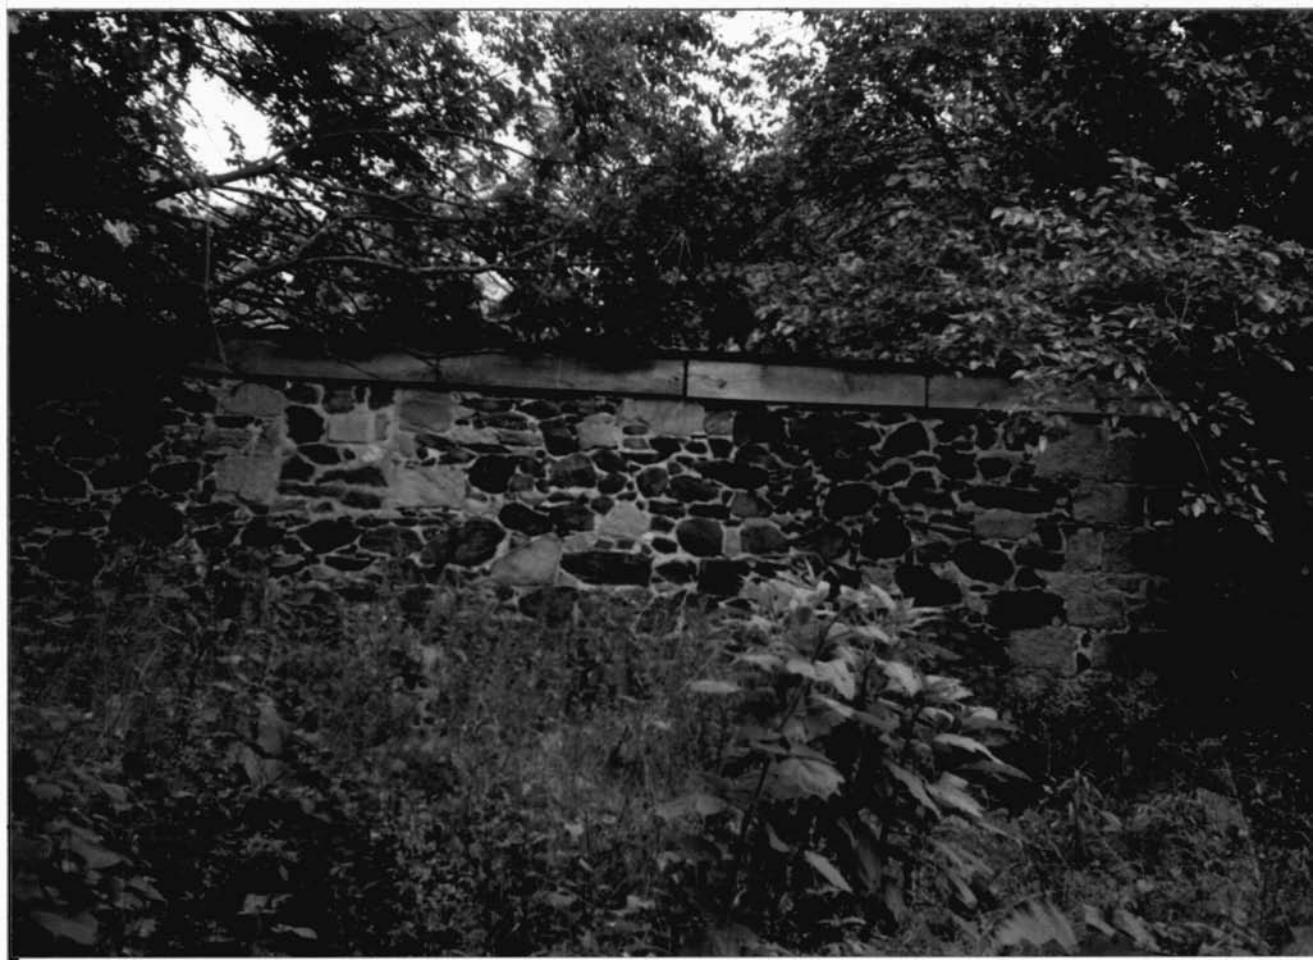
10 OF 13

STRUCTURE #5, FRAME SHED WITH STONE WALL  
REAR OF WALL LOOKING EAST.

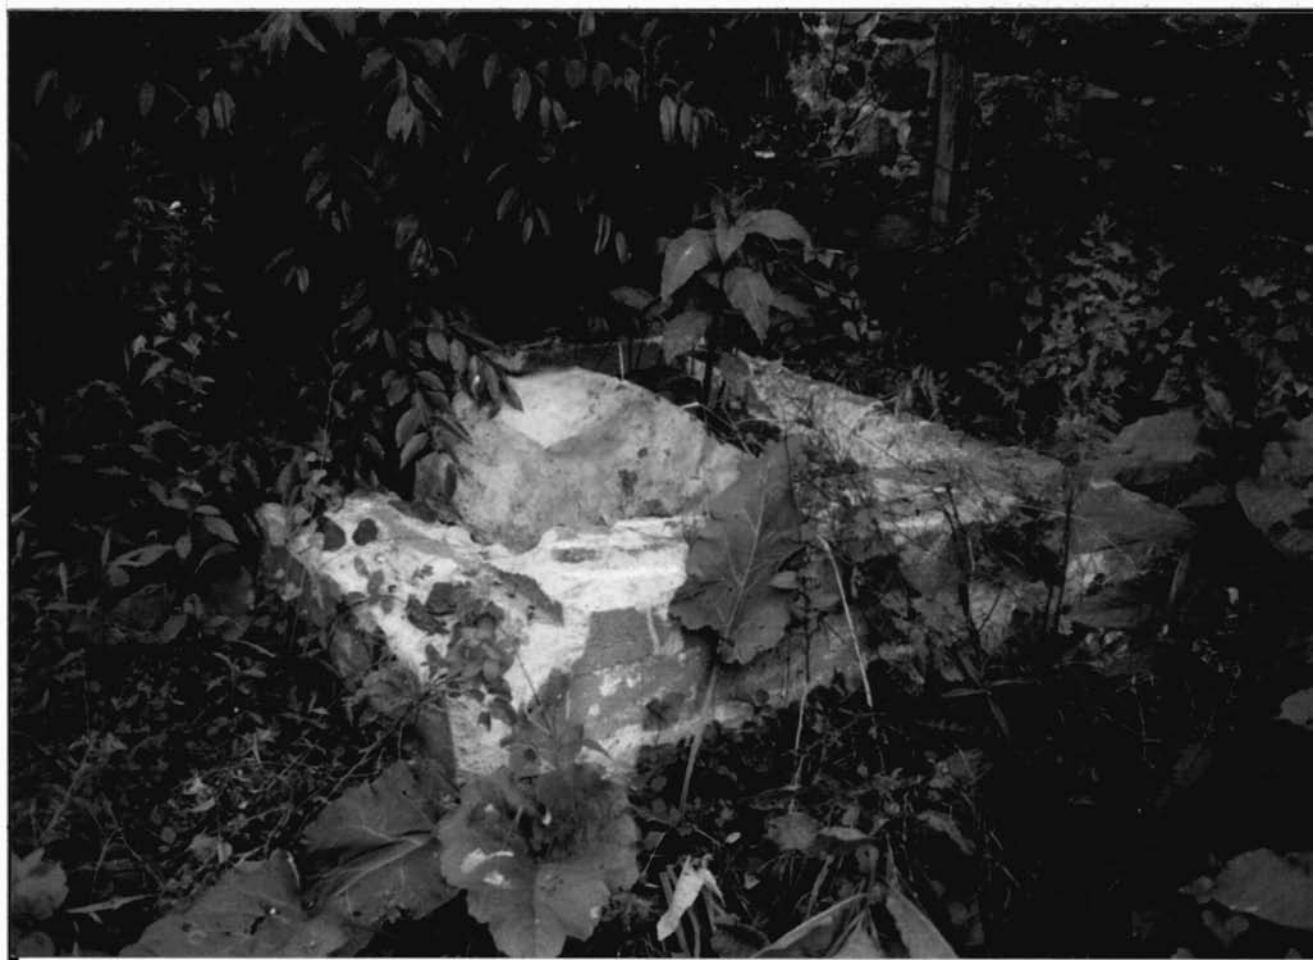
11 OF 13

To the rear of Structure # 5 there is a small rectangular concrete outbuilding foundation. It is designated Structure # 6. This feature measures 6 feet by 6 feet square. Its walls are 12 inches thick and rise to 18 inches above ground level. It has one bay.

STRUCTURE #6, OUTBUILDING FOUNDATION,  
LOOKING NORTH.

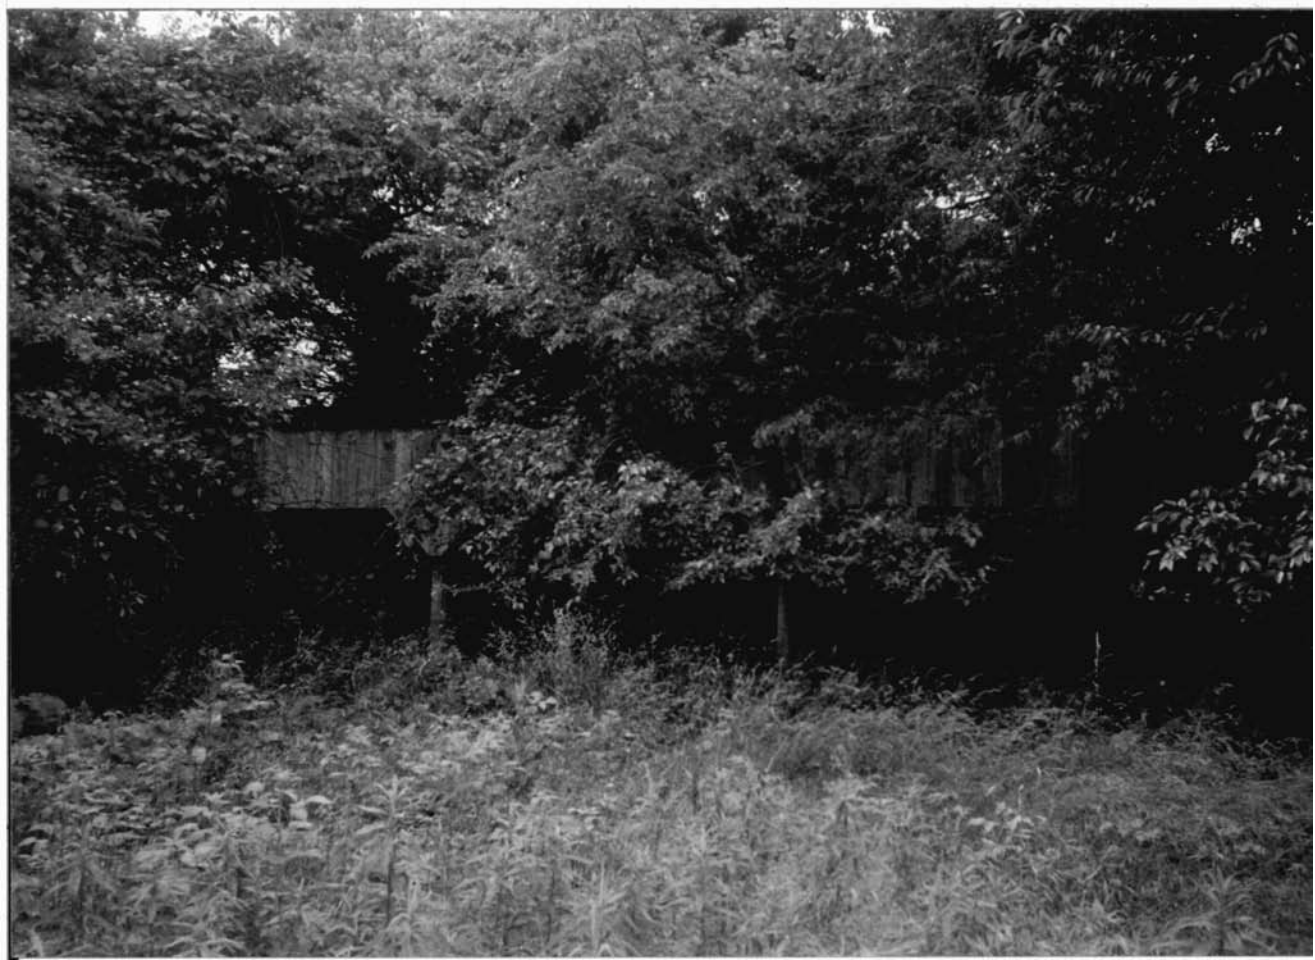
12 OF 13

Structure # 7 is a detached shed situated 84 feet south of Structure # 6. It appears to have served as a garage for farm equipment. A piece of abandoned farm machinery was observed adjacent to the structure.

STRUCTURE #7, GARAGE SHED, FRONT  
ELEVATION, LOOKING NORTH.
