MARYLAND INVENTORY OF
HISTORIC PROPERTIES

Survey No. **HO-648**

and/or common **Perrin's Tenant House**

HO-648, Perrin's Tenant House
DESCRIPTION cont'd

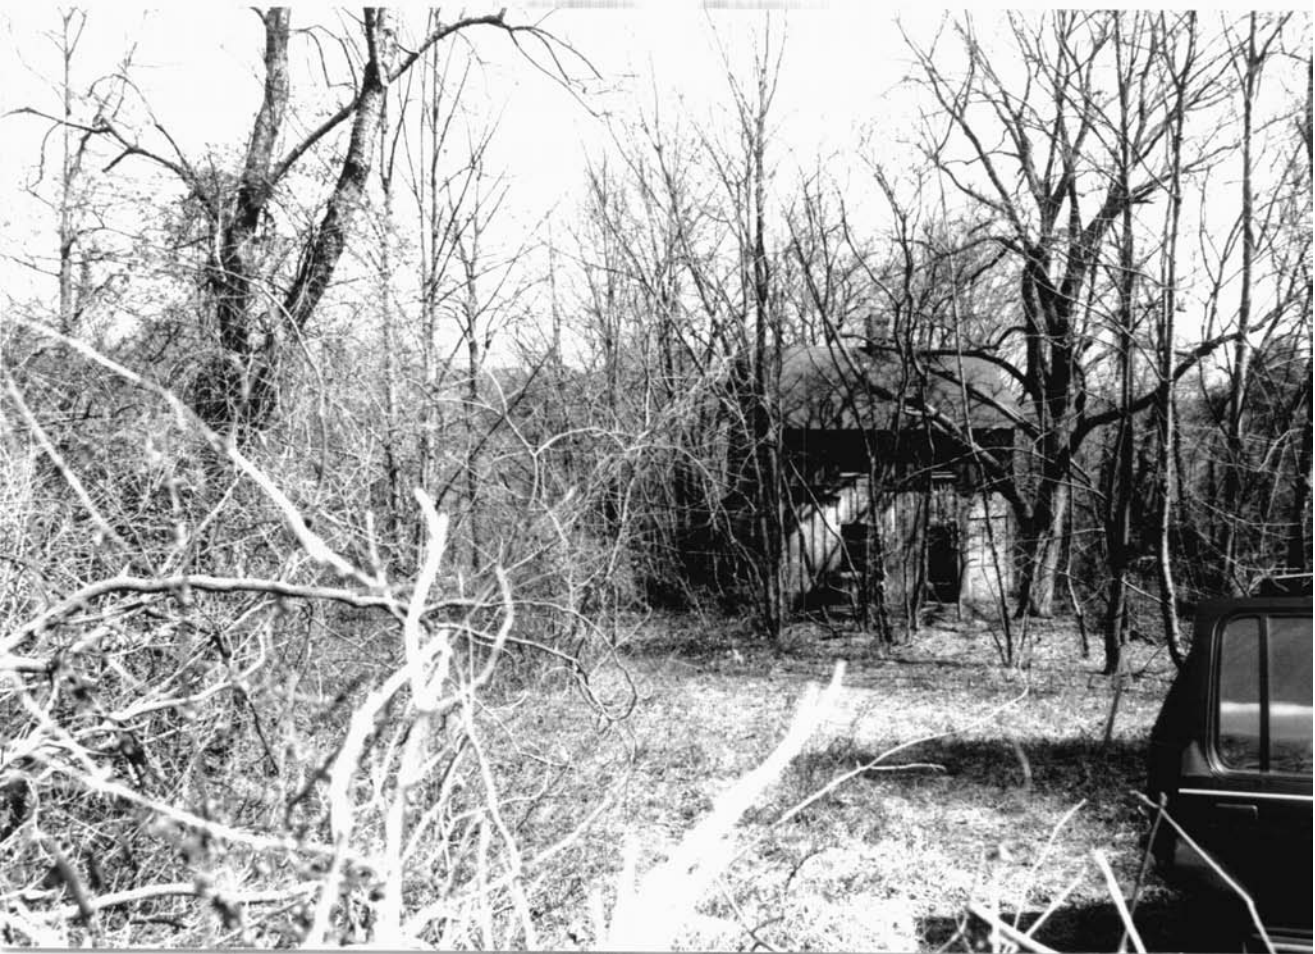
HC-64E

TYPICAL ELEVATION (WEST) SHOWN IN CONTEXT OF
ADJACENT RIDGE AS SEEN FROM HOUSE SITE

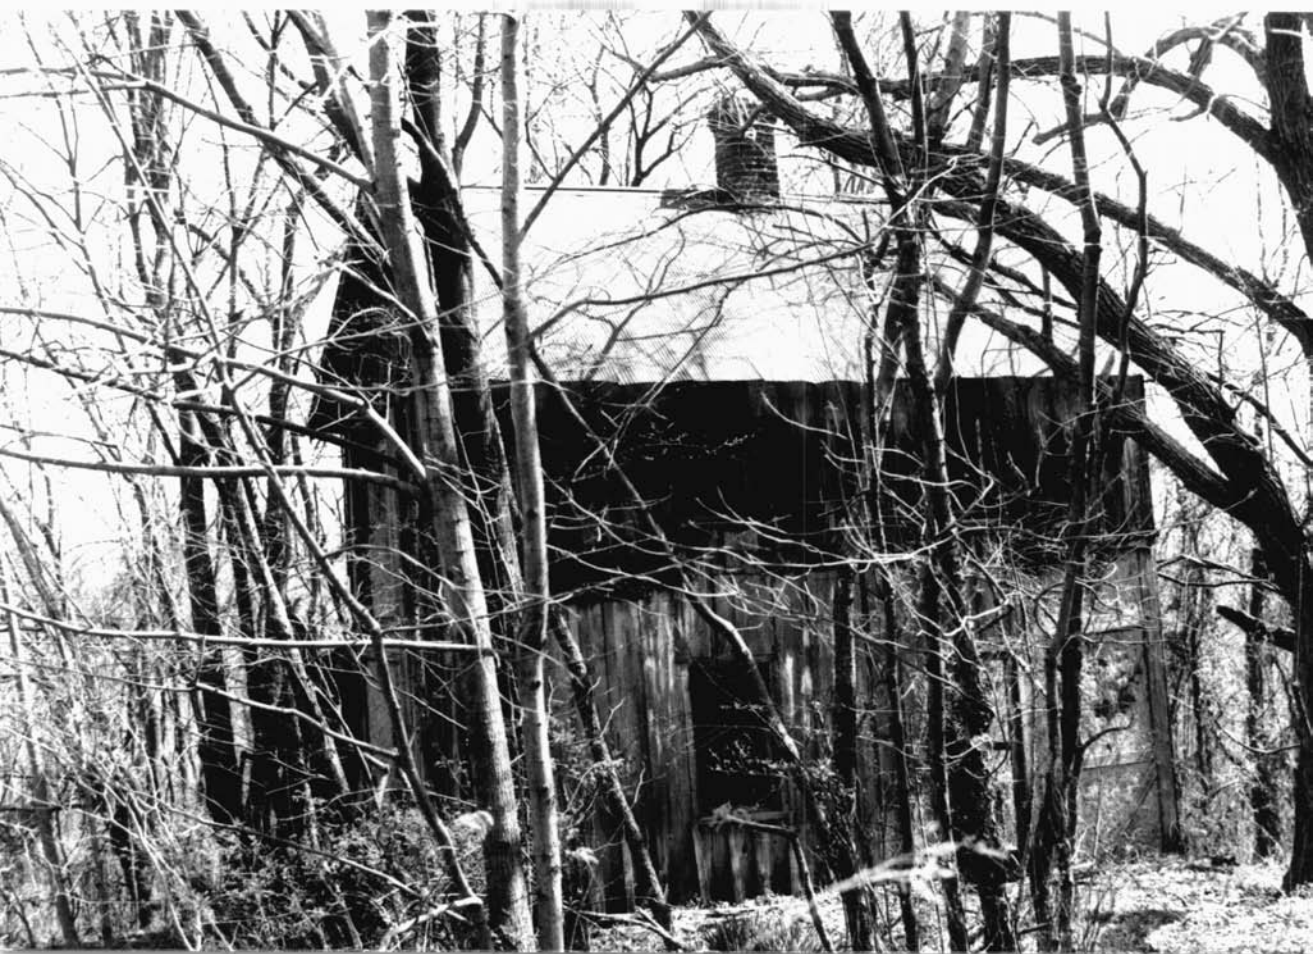
HO-648

1ST CORNER OF HOUSE

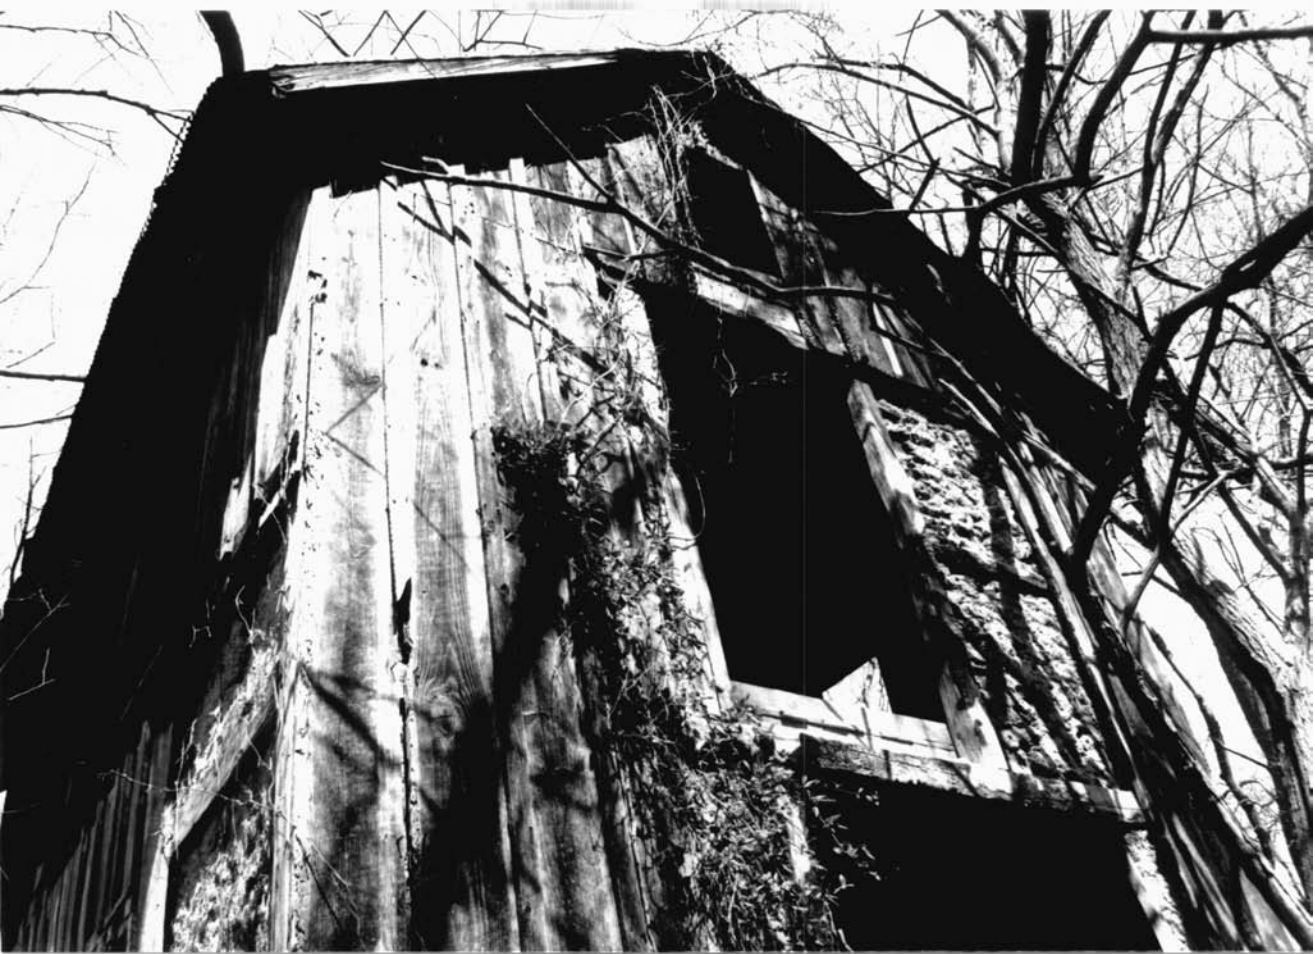
W-648

COPIES OF THE REPORT OF INSURANCE
EVIDENCE OF FIRE DAMAGE

The structure has suffered deterioration from fire damage at the south end and lack of maintenance. Large sections of the exterior walls are missing, as are all the window sash and some of the doors. These losses reduce the integrity of the structure.

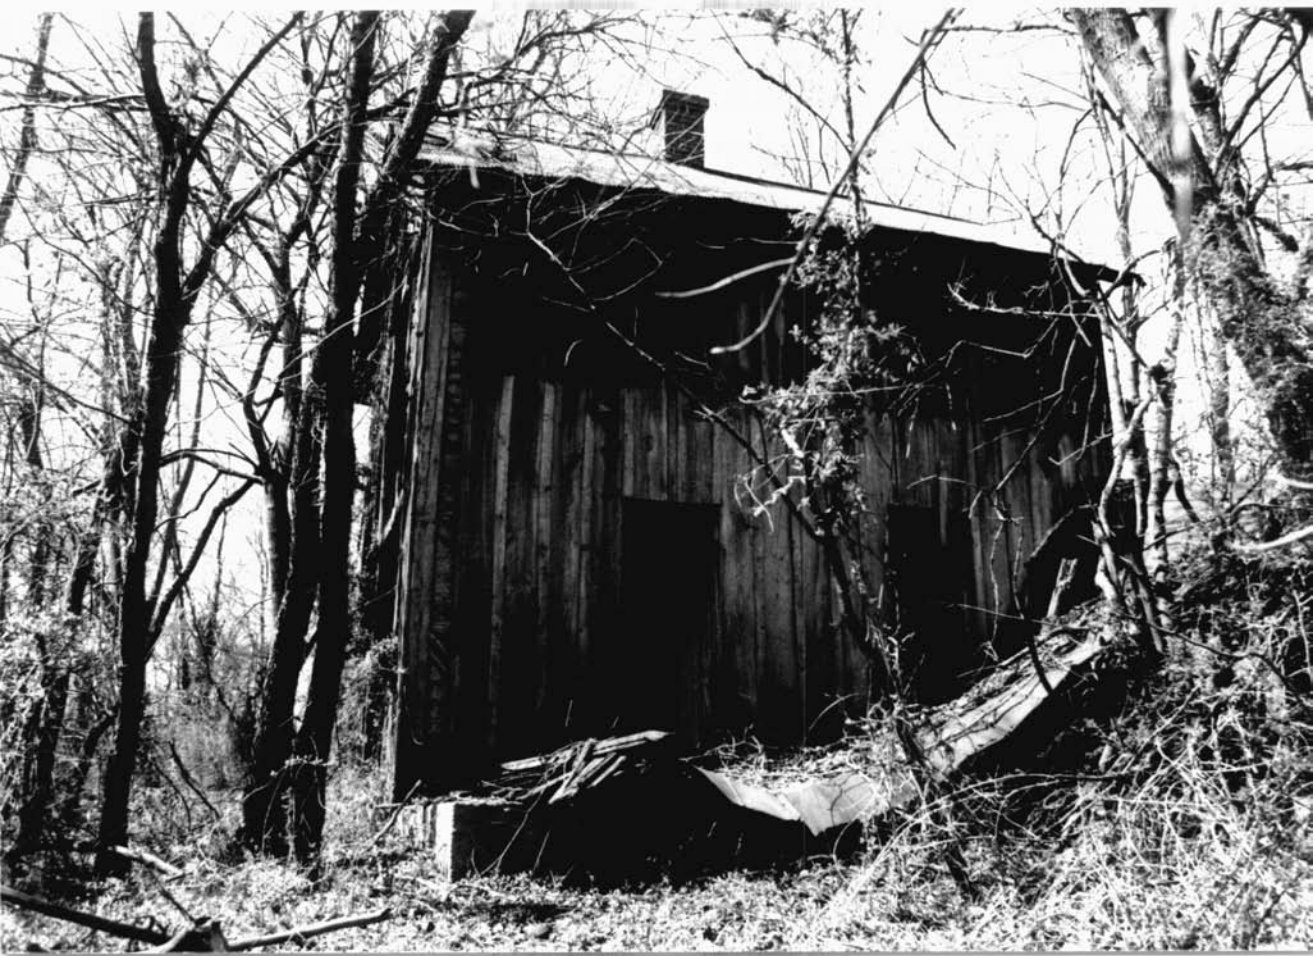
Hg = 649

FAC ELEVATION OF DWELLING WITH COLLARED
ROOFING IN FOREGROUND. BOARD AND BATTEN
SHEATHING CONTINUOUS FROM FOUNDATION TO
EAVE.

The house was originally constructed with a porch across the full width of the front side, as indicated by the discontinuous board and batten siding. Although the remains of the porch roofing are twentieth century materials (red rolled roofing) and the date of the white washing under the porch is unknown, the break in the siding on the front would have been covered by the porch roof at the time of construction. On the rear, a different condition is found indicating the addition was added later as the siding is continuous from foundation to eaves with cuts only in the battens to receive the upper edge of the roof. The area under the roof line of the addition was also whitewashed.

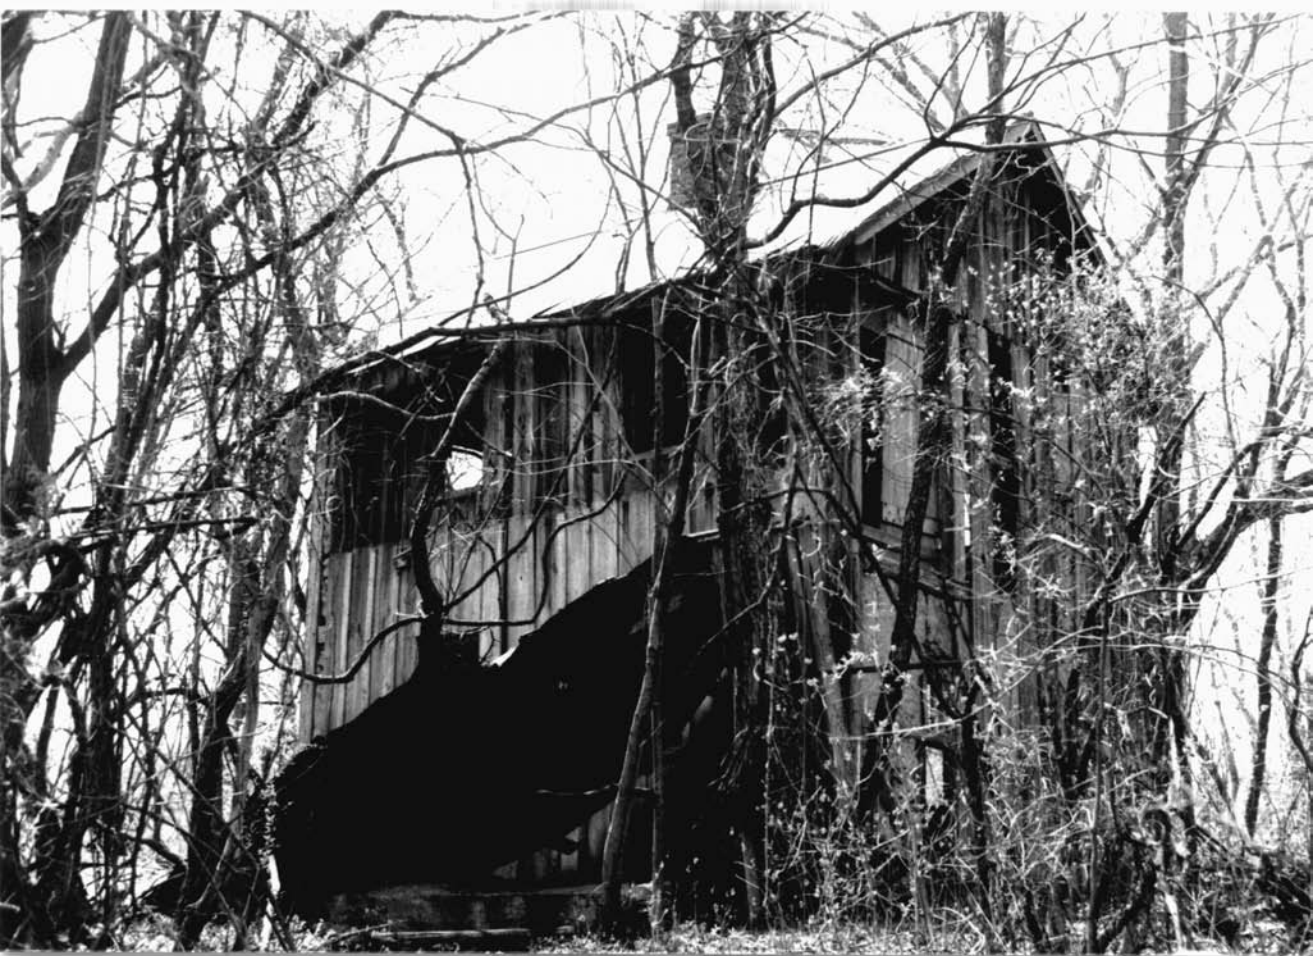
48-648

N.E. CORNER OF DWELLING WITH REMAINS OF
COLLAPSED ADDITION IN FOREGROUND.

There is a basement below the main structure, accessed from a stone stair incorporated into the one-story, rear addition. That shed addition has a poured concrete foundation and slab. The addition, now collapsed, is also clad in board and batten siding and its standing seam metal roof is supported by posts.

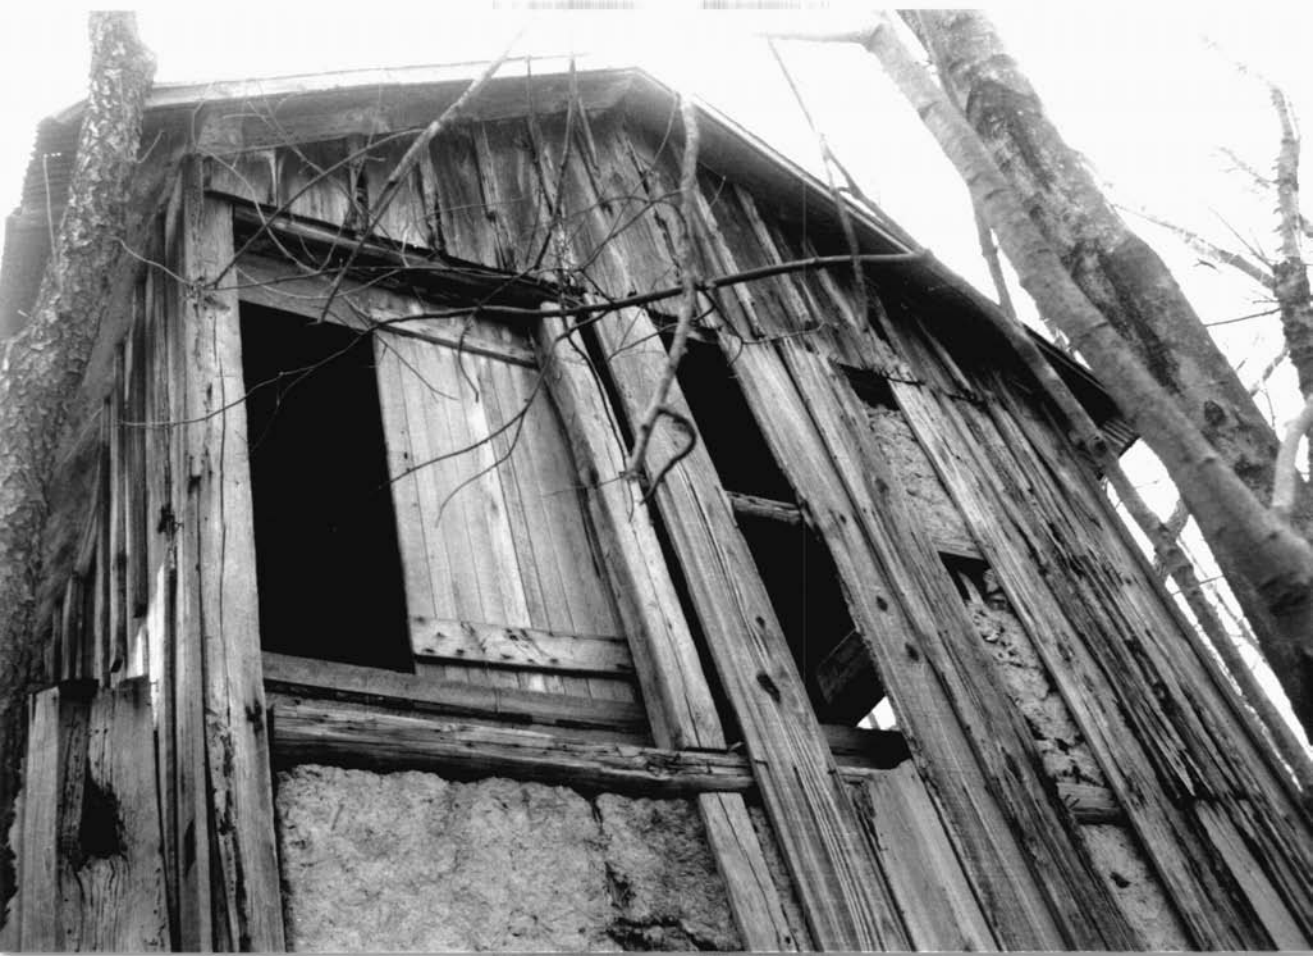
HU-349

SECTIONS OF SIDING, DAVISING, AND EVEN FRAMING
ARE MISSING. BOARD AND BATTEN DOOR FROM
SOUTH BEDROOM COVERED PART OF 2ND FLWR
OPENING

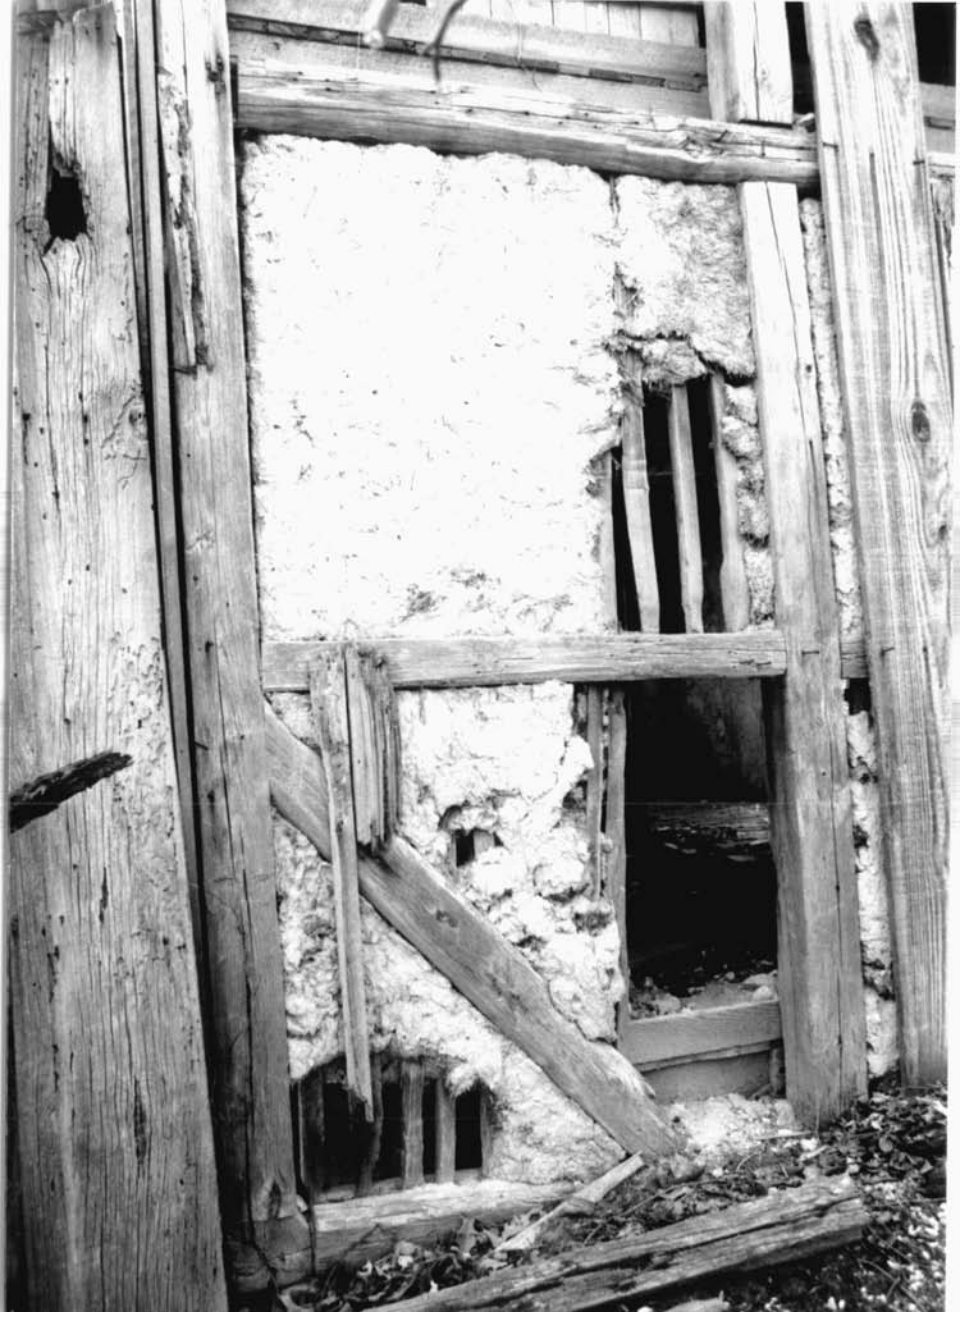
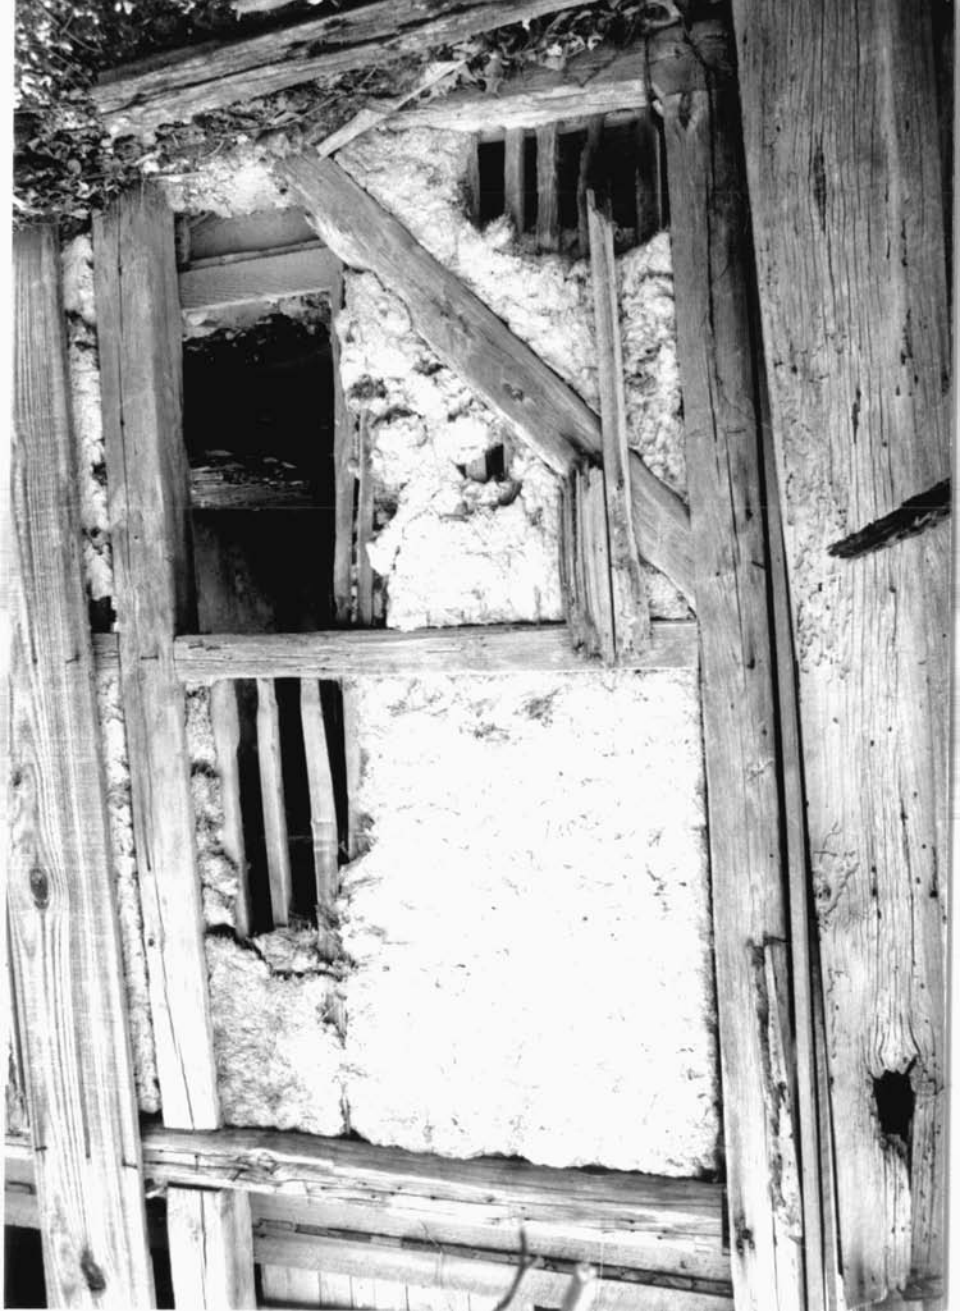
HC-648

EXPOSED FRAMING ON NORTH ELEVATION
PROVIDES CLEAR SAMPLING OF
STAVES, LET INTO CHANNEL CUT IN
FRAMING, CORNER BRACING,
MORTISED FRAMING, AND MUD & STRAW
DAUBING

The hewn frame of the structure has 6" +/- square corner posts sills, girts, and plates, resting on a random rubble "bog iron" foundation. The frame is braced with diagonal braces in the lower corners. The joists are logs flattened only on the top side to receive the level flooring. The timber frame is filled in with vertical staves let into channels in the sills, plates, and mid-story horizontal framing. The rough hewn staves support the straw binder and clay mud daubing. Large sections of this infill are missing, as is a notable percentage of the board siding.

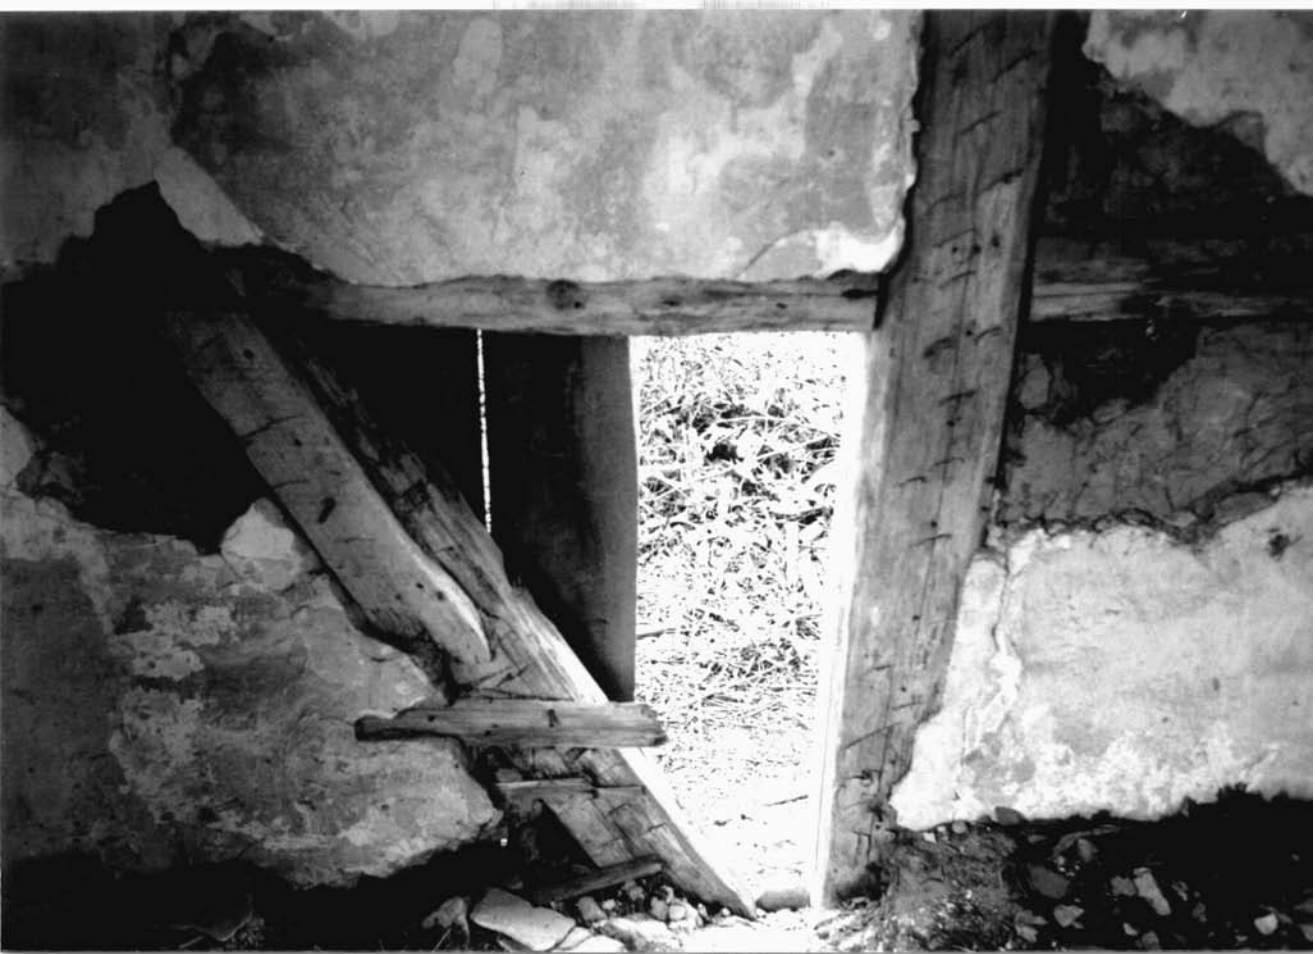
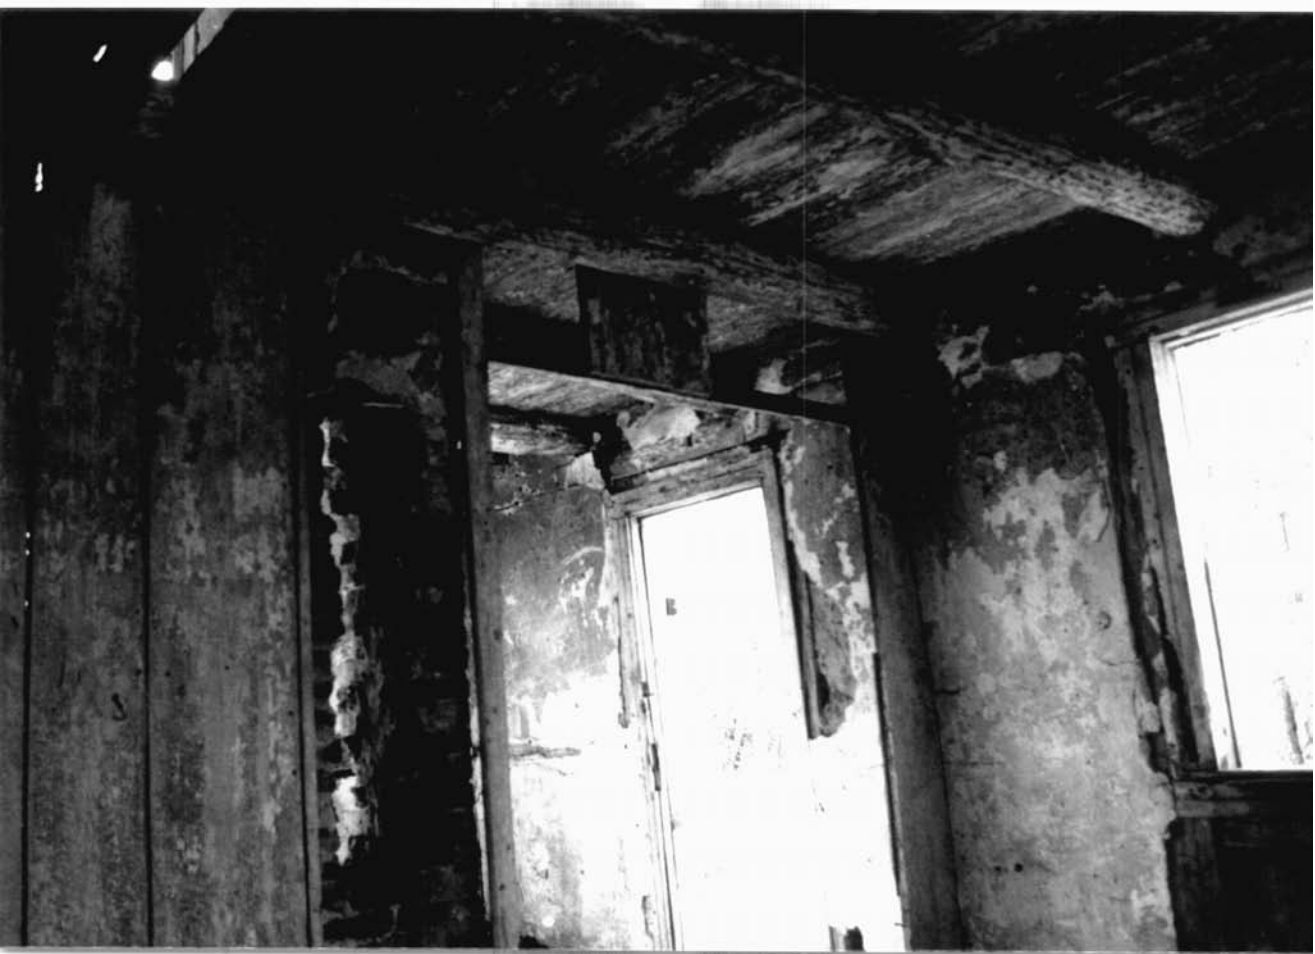
HC 64F

NORTH ROOM, 1ST FLOOR, LOOKING SW TOWARD
FRONT DOOR - NOTE BEANET WALL CASING,
BOARD PARTITION, DEGENERATED CHIMNEY WITH
WOOD GIVE FIVE PIPE HOLE AT TOP AND EXPOSED
CEILING FRAMING.

The dwelling is divided into two chambers on each floor by a vertical board partition abutting the chimney. The circular sawn boards range in width between 8" and 12". The quarter-turn staircase with winders is incorporated into the east end of the room partition. The stair ascends from the northern room and ends at a landing one step down from the two bedroom doors. One of these two batten doors still hangs in its frame on butt hinges, but its thumblatch is missing, but the other one has been moved against a large hole in the north wall. Located side by side between the chimney and the front wall of the house, there is a closet facing into each of the bedrooms. The doors have been removed, although the hinges or their locations can be seen.

The brick chimney, approximately 18" x 20" in size with high holes for first floor wood stoves, is located in the center of the house and has hard, creamy colored mortar. The chimney is plastered on the upper levels, but not in the basement below.

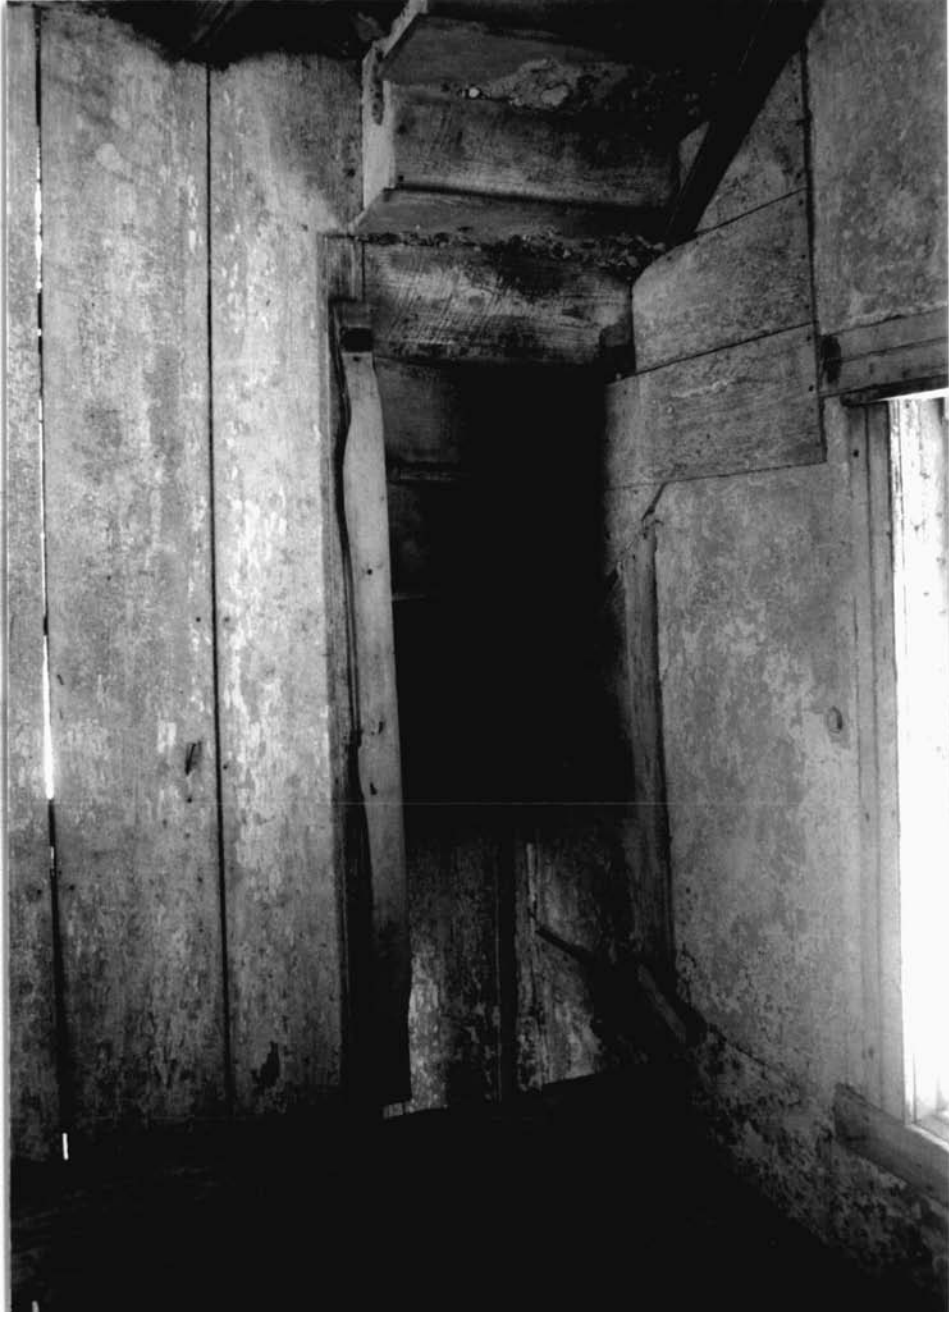
TAPE TO BE KEPT STRUNG IN SE
CORNER OF FIRST FLOOR NORTH
ROOM.

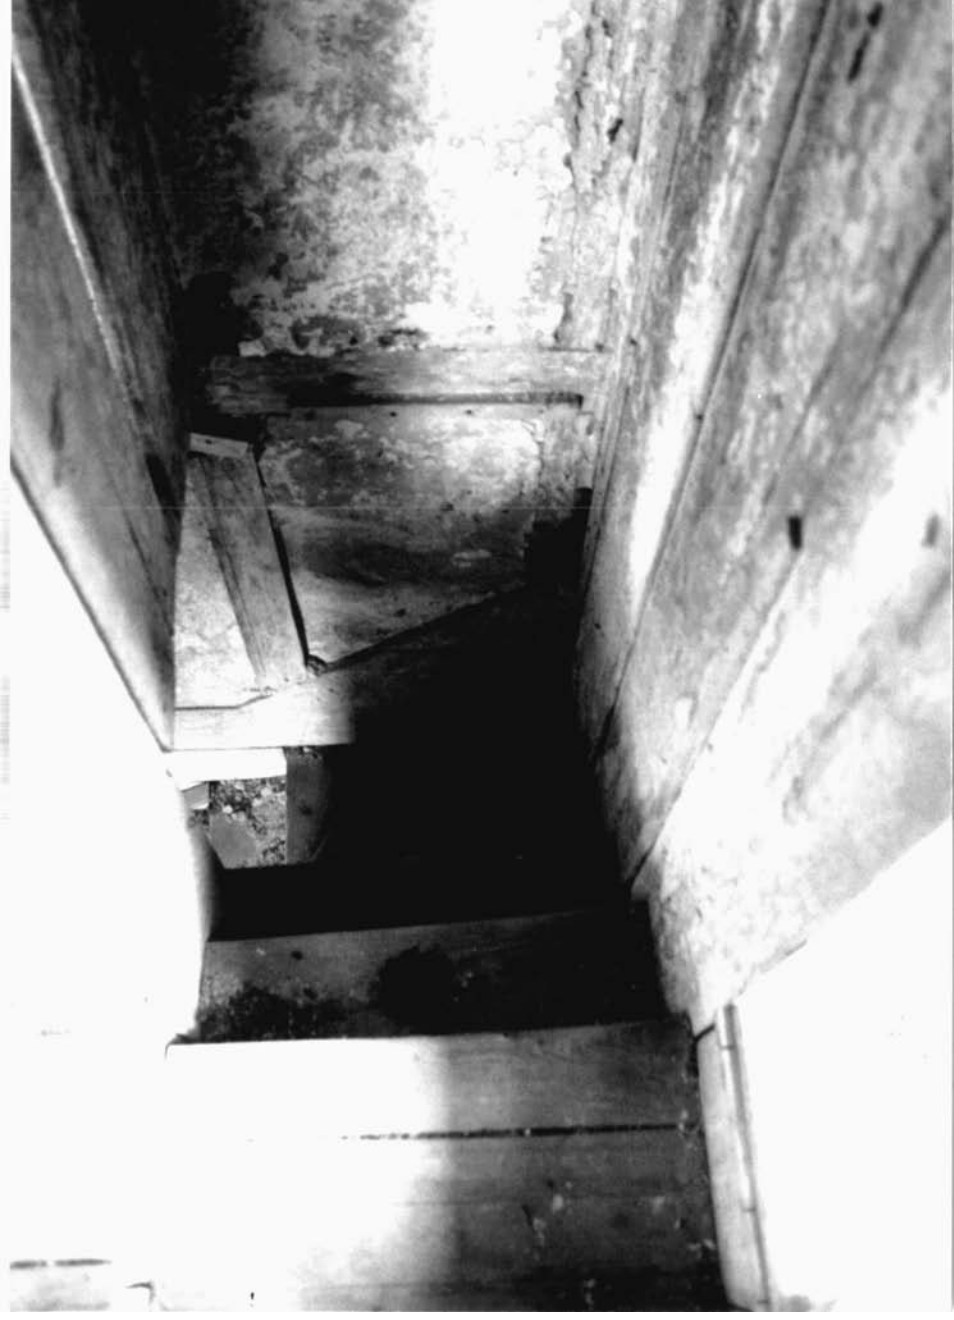
LOOKING DOWN WINDER STAIR
FROM 2ND FLOOR LANDING
BETWEEN BEDROOM DOORWAYS

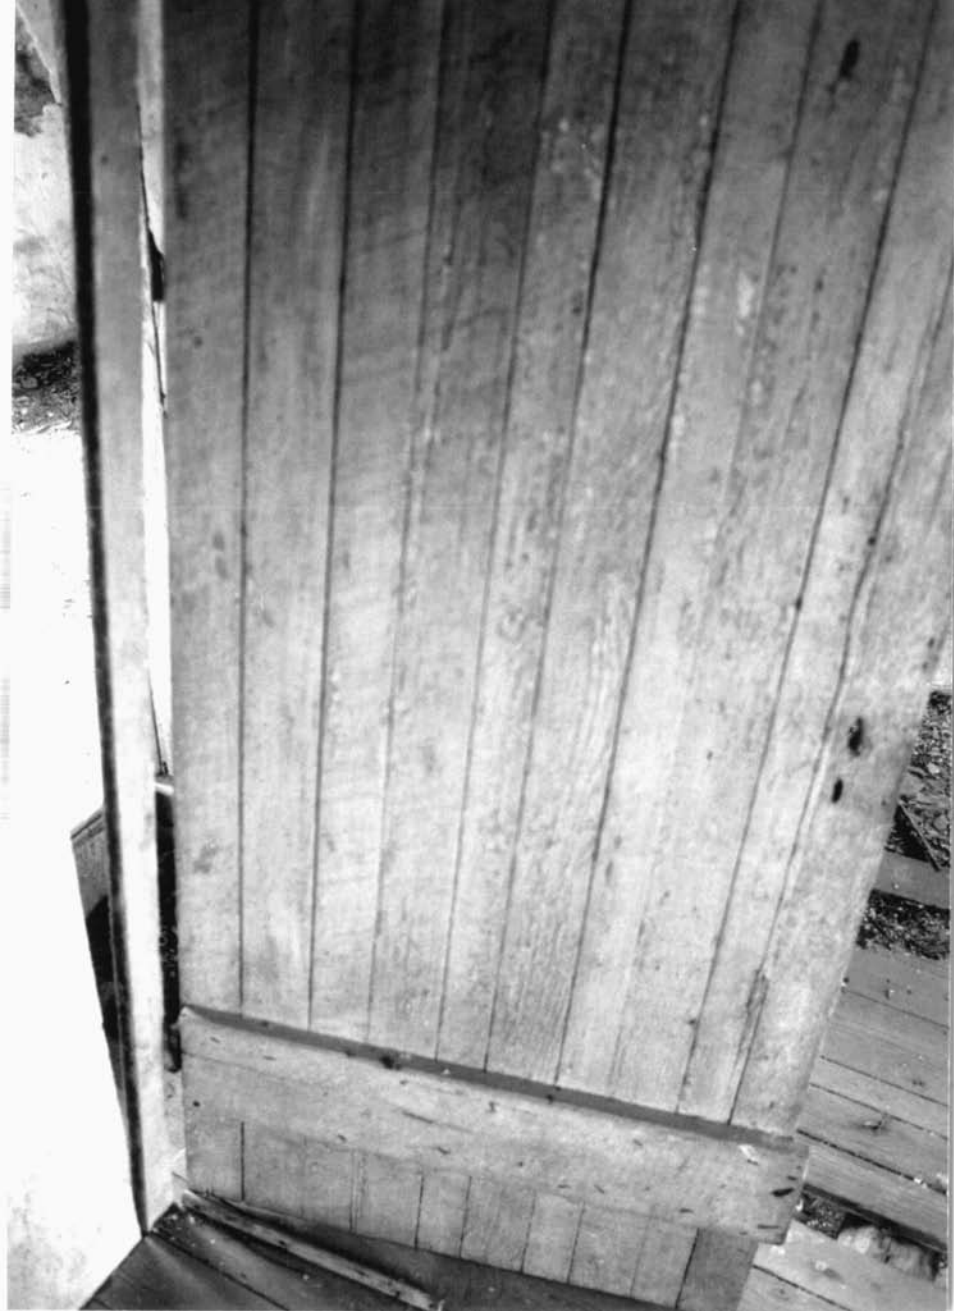
LC-432

NORTH BEDROOM DOOR HINGES ON
BUT LINGERS

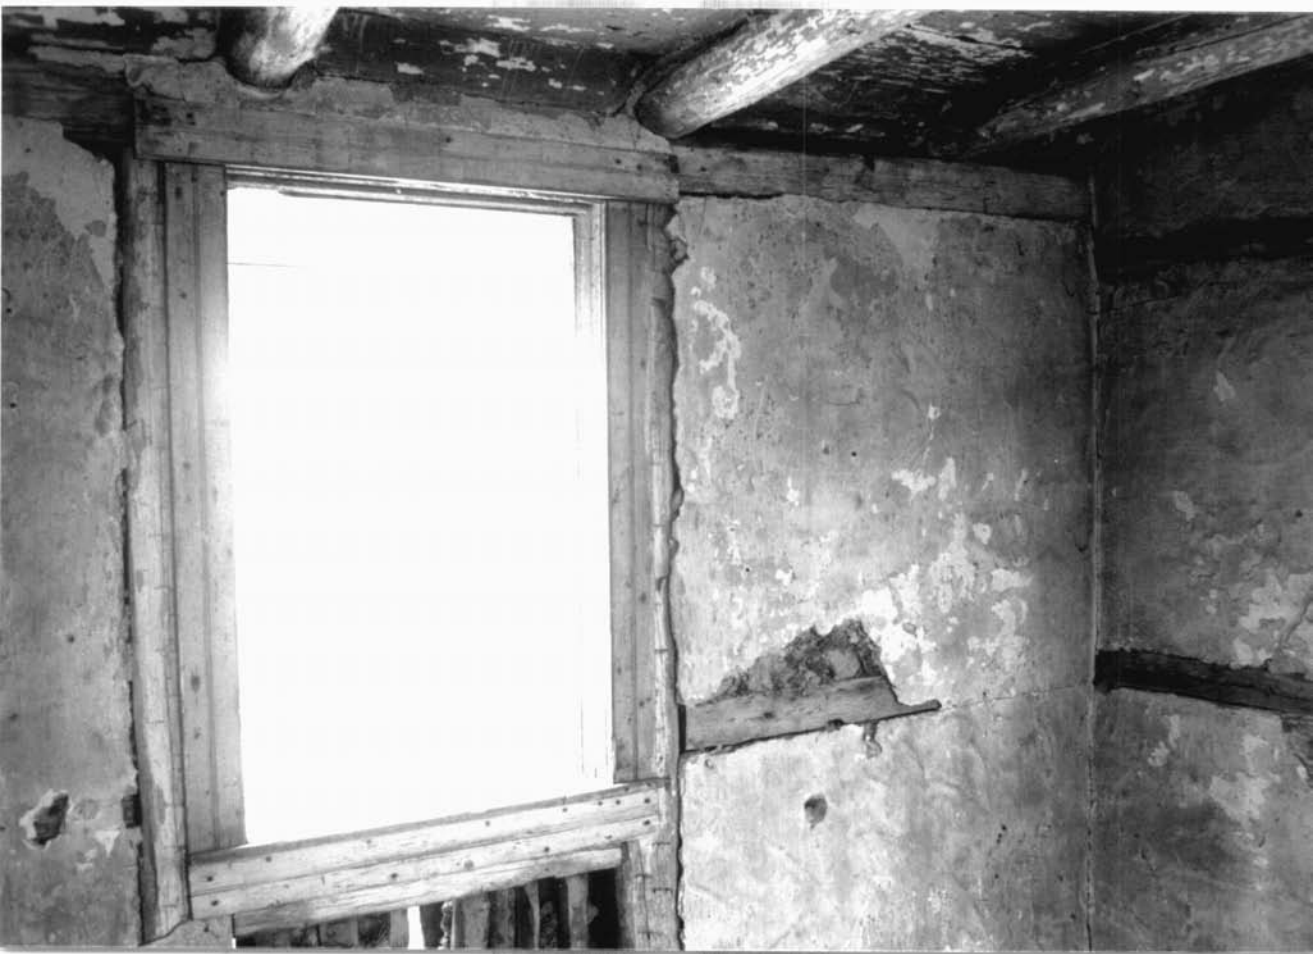
SECOND FLOOR, NW WINDOW CASED WITH BEADED BOARD

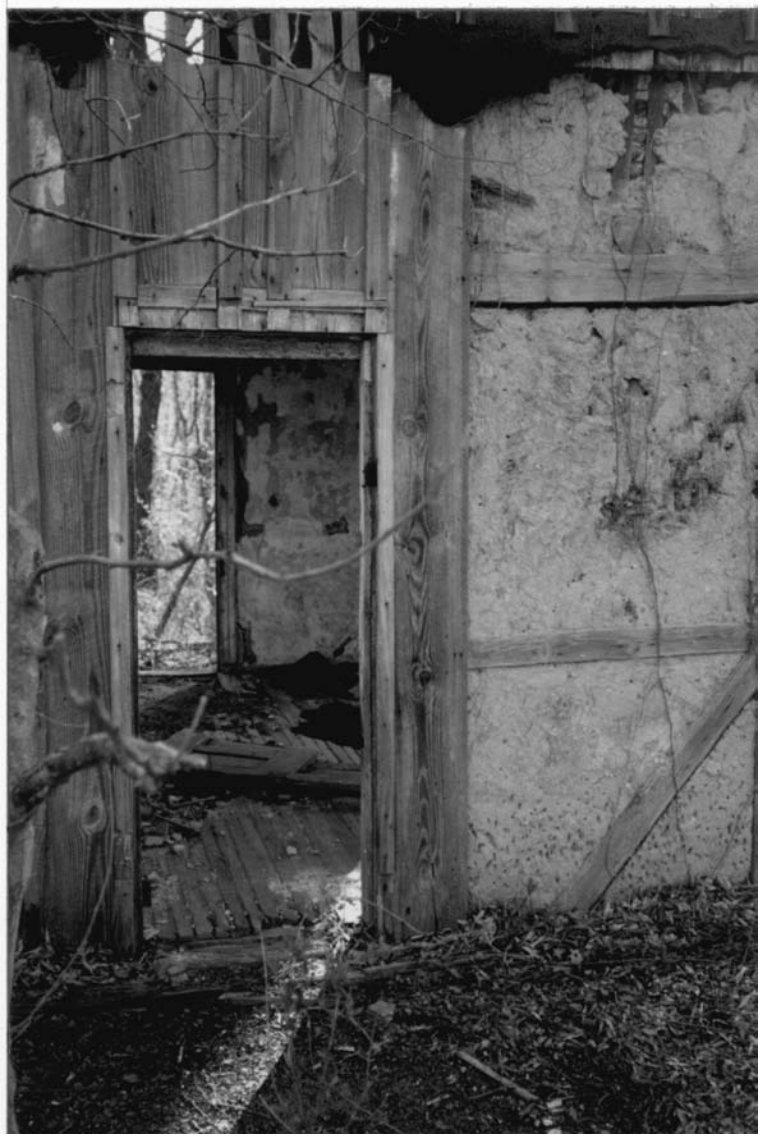
HC-629

WEST ELEVATION

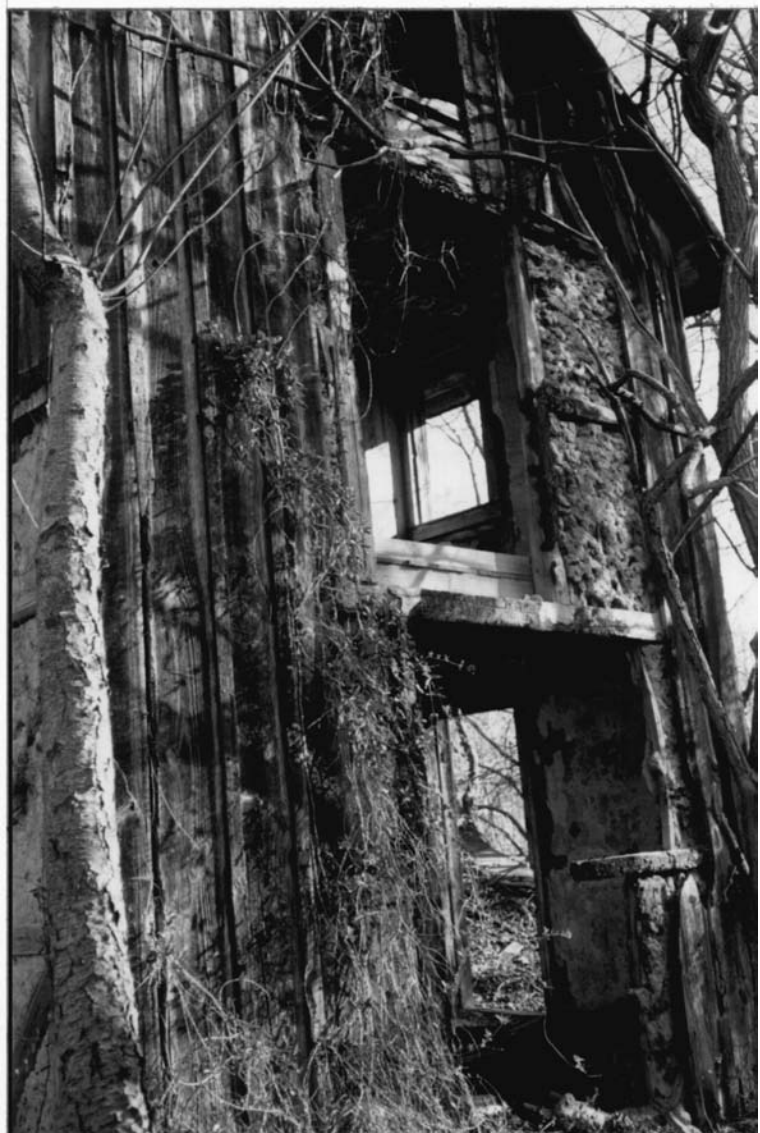
HD - 643

SOUTH ELEVATION

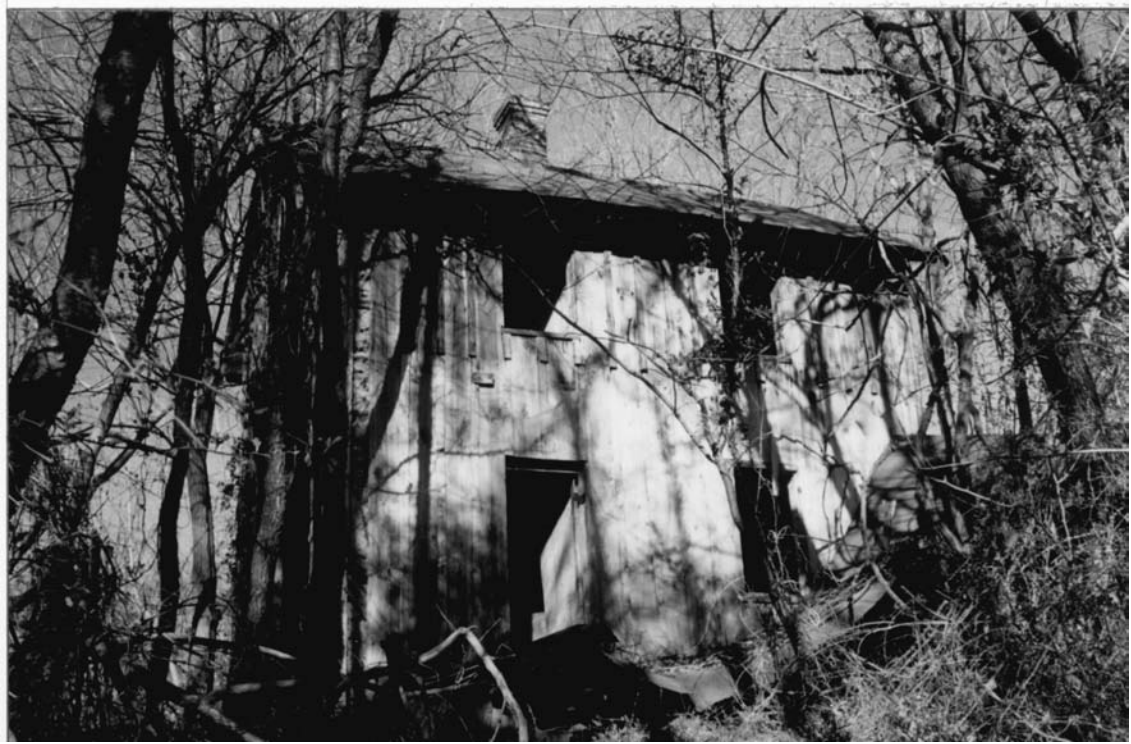
HO-648

SE CORNER
