HO-770, Killarney Woodstock, Howard County Ca. 1855, ca. 1903 Private

Maryland Historical Trust Maryland Inventory of Historic Properties Form

i. Name of F	roperty	(indicate preferr	red name)	
historic	Killarney			
other	Good Fello	wship, Cavey Farm		
2. Location				
street and number	10375 Cave	y Lane		not for publication
city, town	Woodstock		- 44	vicinity
county	Howard			
3. Owner of F	Property	(give names and ma	iling addresses of all owne	ers)
name	Francis and	Alice Bender		
street and number	10375 Cave	y Lane		telephone 410-465-1681
city, town	Woodstock		state MD	zip code 21163
city, town	Ellicott City	<u>, </u>		liber 840 folio 151
Contributing R Contributing R Determined El Determined In Recorded by H	Resource in Nation Resource in Local Resource in Resource in Resource in Local Resource in Resource in Resource in Resource in Local	conal Register District al Historic District tional Register/Maryland lational Register/Maryland esearch Report	Register

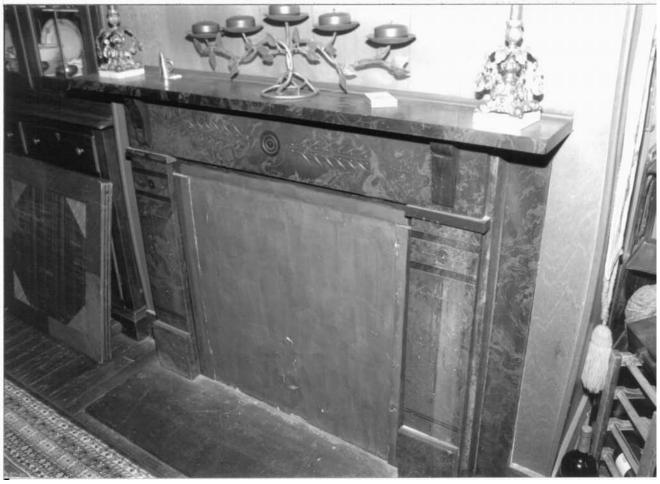
HO.770, K HOWING TURO - 12 1 1 1354/20 Martle in the forter row on the first floor of the 1903 section. 6 of 21

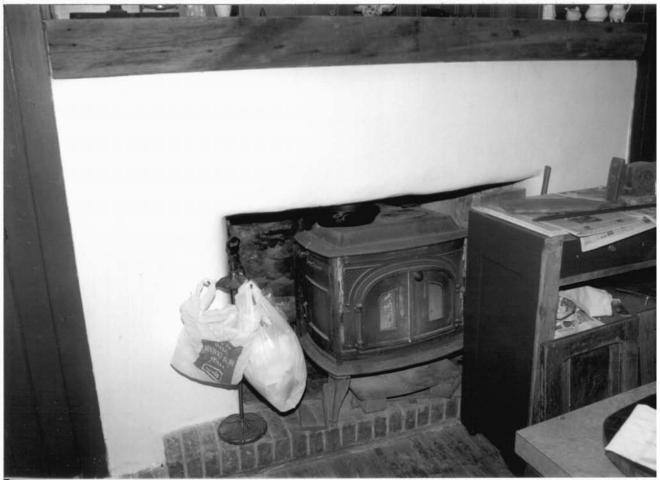
HO.770 Killsmy 11 - 41, 6/03 Neurthe et 1. JSHFC 11-wen fireplace in the fire person for way. 8 01 21

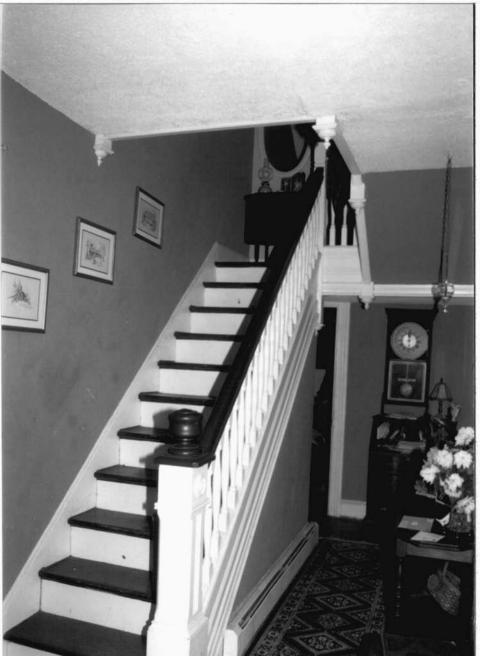
HO-770, 1 harney Howard wanty, MD Kist - Hill, 6/03 Nevolve at MISTIPE Stair in 1903 Section 9 08 21

dining room and a parlor. The hall continues through the front half of the house through a doorway into the kitchen in the rear wing. The window and door trim features bull's eye corner blocks and molded architrave trim and single light transoms above all interior doors. The existing doors into the dining room and parlor are recent French doors. The closed stringer stair features a large square newel with bulls eye adornment and chamfered corners. The balusters are turned and a wide band of raking molding decorates the closed stringer. Drop pendants also decorate the underside of the stair.

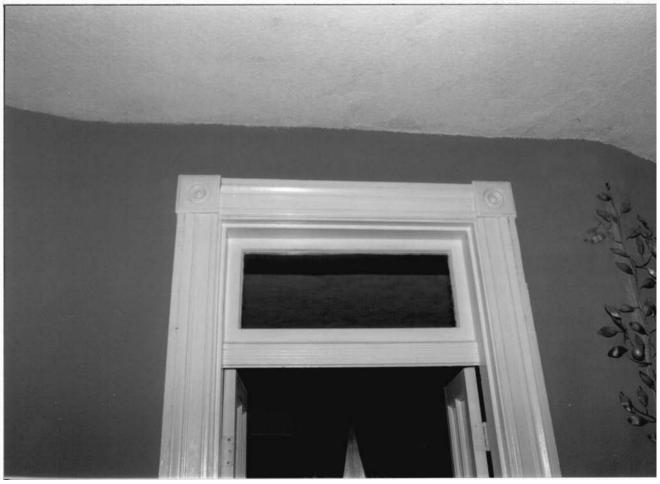
Ho. 770, Killarney toward bunty MD Neodtive at 1 12 HP 913 21+888 HHANN 676 Door trim in the 1903 section

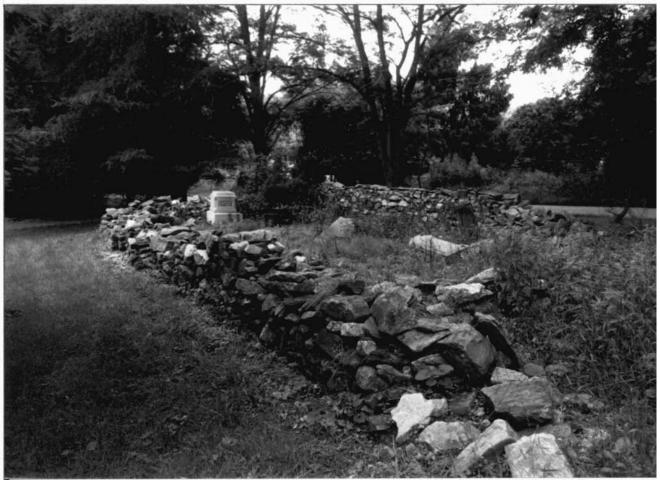
HO 770, Kilainey NOUST WE AT MOSHING 21+02 HINAHI 576 Cemetry located 1500 of 1 six

Located northwest of the main house is a small family cemetery surrounded by a stacked rubble stone wall. Only two headstones remain: one is for Caleb Davis who died Sept. 4, 1850 and one is for Hester Wagon who died in March 1843 at the age of 5. According to the owner, there used to be more headstones but they have slowly been disappearing. The cemetery is very overgrown and neither of the existing headstones can be trusted to be in the correct place. Extensive mounding inside the walled area, which measures approximately 39' by 19', suggests more graves are present.

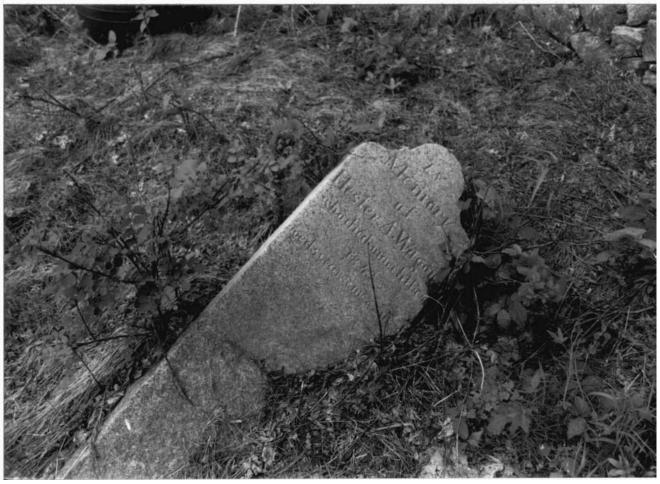
40.770 Killarner Kristin Hill, 6/03 NEGATIVE OF MUSH PO BE 21-BE NHINN EZE one of the orace - - remaining a the remetery

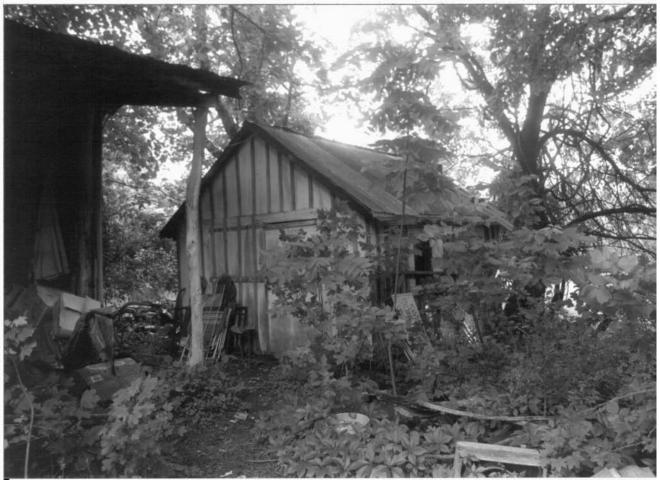
'Slowellterk use', heread 1.7 x 12, Sw elevation

Located behind the main house is a small, one room frame building with a gabled roof and a composite masonry chimney that, according to a former resident, was used as a slaughterhouse. The chimney was always intended for a stove only – there is only a small, stovepipe hole on the interior. The interior is not finished, and the building is open to the rafters. There is a window and door opening on the south wall, two window openings on the north wall, and double doors on the west wall. All of the windows and the single door are missing. The building is clad with board and batten siding and all wood is circular sawn and wire nailed. Next to this building is a very simple shed and next to the shed is a small, one room gable roofed building that the current owners have moved onto the site and are restoring.

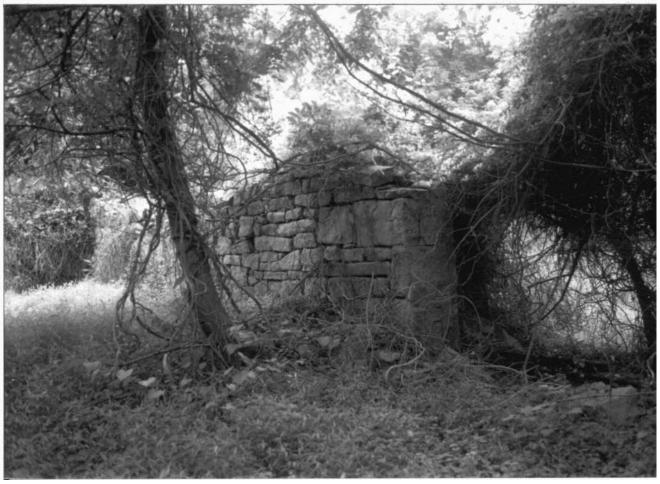
40.770 Killorray Negative at MOSHIC Stone fear was it was st book bain est wall 15 of 21

An overgrown farm lane is located southwest of the house and runs down the hill towards the creek. Located along this path are the foundation remains of four agricultural buildings. Located closest to the house is the quarried granite foundation of a large bank barn. According to the current owner, this barn burned down in the 1950's and today all that remains are the side and rear walls of the foundation which measures approximately 30' x 50'. There is no evidence left to date this structure.

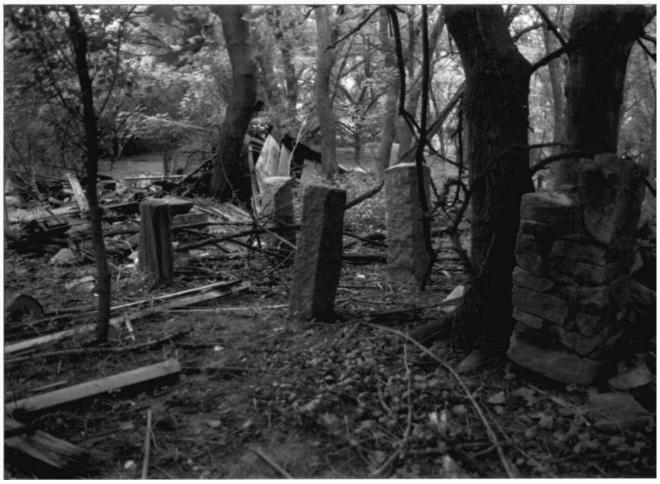
40-TO, Kilone Howard Courty 10 hrstn 4.1. 6/03 N. J. J. M. -72 16 21+02 NHNNH 676 The tradicit remains of clandry, looking east at east hat

Adjacent to the remains of the stable is an odd collection of stones. There are two parallel mostly collapsed stone walls about 4' high spaced about 22' apart. In between these two walls are five upright quarried granite blocks, all between 3-3 ½' high. Four of the stones form a square with one of the edges lining up with the outside edge of the parallel walls (see sketch map). One upright stone stands off by itself but at least one other large stone is flat on the ground nearby. Some of these stones have evidence of having hinges or some other metal object attached to them. There is no mounding associated with the upright stones to suggest that they are grave markers and it seems likely that these stones formed the foundation and support piers for some sort of agricultural building, perhaps a granary, that needed to be raised off the ground. There is no evidence left to date this structure.

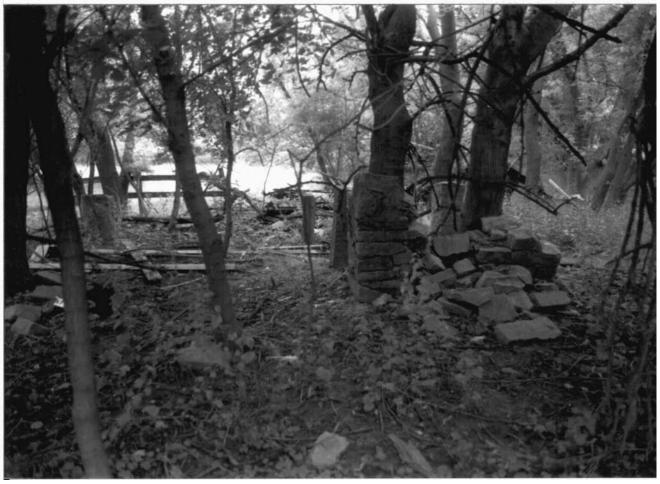
HO-770, K, WILL, star towns I be remark of movey, looking north 17 of 21

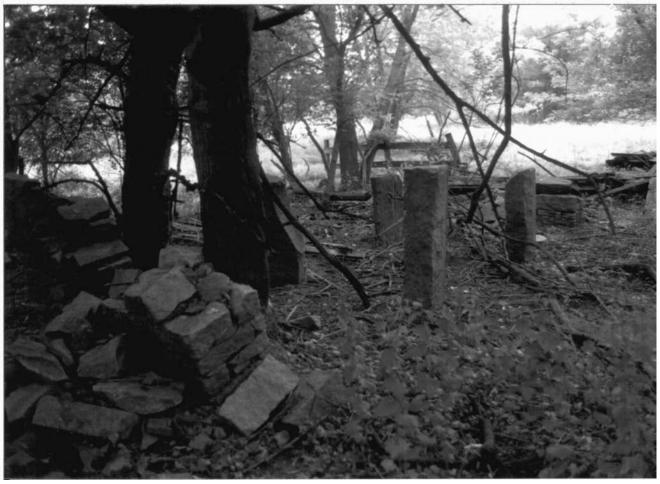
HO-770, Kalarney NOUG-11- 1 1 - 1 018 21+82 NHHNH 676 store foundation remains of eventry, toolog, with 17 of 21

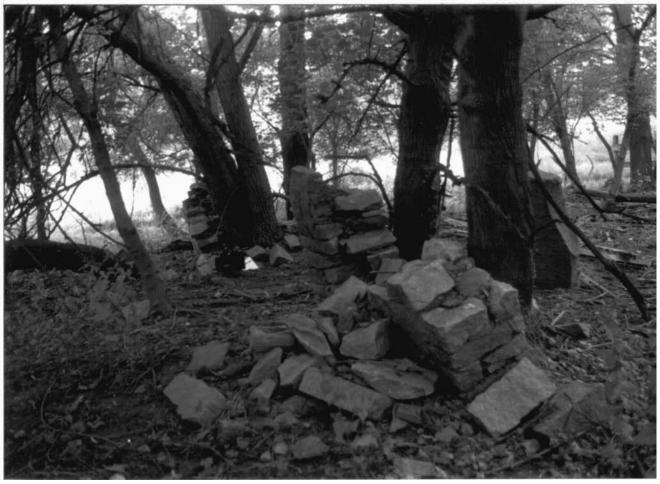
40.770, Kilaney Howard Courty, NO Knot ~ toll, 6/03 19 21+82 NNNN 676 Et no foura - on remains of armany, looking west from SE corner

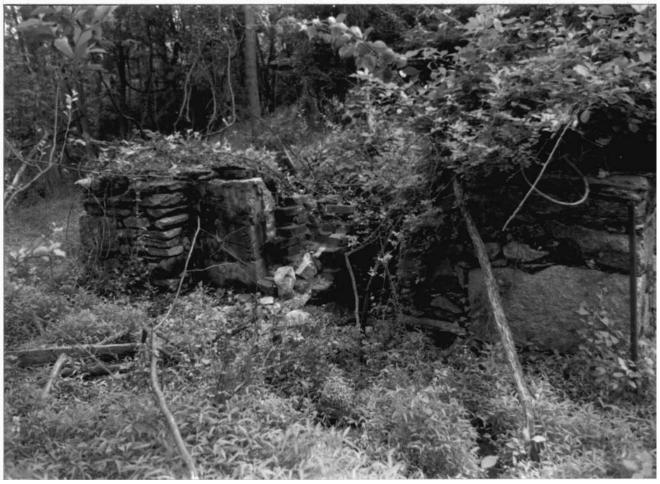
Stone down by four but on, South well

Located at the bottom of the farm path furthest from the house is yet another stone foundation. This one looks as if it was a dwelling at some time during the 20th century – an old water heater is still located in the cellar hole. The structure has collapsed, however, and all structural wood is too rotted for dating evidence. A few visible timbers contain wire nails. There is evidence of a small square brick flue located on the south wall of the structure and one in the interior of the structure. Some cinderblocks are visible in an interior wall inside the cellar hole. The foundation measures approximately 15' x 30'. All remaining evidence points to a 20th century date but the majority of the evidence is gone and the building could have dated earlier. There are several large,

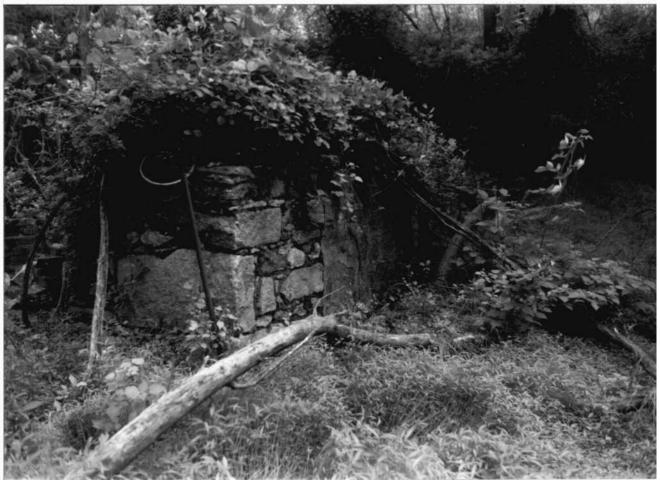
40-770, Kilainey Howard County MD Kn-11 - 6/03 Store doubles, formation, SE conter 21 01 21
