Maryland Historical Trust Maryland Inventory of Historic Properties Form

HO-902

The Mackall-Wolfe Farm is located at 14822 Burnt Woods Road, on the north side of the road, just east of Route 97, in western Howard County, Maryland. The farm is now Walnut Springs Nursery, and contains numerous modern buildings for that operation. There are also two houses on the property that appear to be tenant houses, both of which are frame.

Mackall-Wolfe Farm

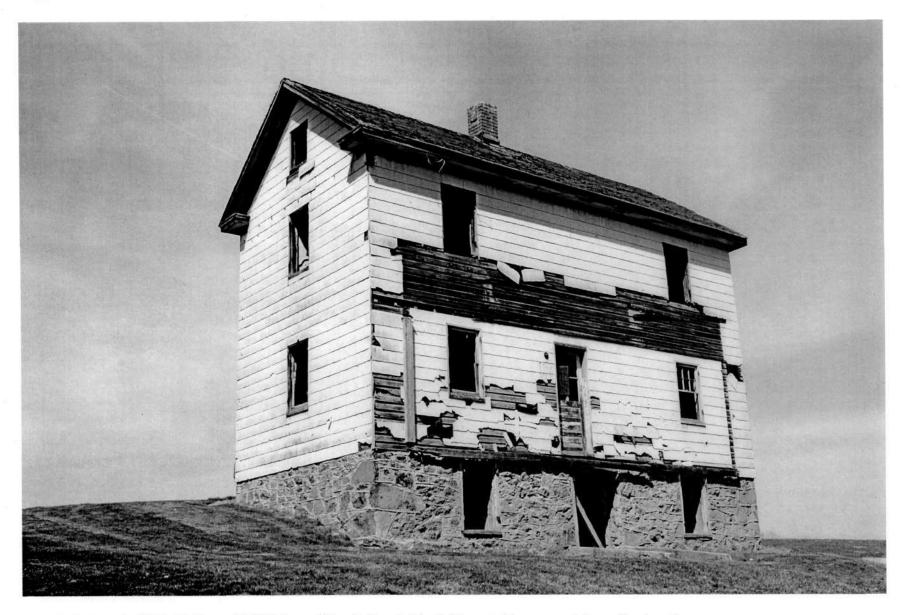
HO-0902 Mackall-Wolfe Farm 14822 Burnt Woods Road, North Tenant House-west & south elevations Ken Short, April 2006 1/8

The south elevation foundation has a doorway in the center with a circular-sawn frame that is wire-nailed. The frame is rotted, and the door is missing. There are concrete cheek walls on either side of this doorway. The stone is pointed with a bead. Each end bay of the foundation has a window opening with a wood sill and lintel, butt hinges for shutters that have two knuckles each, and the sash is missing. The first story has a center doorway with four lights over three lying panels in the door. The doorframe has a beaded interior edge. There is one window to either side of the door, also with a beaded-interior-edge frame, and the remains of six-over-six double-hung sash. These windows also have shutter butt hinges with two knuckles. There are traces of a three-bay, one-story porch that had pilasters or engaged square half columns against the house, and a shed roof. The second story has a matching window opening in each end bay, and there is a wood box cornice with returns.

The west elevation has no openings in the foundation. The first and second stories have a single typical window opening in the center bay, and the gable end has a short window opening in the center. On the north elevation the foundation is mostly hidden in the bank of the hill. The first story has a typical window opening in the east bay, no opening in the center bay, and a doorway in the west bay that has a beaded-interior-edge frame. Only the hinge stile of the door survives, but it indicates that the door had four panels with ogee moulds and has stamped plate butt hinges with five knuckles and loose joints. There is a ghost of a one-story, two-bay shed roof porch or addition on the center and west bays. The German siding was not covered here, and there is no apparent foundation, suggesting this was a porch. The second story has a typical window opening in the east and west bays, and the box cornice matches the south elevation. The east elevation has no openings in the foundation. The first story has a typical window, and the wall below it is mostly rotted out. There are circular-sawn 2 by 4 studs with downbraces at the corner that are let into notches in the studs. There are short pieces nailed between the studs between the foot and sill level, to give something to nail the interior wainscot to. The second story has a typical window opening, and the gable end has a typical window opening with the remains of a six-light sash.

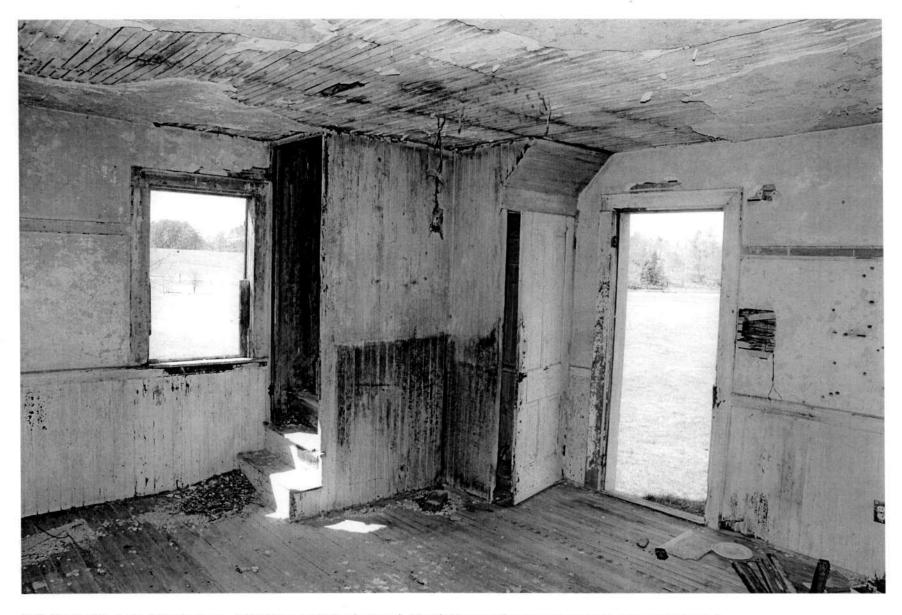
HO-0902 Mackall-Wolfe Farm 14822 Burnt Woods Road, North Tenant House-west room, view northwest Ken Short, April 2006 3/8

The first story has a hall-parlor plan divided by a wall that runs north-south. The west room has 2-1/2-inch tongue and groove pine flooring that runs east-west and is milled on the bottom. There is V-groove vertical-board half wainscot and chair rail with a torus on the shelf and a bevel at the bottom edge. The architrave is pulvinated, with a bead on the inner and outer edges, and is mitered

at the corners. The building has circular-sawn lath with wire nails, covered with plaster. The west room wall finishes on top of the plaster consist of a pale gray, a medium gray, a medium blue, a putty, and a tan color on top. The east elevation has a brick chimney in the center with a stovepipe hole, and a door to the south of this that has four panels with sunken fields and ovolo panel moulds. The door has stamped plate butt hinges with loose joints, and the rim lock is missing. There is peg rail on all sides of the room, and it has a bead at both the top and bottom edges. The sash have plain meeting rails and no parting beads. There is an enclosed winder stair in the northwest corner, with V-groove vertical boards. There is one step set below a missing door, and the stairs ascend to the north, with winders in the corner, and then turn to the east. The edge of the stairway where the winders turn has corner wood bead that is turned in the center. Beneath the stairway is a closet with a typical four-panel door with this building, and it has part of a cast-iron Suffolk latch. The east room has typical flooring, wainscot, chair rail, lath and plaster walls, architrave, and sash. The east room finishes have a dark blue on top of the plaster, then a light blue, peach, dark gray, light gray, on top. The dark blue has faded to a medium blue where it has been exposed for some time. The west wall has a stovepipe hole into the chimney in the west room. The exterior wall studs are spaced 16 inches on centers, while the interior wall studs are spaced 24 inches on centers.

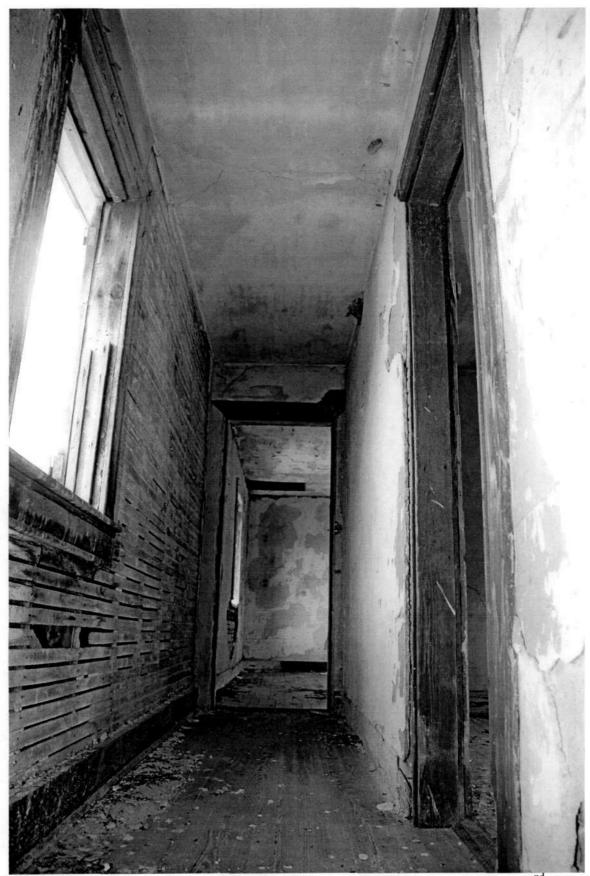
HO-0902 Mackall-Wolfe Farm 14822 Burnt Woods Road, North Tenant House -2nd story passage, view east Ken Short, April 2006 5/8

The second story has a passage that runs along the north wall with a chamber to the southwest and a chamber at the east end. The passage has typical flooring, plain baseboard, typical architrave, and plaster on lath. The west chamber also has typical flooring, baseboard, walls, and architrave. There is pegrail on the north wall though there are no pegs. The chimney on the east elevation has no stovepipe hole. The northwest corner is built in around the stairway from the first story. The sash details also match the first story. The east chamber has a stovepipe hole in the west wall. There is typical flooring, baseboard, architrave, and walls. The southeast corner of the room has pegrail, and there is a hatch in the ceiling in the northeast corner that gives access to the attic. The attic joists run north-south, are circular-sawn 3 by 6s and are spaced 24 inches on centers. The attic is mostly unfloored. The rafters are also circular-sawn, are 2 by 4s and are mitered at the ridge. They support shingle lath and boards nailed between this lath.

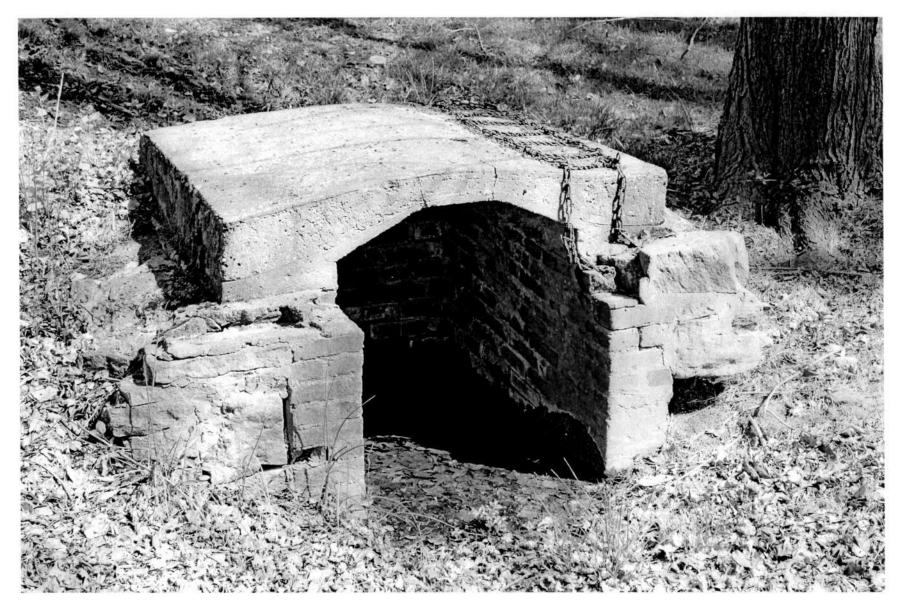
HO-0902 Mackall-Wolfe Farm 14822 Burnt Woods Road, Spring head near North Tenant House Ken Short, April 2006 7/8

About 100 feet west of the house is a springhead cover with stone walls that are lined with brick, and with an arched top.
