HO-935

12408 Clarksville Pike, Clarksville  
Howard County, Maryland

## Maryland Inventory of Historic Properties Form

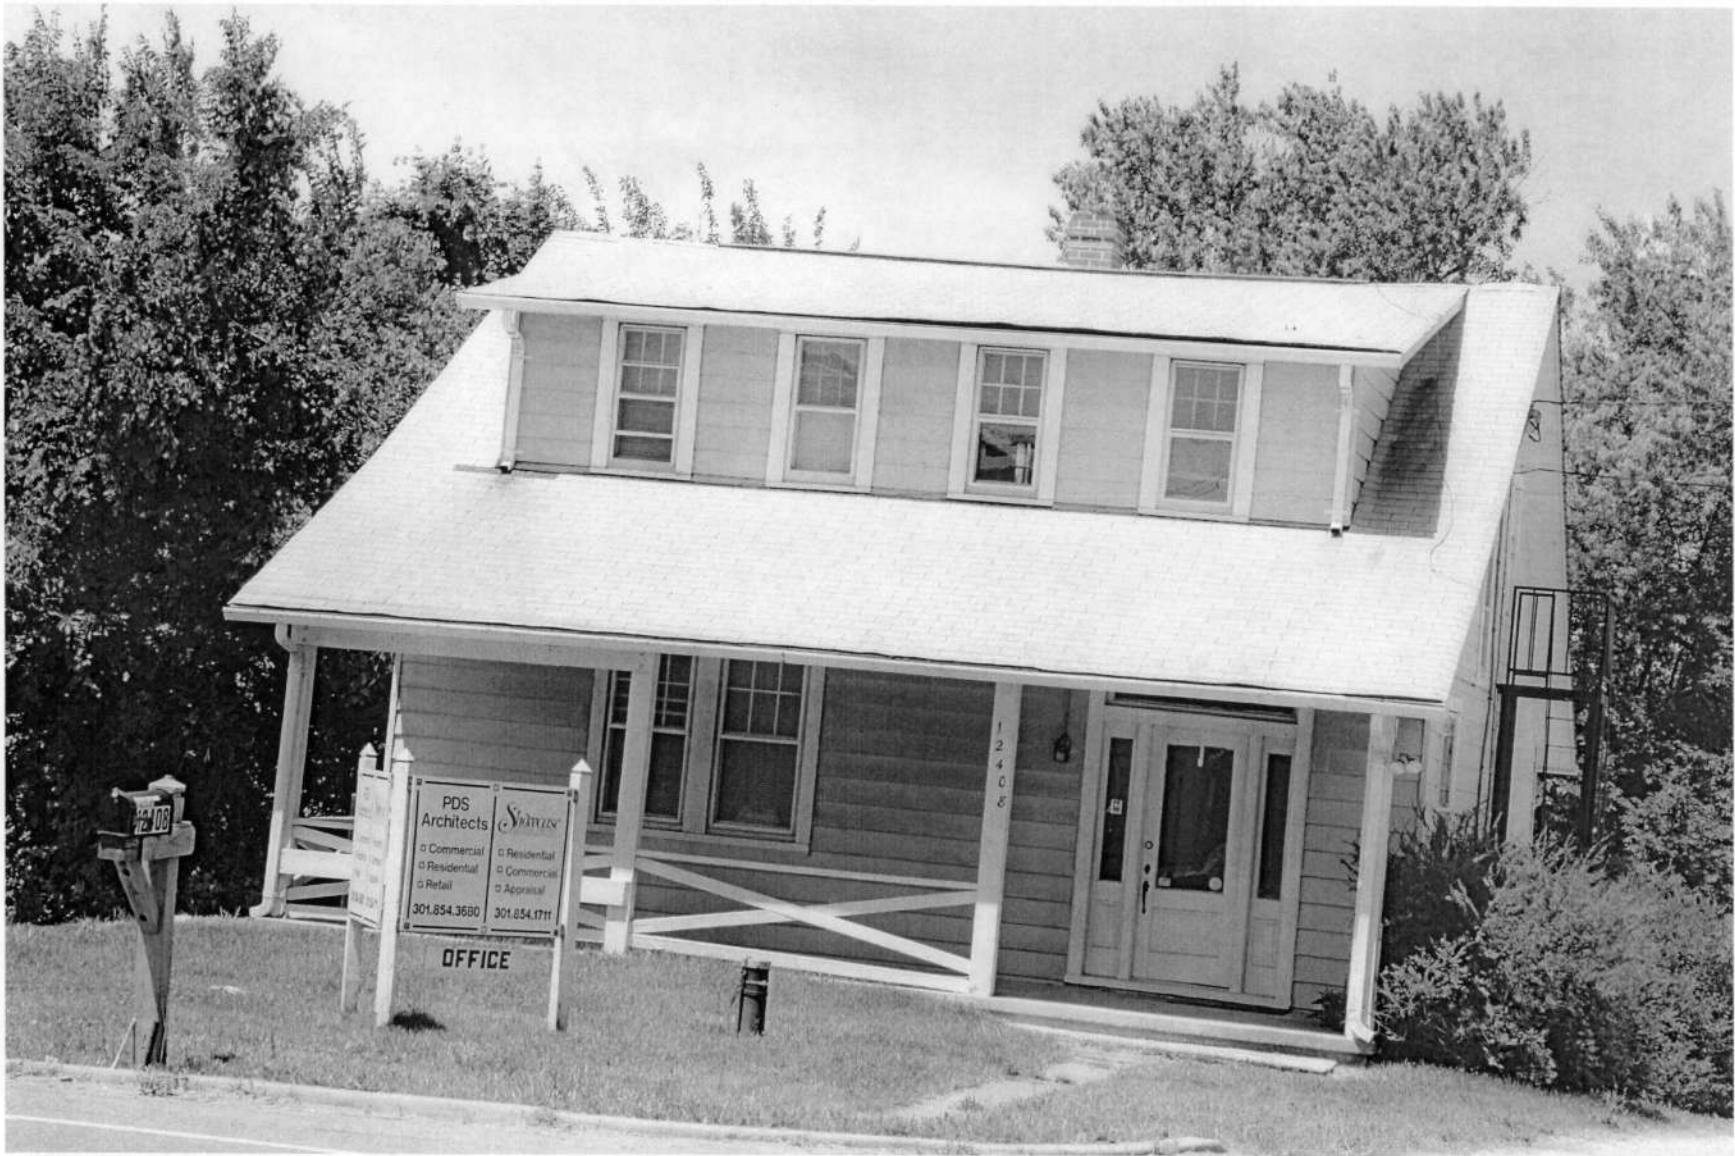
HO-935 12408 Clarksville Pike East elevation  
Ken Short, June 2007 1/1

HO-0935\_20070622\_01  
12408 Clarksville Pike  
Howard County, Maryland  
East elevation  
Ken Short,  
June 2007  
1/1
