HO-941
John and Sarah Wilson Farm
13741 Frederick Road
West Friendship

Addendum

RECONSTRUCTED FIRST FLOOR PLAN FOR EARLIER LOG HOUSE -- MEASURED & DRAWN BY KEN SHORT -- JUNE 2009

Maryland Inventory of Historic Properties Form

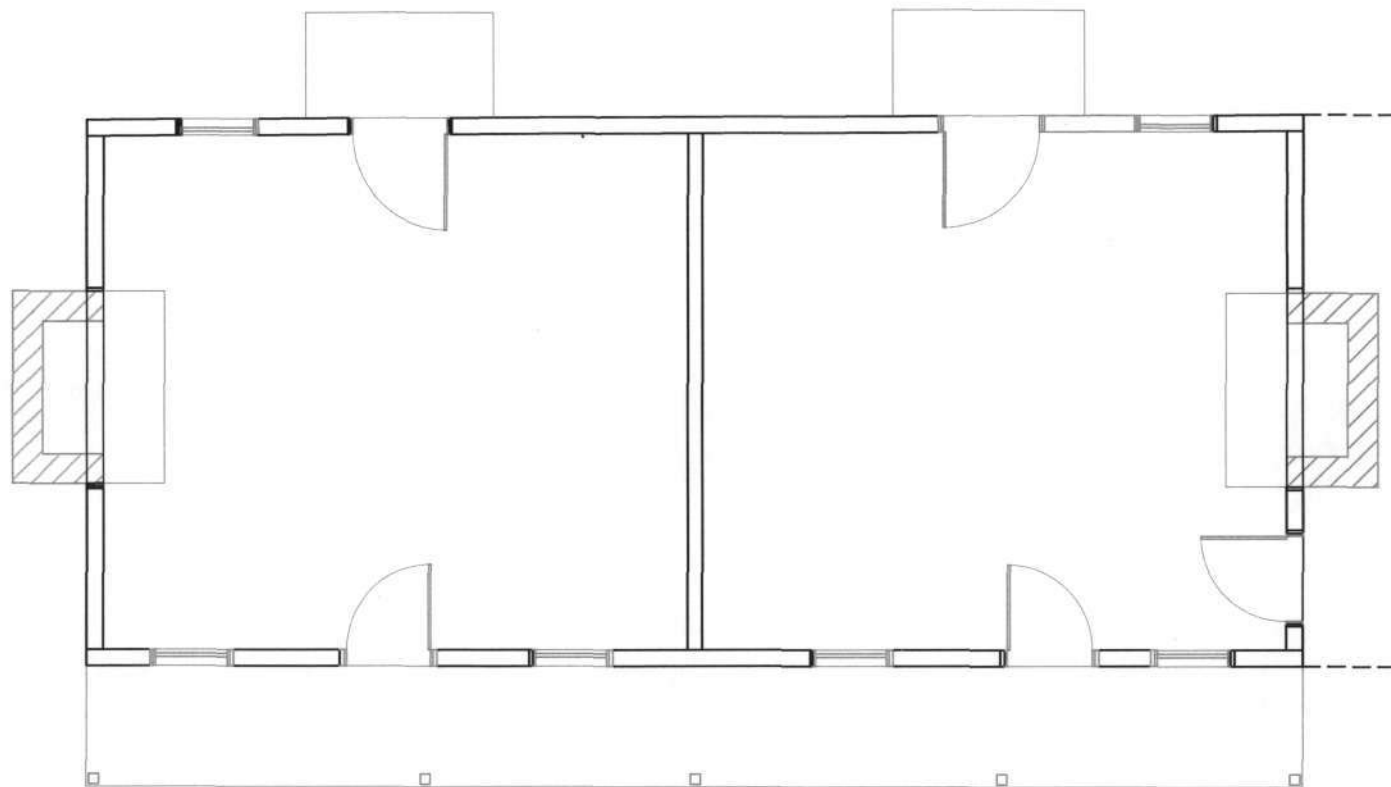
1. MISSING ELEMENTS SHOWN IN GRAY.
2. DEPTH OF PORCHES, FIREPLACES, AND HEARTHES CONJECTURAL.
3. MISSING ROOM ON WEST END NOT SHOWN. PERIOD OF IT'S EXISTENCE UNKNOWN.
4. ALL EXISTING SHOWN JAMB BOARDS PEGGED TO LOG ENDS. MISSING ORIGINAL JAMB BOARDS REMOVED WHEN BUILDING WAS RENOVATED C. 1906.
5. NO CLEAR EVIDENCE OF STAIRWAYS FOUND. NO EVIDENCE OF A SECOND STORY-- BUILDING APPARENTLY ONE STORY AND ATTIC.

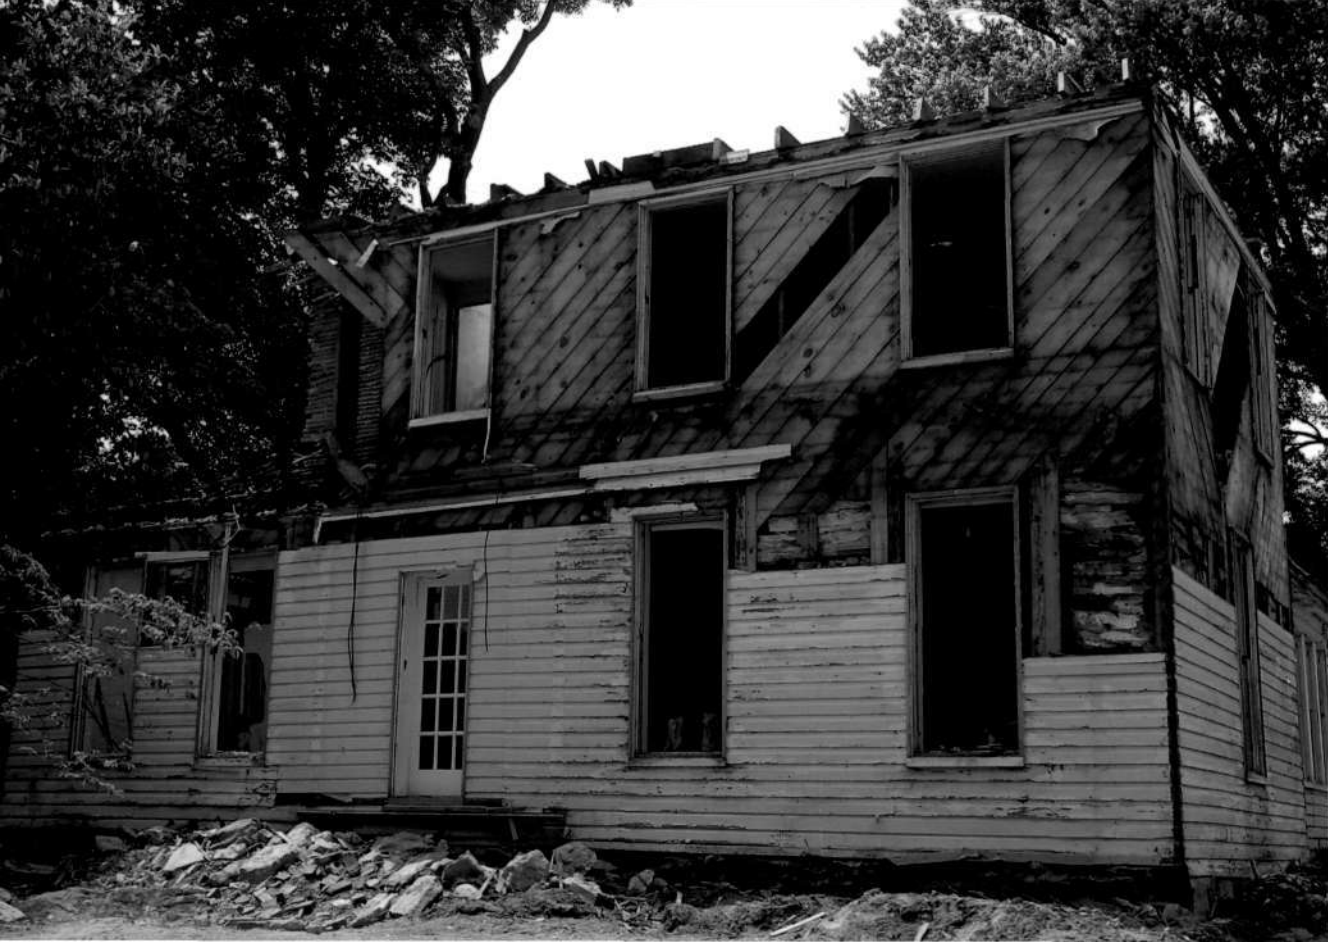
1 of 2

House, north + west elevations
during dismantling

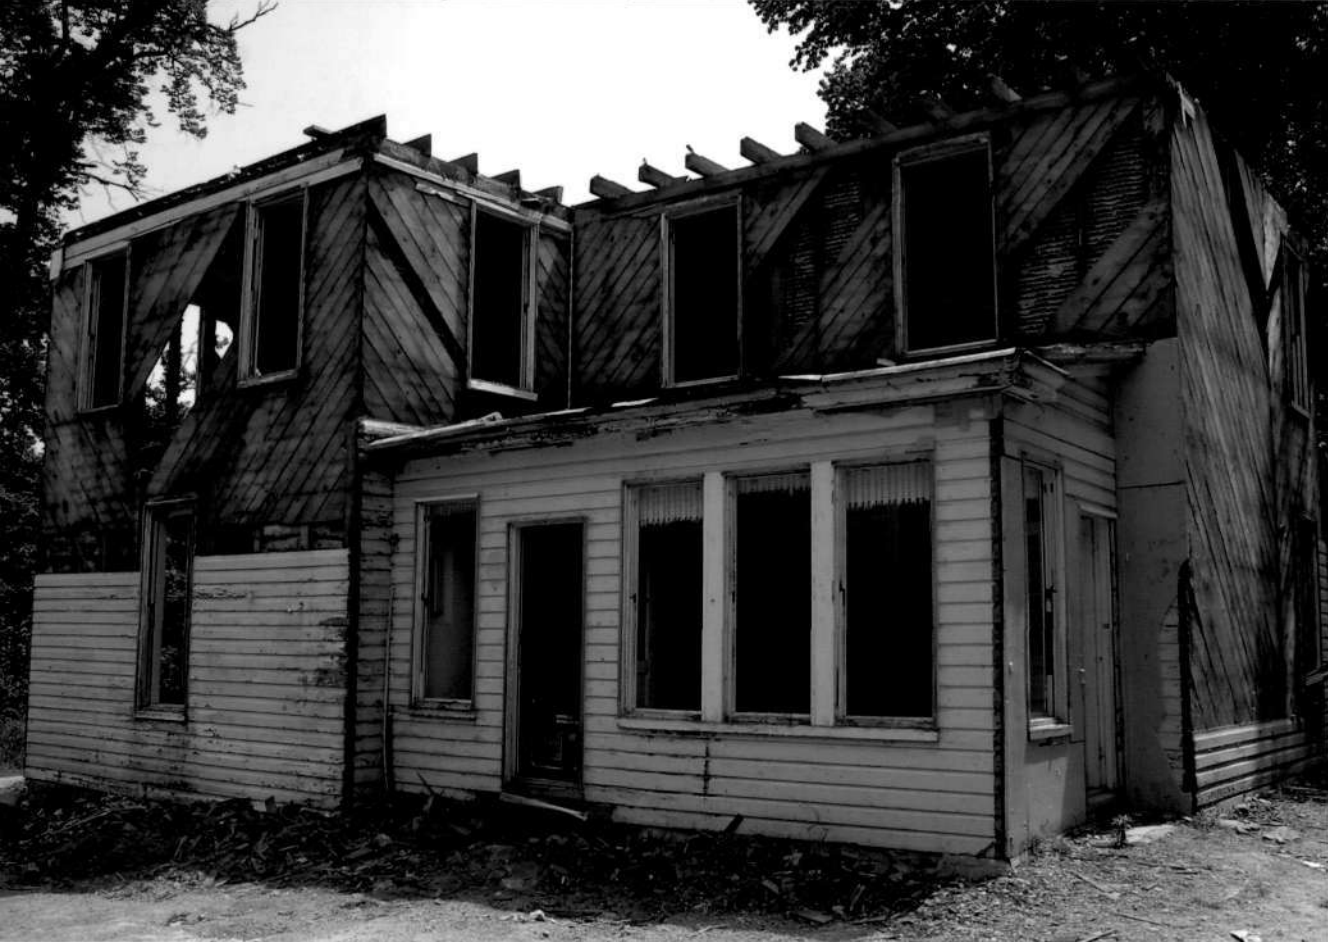
6-2-09
House, west, + south elevations
during dismantling
2 of 2

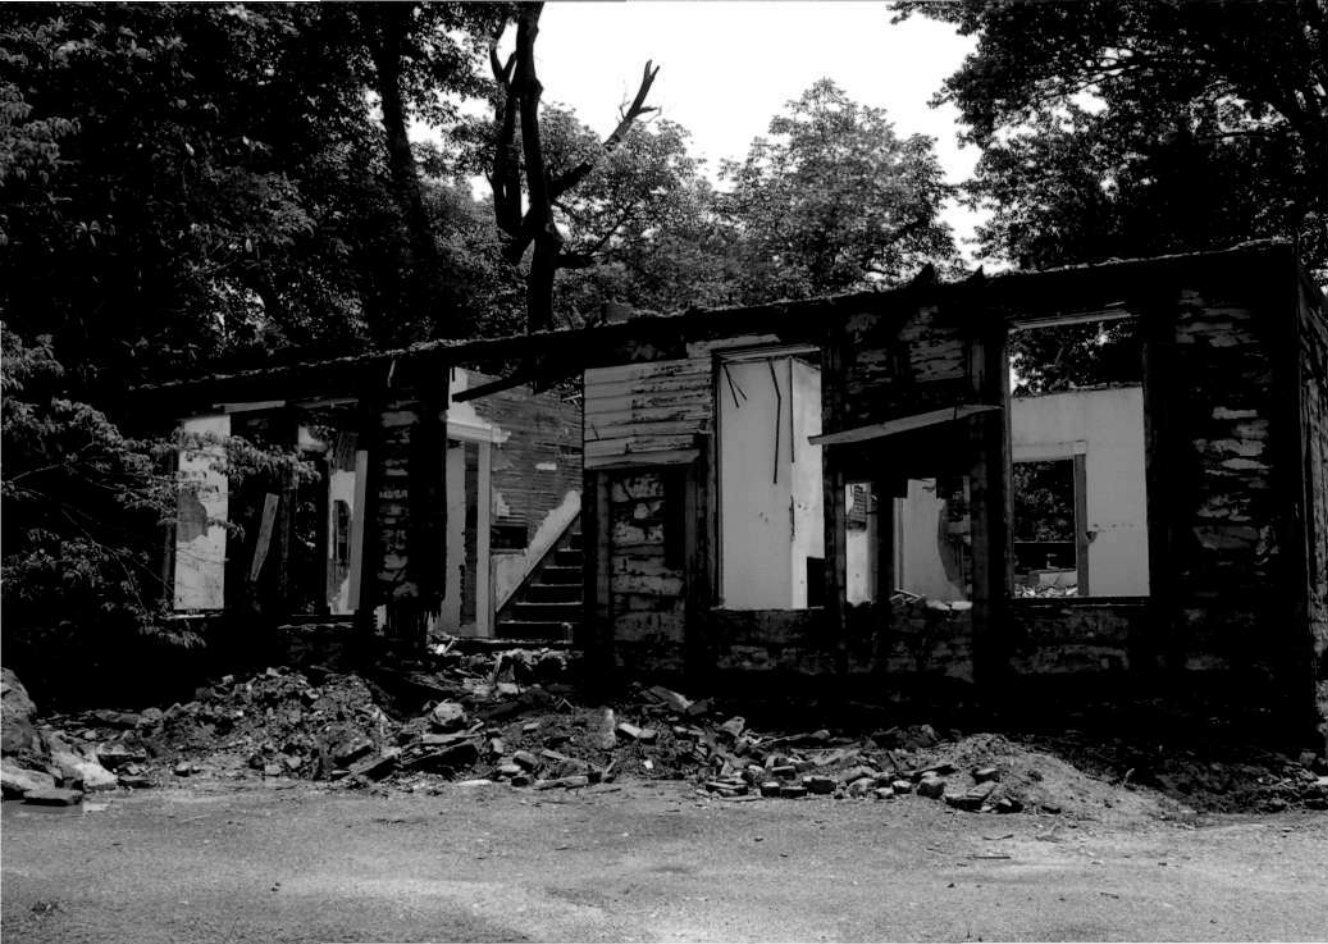
1 of 6

House, north elevation of log
structure

The northwest elevation has cut lath nails on the exterior, and was then sided over. At the north end is some circular-sawn vertical lath with plaster on it, and the plaster has several coats of a bright blue pigmented whitewash over several coats of white over a black or very dark brown. There was a doorway at the north end. There is a wide opening in the center that has later infill in it, and this was apparently for a fireplace. The bottom log in the wall here is patched. There is heavy soot at the top of both sides of this opening. There are two mortises in the first full log above the doorway on either side of the fireplace jambs, probably for an addition on this side. The west end has two 1-1/2 inch diameter pegs broken off in holes in the wall 5 feet, 2 inches above the foundation. On the southwest elevation, at the west end, there are no lath nails on the exterior face of the logs. There is a sash-sawn window jamb board pegged to the log ends, and this window was later converted to a door, and then closed up with drywall. The southwest elevation, in the center, has a small lap joint in the bottom log with a V-notch log on top of it for a partition wall that ran southwest to northeast. It thus appears that the whole building was constructed in one phase. A doorway was cut through this center of the wall at a later date. The top log is face-lapped with one bolt connecting the joint, and this probably replaces an earlier peg. There were no windows in the two center bays on this elevation. The southwest elevation had a window at the south end and a doorway to the west of this window. Between the window and door are two notches for a porch railing,

the top notch being 3-3/4 inches by 2-3/4 inches high, with a pyramidal top to the notch, and the notch is 3-1/2 inches high in the center. The bottom notch is 1-1/4 inches wide by 3-1/2 inches high. There is no evidence of notches for a porch railing on the west side of the door in the east-center bay.

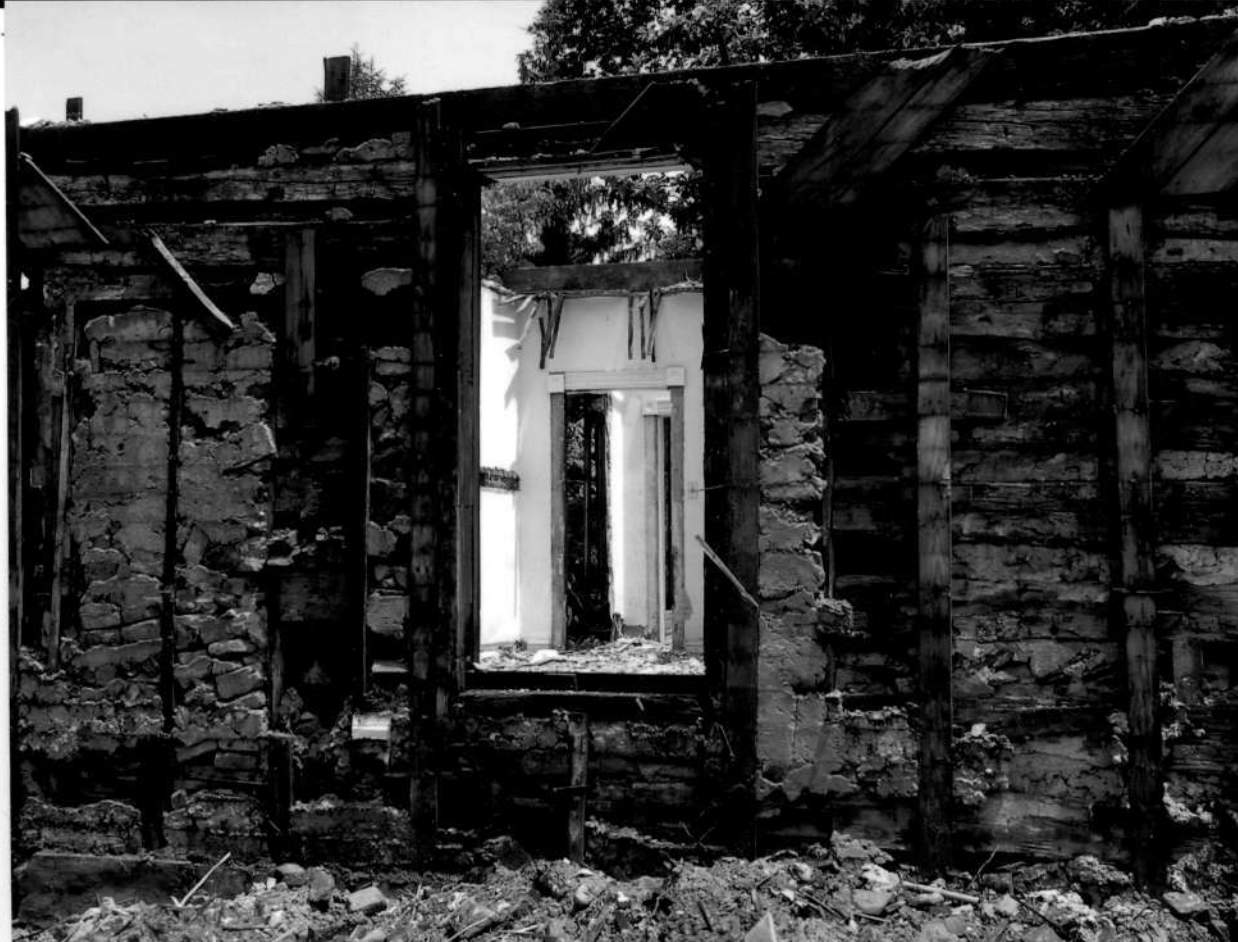
3 of 6

House, west elevation of
log structure

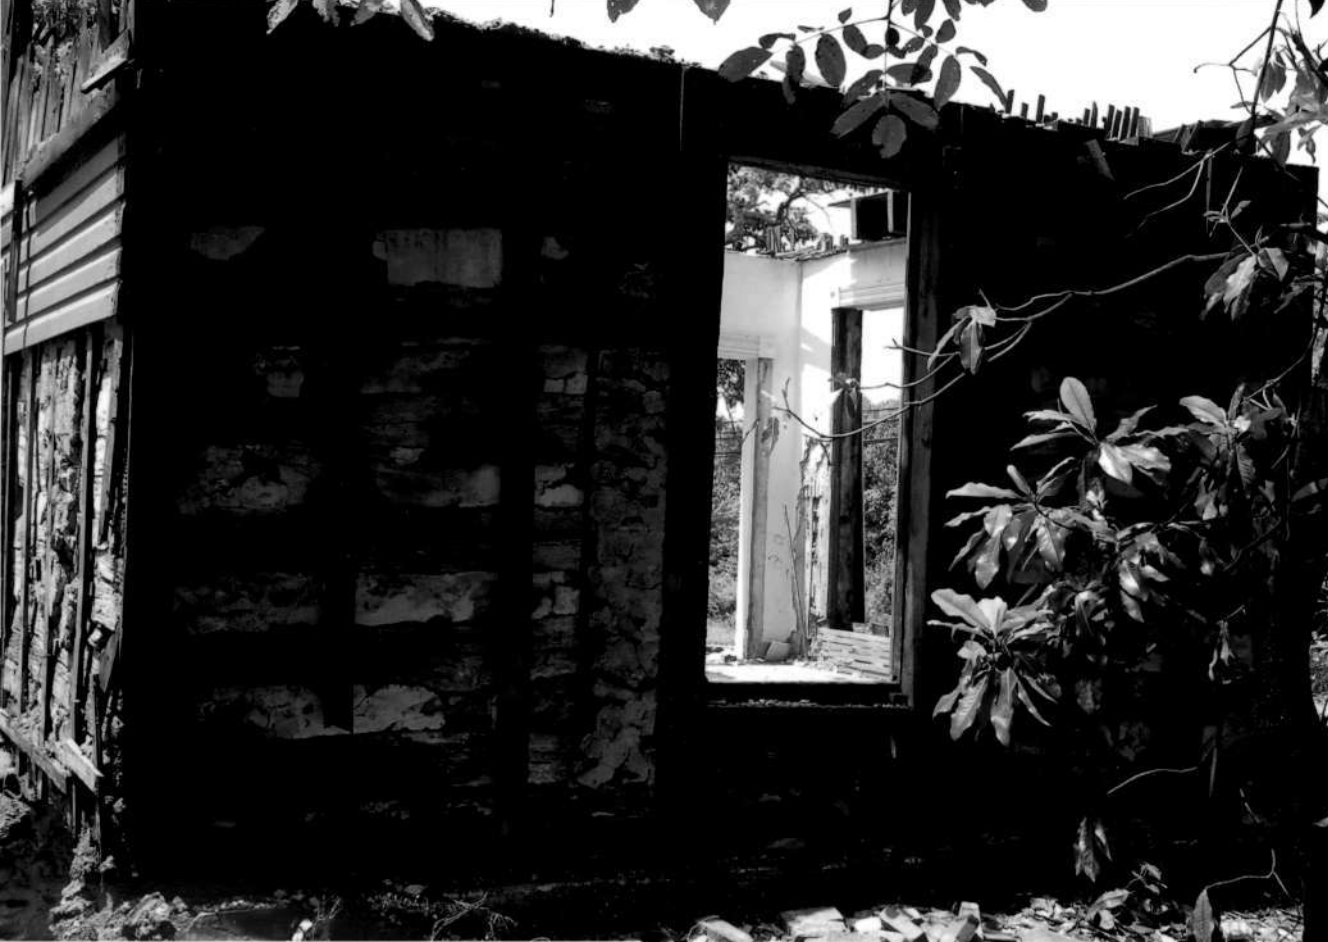
4 of 6

House, east elevation of log
structure

The main block is a V-notched-corner log structure with whitewash on all sides. The kitchen wing and the second story were frame, and were removed first. Sills were added to the top of the first story before the second story addition was put on. The northeast elevation had, from north to east, a window, door, window, an unknown configuration in the center because the wall was opened up for a later doorway, then a window, door, window. All of the jambs are two inches wide, where they exist in the original openings, and are pegged to the log ends. The bottom log in the center is half-lapped, with the end of a V-notch log on top of it that runs back to the southwest below the floor and matches the arrangement in the south wall. On the north end, the log above the window openings has two notches, one above the other, that may have been for a porch that was connected here. There is another mortise between the two north windows. The exterior face of the log wall has cut lath nails in it, and there are diagonal ghosts of the lath in the whitewash. The east end exterior wall also has cut lath nails.

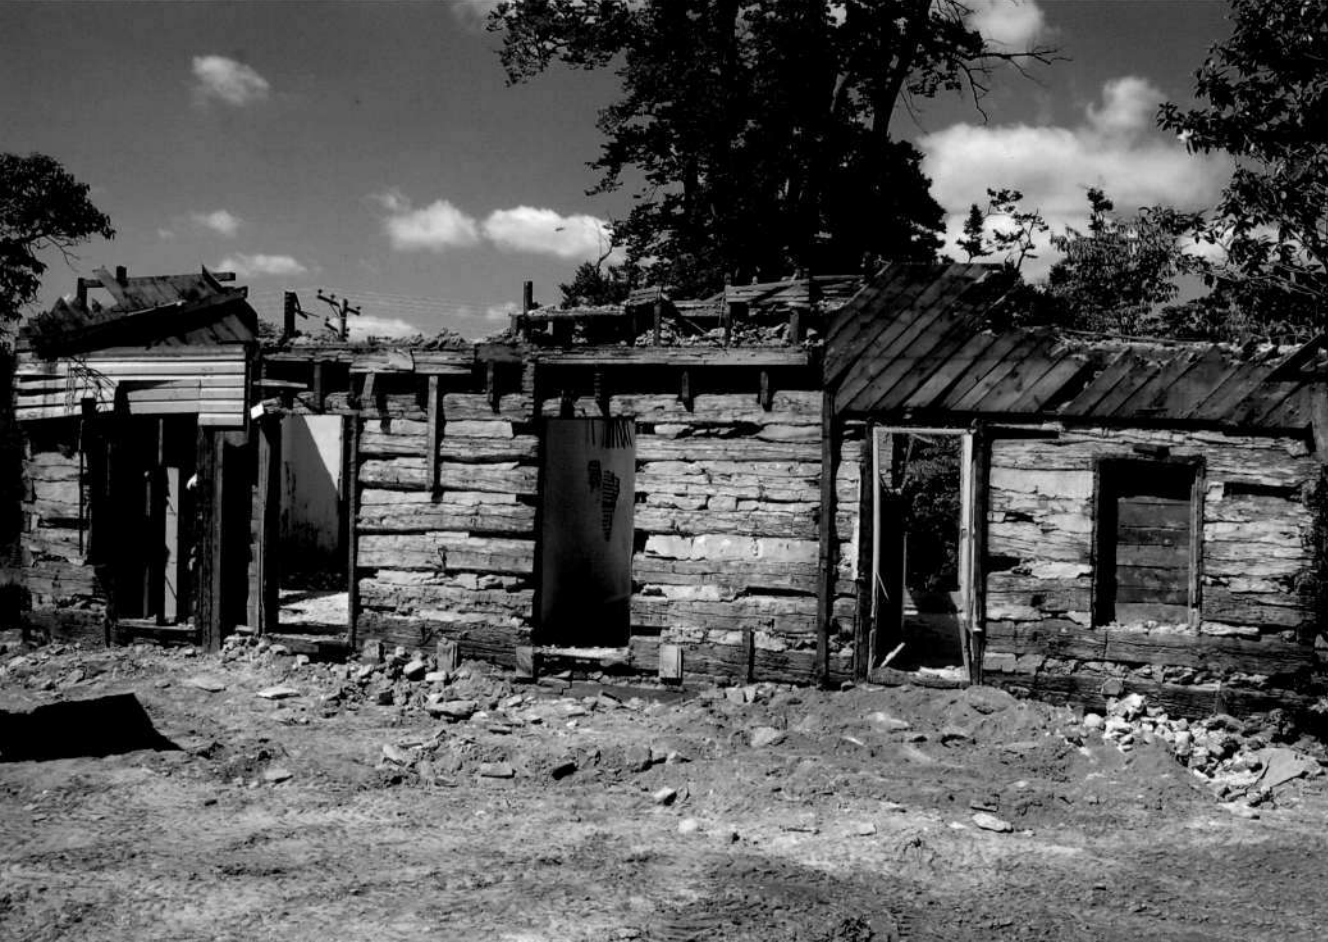
5 of 6

House, south elevation of log
structure

The southeast elevation also had a wide opening apparently for a fireplace. The bottom log in this wall has been pieced together and it appears to be a repair, rather than the addition of a missing section. There are no mortises on this wall in the logs. The flooring in the west end on the first story is fastened with cut nails that are face-nailed.

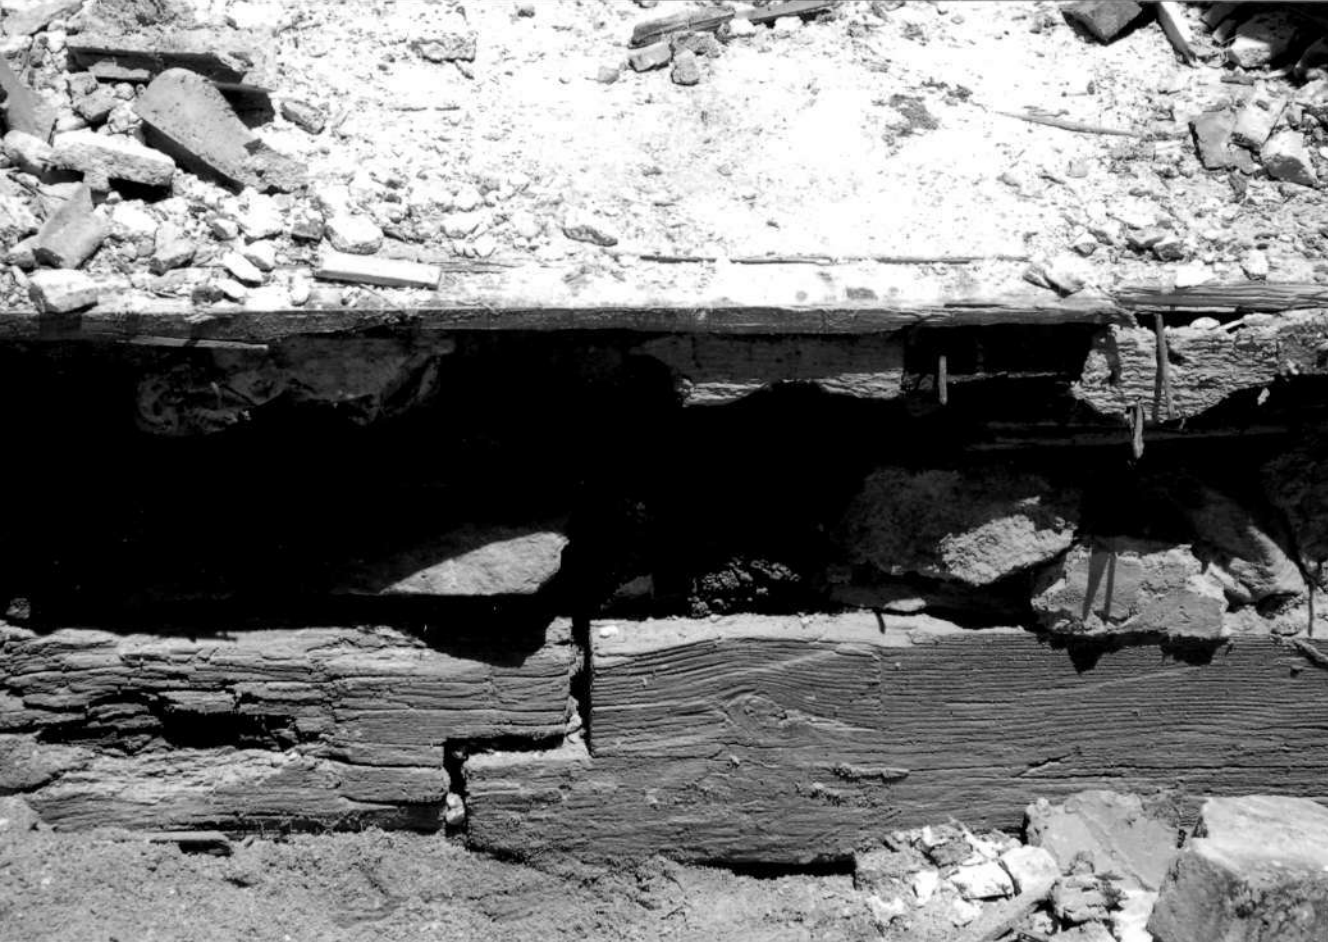
6 of 6

House, south elevation, detail of
center sill and log partition
wall

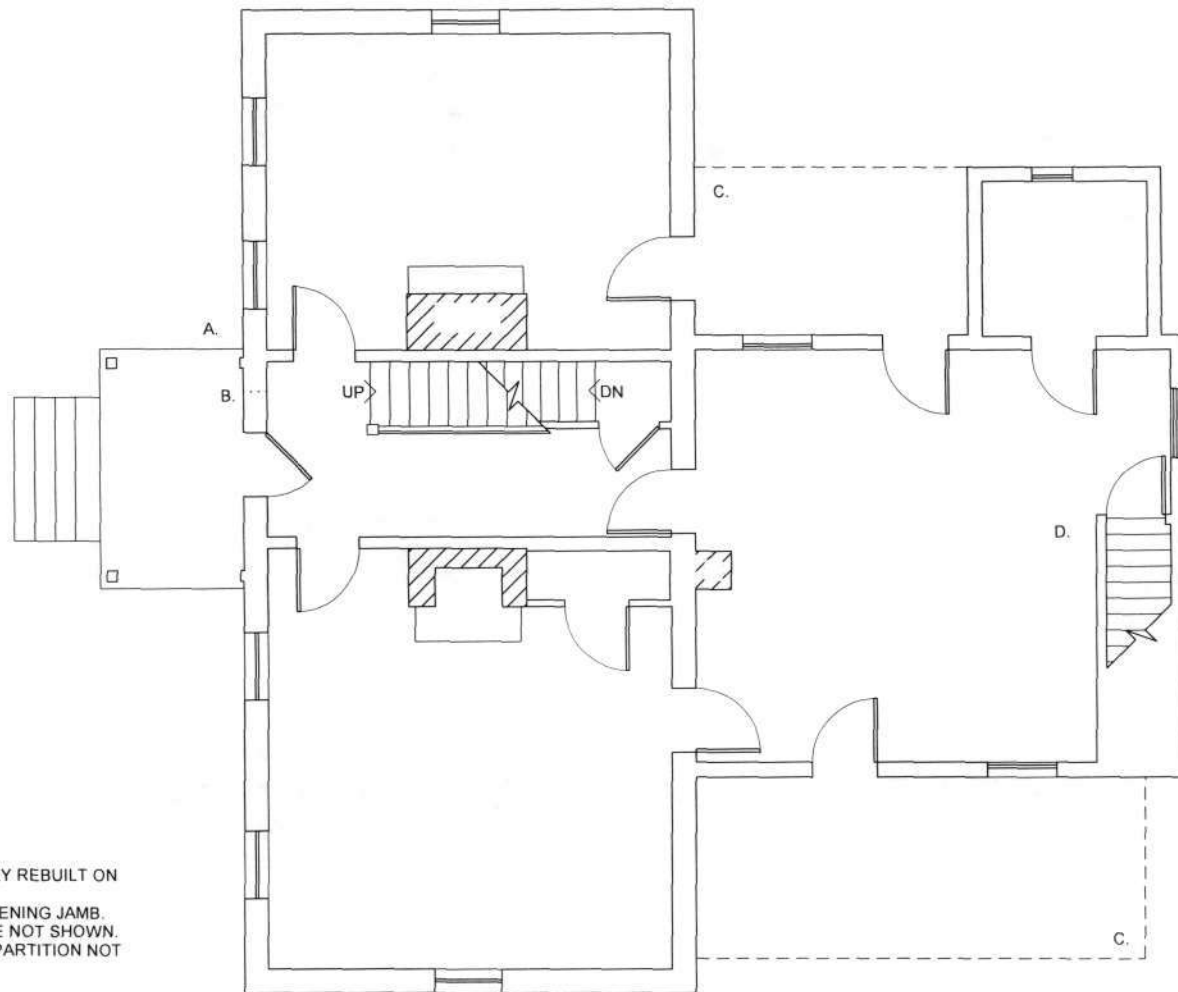
- A. PORCH COMPLETELY REBUILT ON ORIGINAL PIERS.
- B. ORIGINAL DOOR OPENING JAMB.
- C. PORCH ENCLOSURE NOT SHOWN.
- D. MODERN KITCHEN PARTITION NOT SHOWN.

FIRST FLOOR PLAN -- MEASURED AND DRAWN BY KEN SHORT -- NOVEMBER 2007

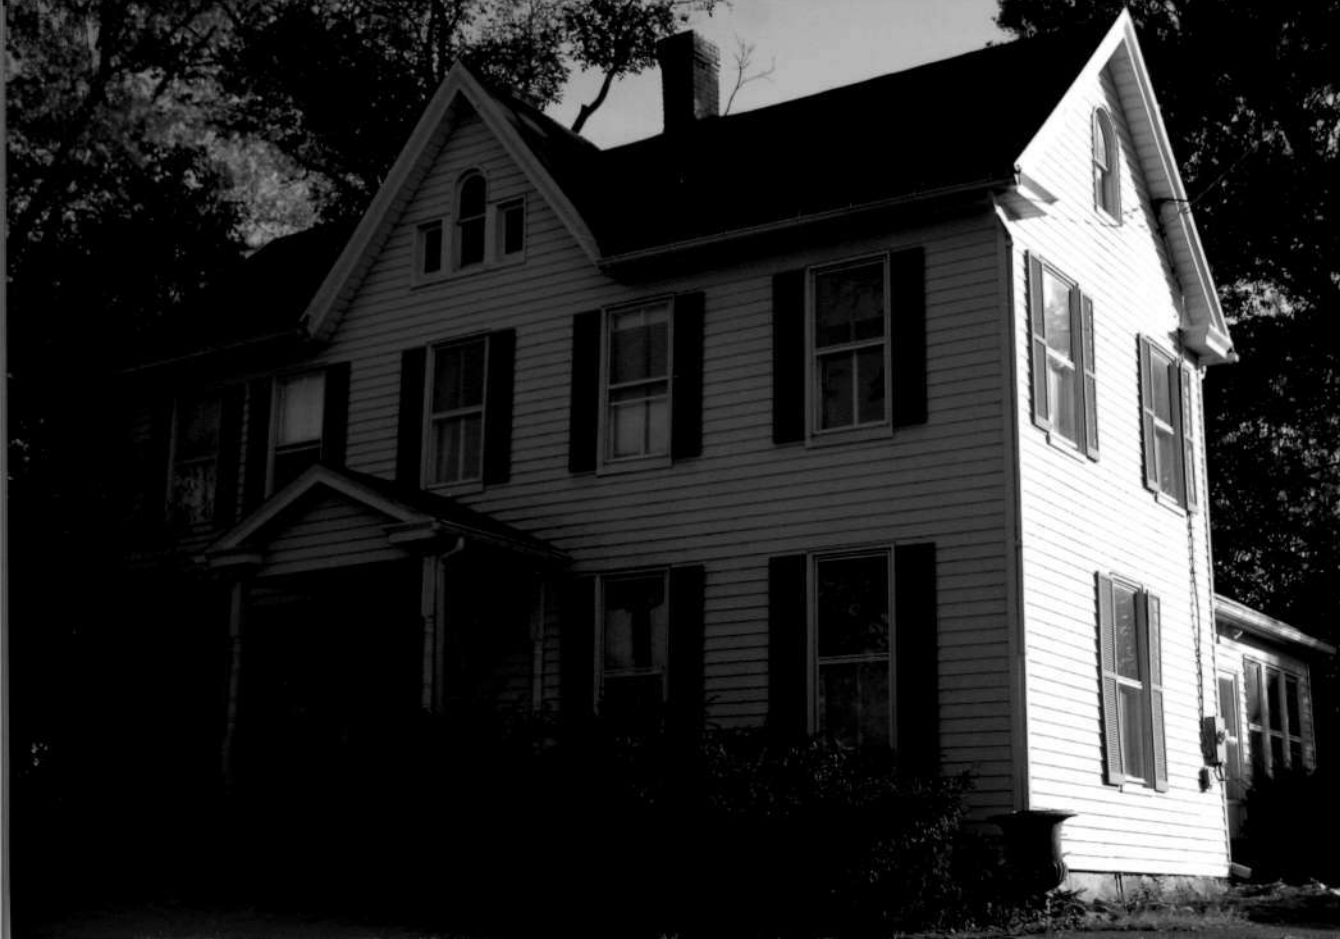
1/8

House, north + west elevations

The house is a 2 1/2-story, five-bay by two-bay frame structure with a parged rubble stone foundation, aluminum siding and a gable roof with standing seam and an east-west ridge. There is a two-story ell on the south, or rear, with a rubble stone foundation, aluminum siding, and a gable roof with standing-seam metal and a north-south ridge. The ell is two bays by two bays. There is an interior brick chimney flanking the center bay of the main block and another where the ell meets the main block. On the north elevation the first story has a center door with 15 lights, with two two-over-two sash to each side that have fake shutters. The foundation has a three-light sash in the east bay. There is a one-bay, one-story gable-roofed porch in the center that has a tongue-and-groove wood deck, turned posts, and asphalt shingles. The roof has a north-south ridge, and aluminum covers all of the roof trim and soffit. The second story has five two-over-sash, and there is a gabled wall dormer that contains a Palladian window with a round-arched top sash in the center above a one-over-one sash. The house has a boxed cornice that is wrapped in aluminum.

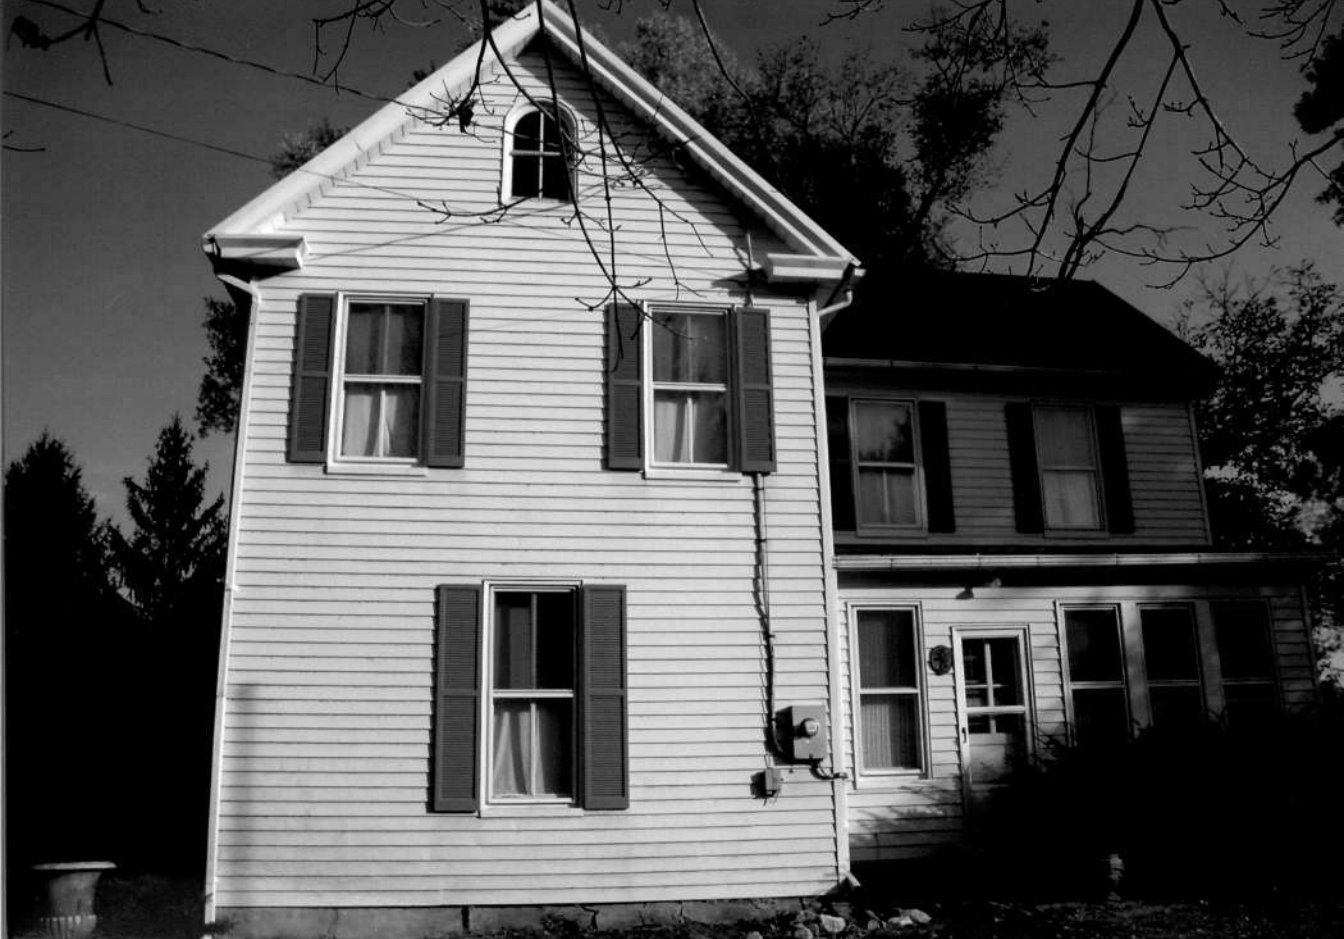
2/8

House, west elevation

The west elevation of the main block has a two-over-two sash in the center on the first story, two two-over-two sash on the second story, and a round-arched two-over-two sash in the gable end. The west elevation of the ell has an enclosed porch on the first story that has a one-over-one sash, a door with four lights over three lying panels, and triple one-over-one sash to the south. The porch has a standing-seam shed roof. The second story ell has two two-over-two sash. The south elevation of the west addition to the ell, on the first story, has a one-over-one sash and a door with four lights over three lying panels. The main block on the second story has a two-over-two sash. The south elevation of the ell has no openings in the west bay of the first and second stories, and a two-over-two sash in the east bay on both stories. There are no openings in the gable end. The south elevation of the east addition, or enclosed porch, has no opening on the pantry on the first story. The addition to this story has a door with four lights over three lying panels, and a four-over-four sash. The second story of the main block has a two-over-two sash. The east elevation of the ell, on the first story, has a small four-light sash on the pantry and a triple six-over-six sash on the addition. The second story has two two-over-two sash on the ell. The east elevation of the main block has a two-over-two sash in the center on both the first and second stories. The gable end matches the west elevation.

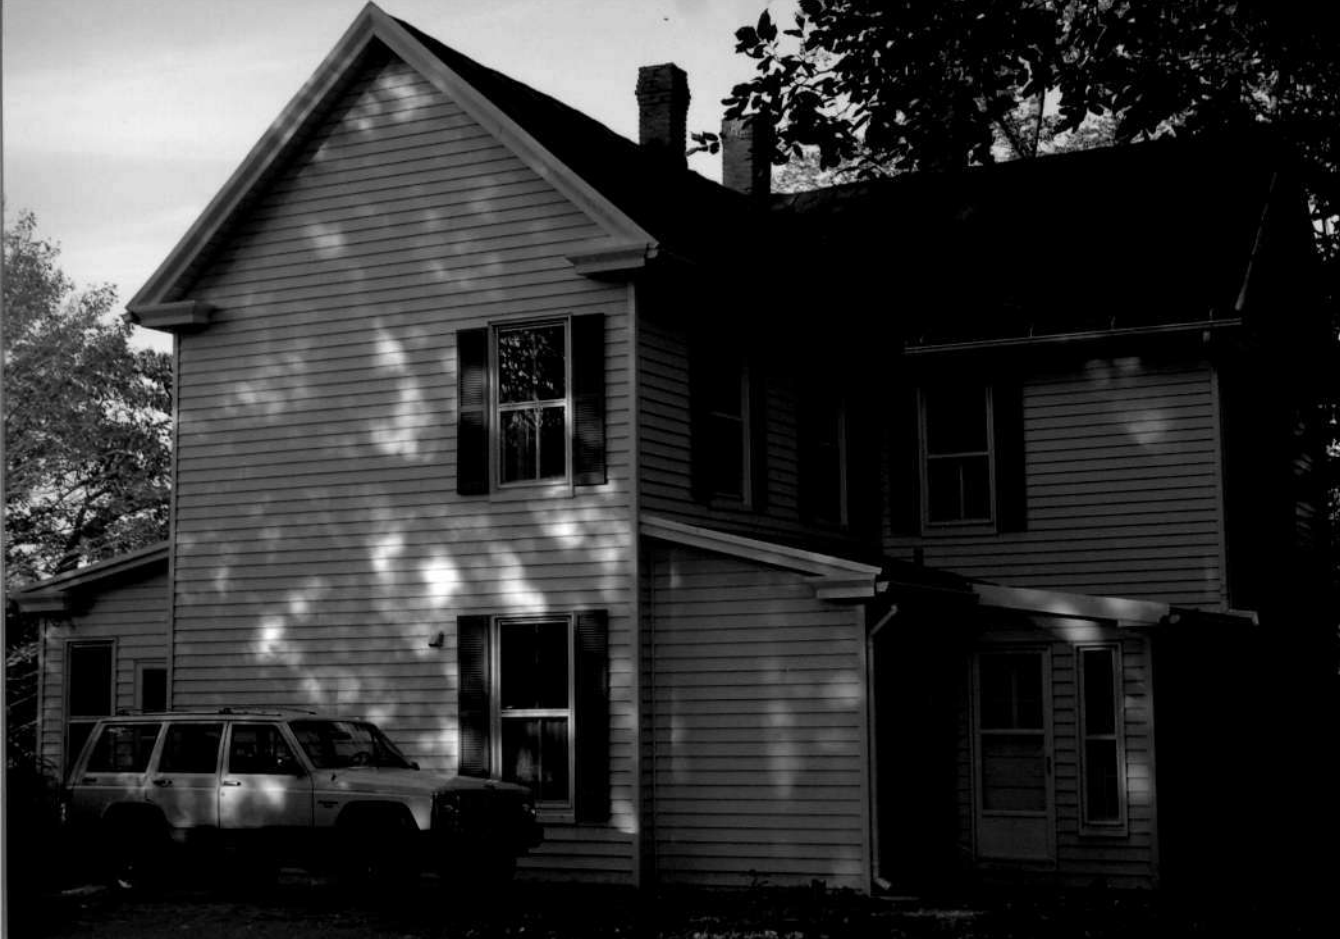
3/8

House, south + east elevations

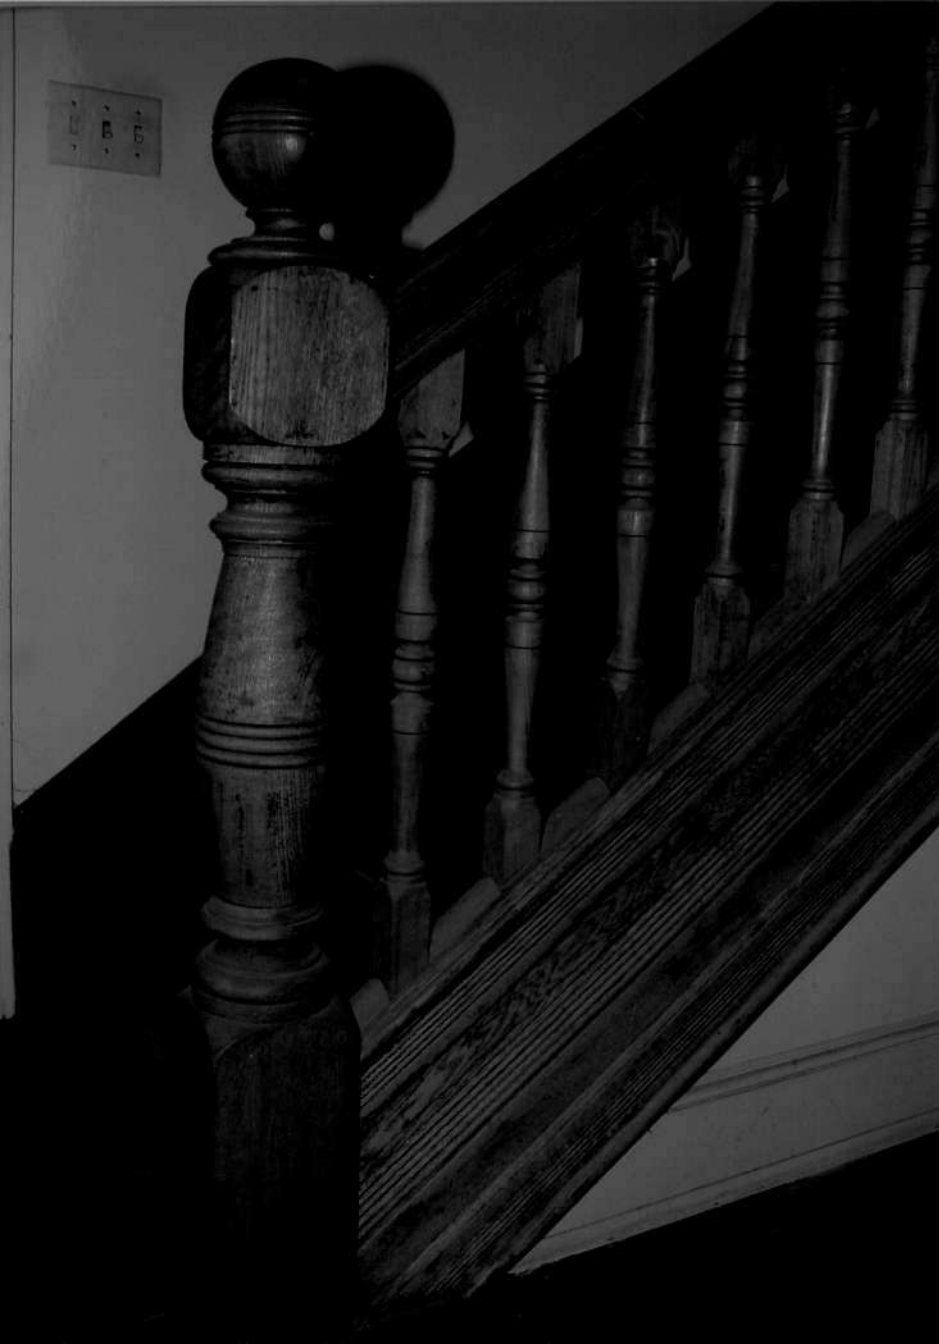
4/8

House, stair newel

edge. There is a turned newel post with three beads in the center and a ball on top that has two beads around the center. The balusters are turned, and there is a moulded handrail. The stairway is all constructed of oak, and most of the original varnish has been removed. The rear door has 15 lights, a lock and hinges that match the front door, and porcelain knobs. There is a door beneath the stairway leading to the cellar, with typical four panels and plain cast iron rim lock with metal knobs.

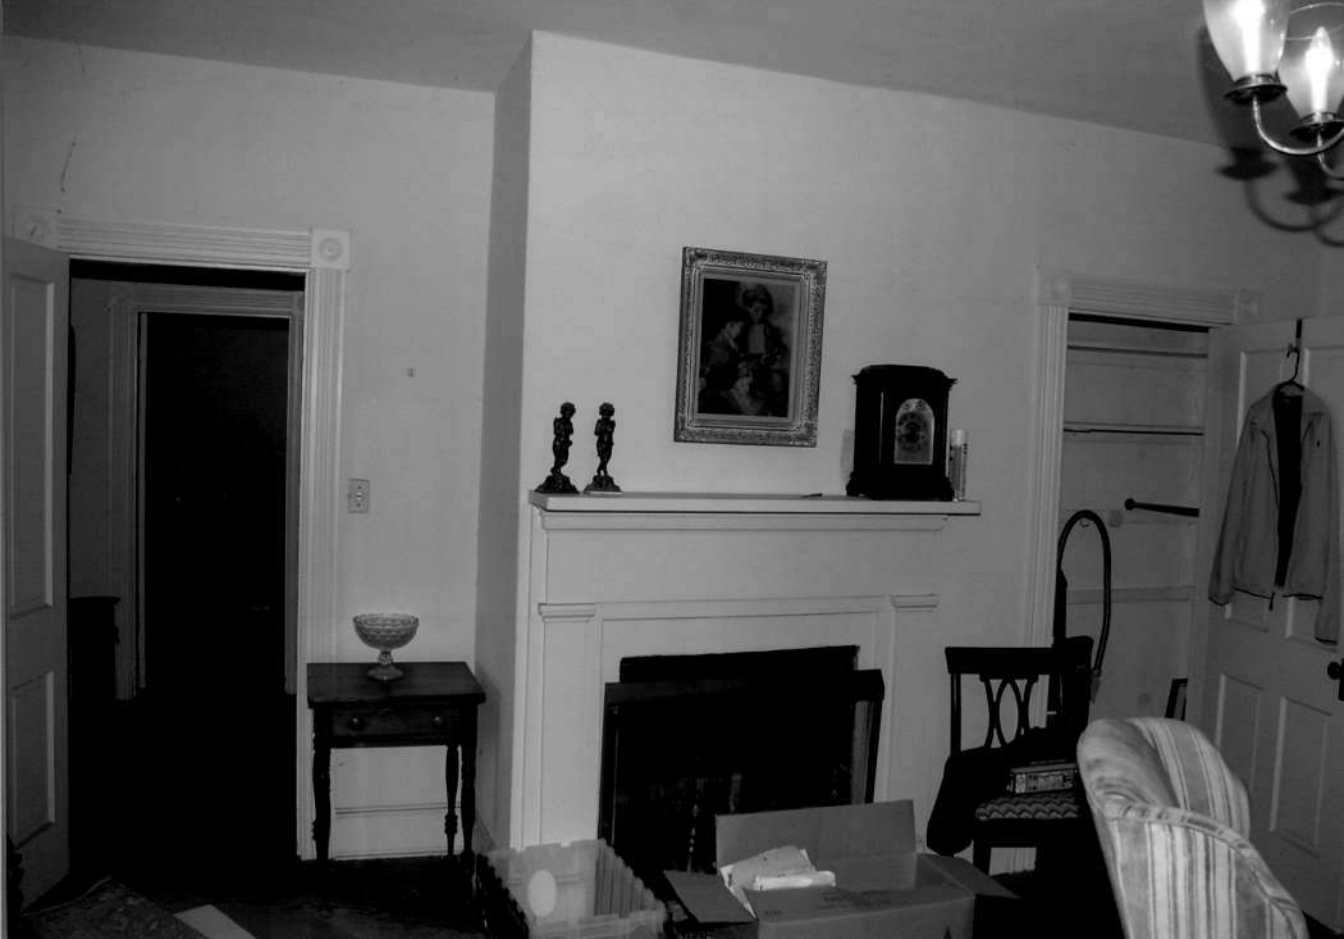
5/8

House, west room, view east

The west room flooring matches the passage and runs east-west. It has typical baseboard and architrave, and the two-over-two sash are hung on cords and are not mortised and tenoned and pinned. There is a fireplace on the east elevation with a brick hearth and straight brick jambs. It has a wood mantel with plain pilaster strips that have quirked ogee and bevel capitals, and there is a plain frieze. The bed mould has a quirked ogee and bevel above a field and a cavetto below the field. The mantel shelf is plain. To the south of the fireplace is a closet with a typical door and architrave, and there is a typical door on the south elevation that leads to the ell.

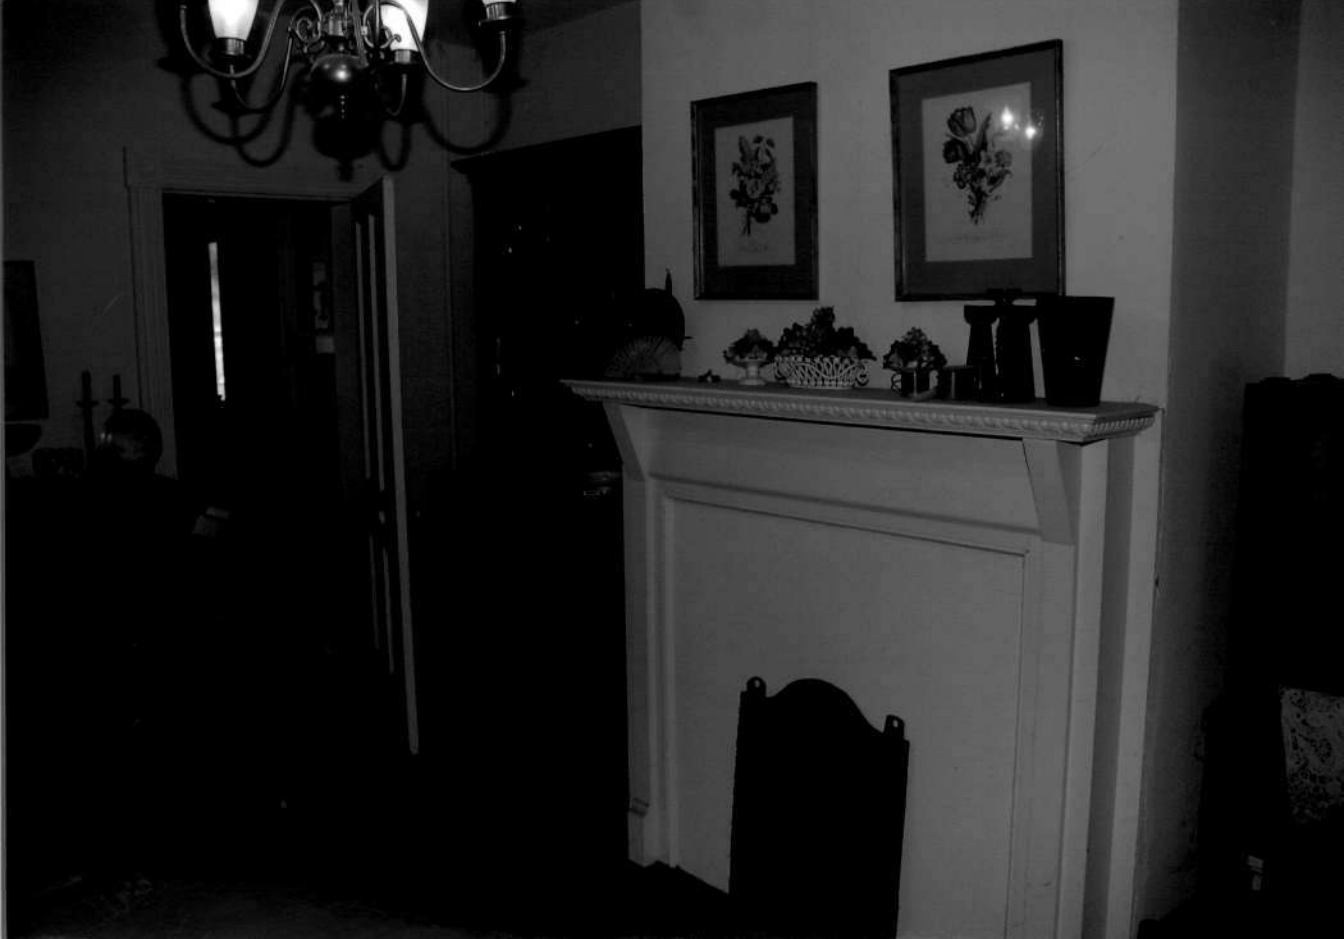
6/8

House, east room, view southwest

The east room flooring is 2 1/2-inch oak that is laid over the original floor. The baseboard is typical, though most of it has been removed for baseboard heating, and the architrave and sash also match the west room. There is a closed-off fireplace on the west elevation with a brick hearth and a wood mantel that is boxed and has plain triangular brackets, a plain frieze and pilaster strips, and an egg and dart moulding on the mantel shelf. There is a typical door on the south elevation that leads to the enclosed porch.

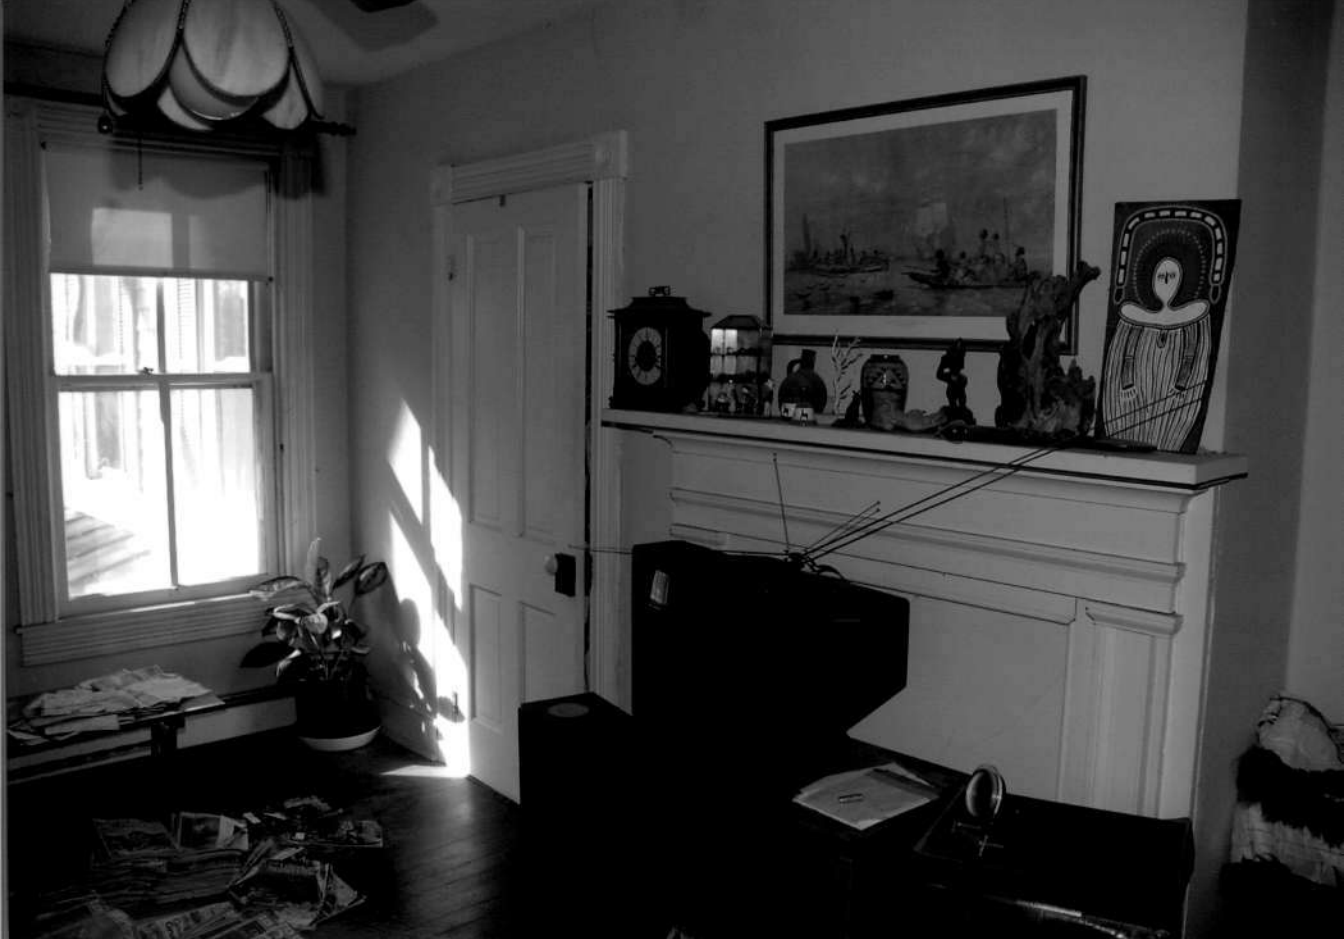
7/8

House, east chamber, view
southwest
