HO-941
John and Sarah Wilson Farm
13741 Frederick Road
West Friendship

Addendum

RECONSTRUCTED FIRST FLOOR PLAN FOR EARLIER LOG HOUSE -- MEASURED & DRAWN BY KEN SHORT -- JUNE 2009

Maryland Inventory of Historic Properties Form

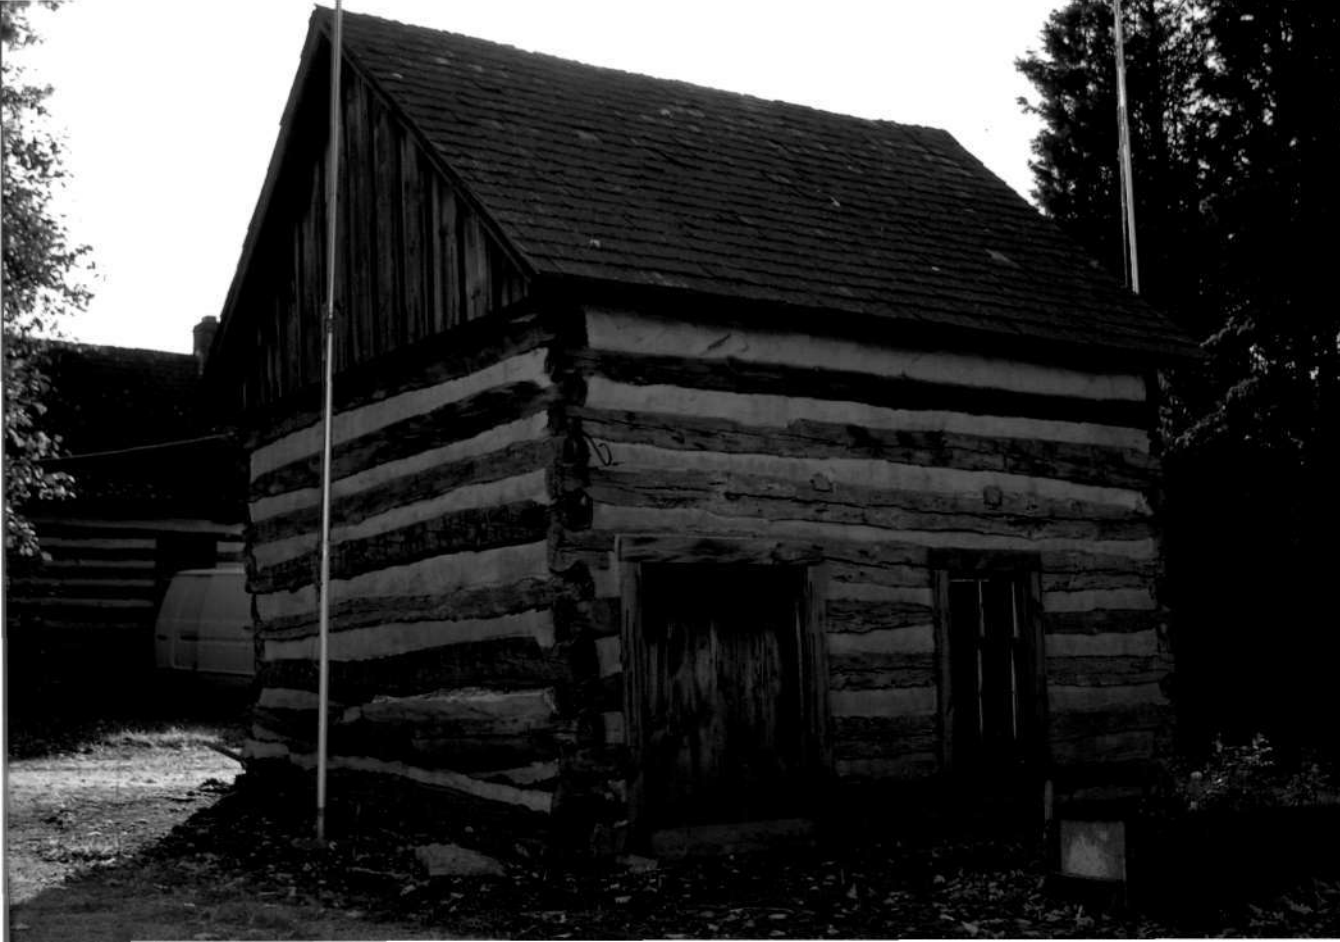
8/8

Log outbuilding, east + north
elevations

There is a log outbuilding that is possibly a smokehouse located about 25 feet west of the ell of the house. It is a one-story, two-bay by one-bay V-notch-corner log structure with no foundation visible, board-and-batten siding on the gable end walls, and a gable roof with an east-west roof and wood shingles. Some of the logs have rotted, and the walls have moved, rendering the doors inoperable and the interior inaccessible. The north elevation has a rebuilt vertical-board door in the east bay that is set low, with a window opening that has a two-over-four sash in the west bay; the sash has been cut down. There are two log ends of logs that run north-south in the center of the wall, and one of these logs is above the openings. The east and west elevations have no openings. The south elevation has a vertical-board door in the center with a small board door above it and to the west. There are four log ends visible on this side.
