HO-963
Berry House
4548 Route 97
Roxbury Mills vicinity

Maryland Inventory of Historic Properties Form

Inventory No. HO-963

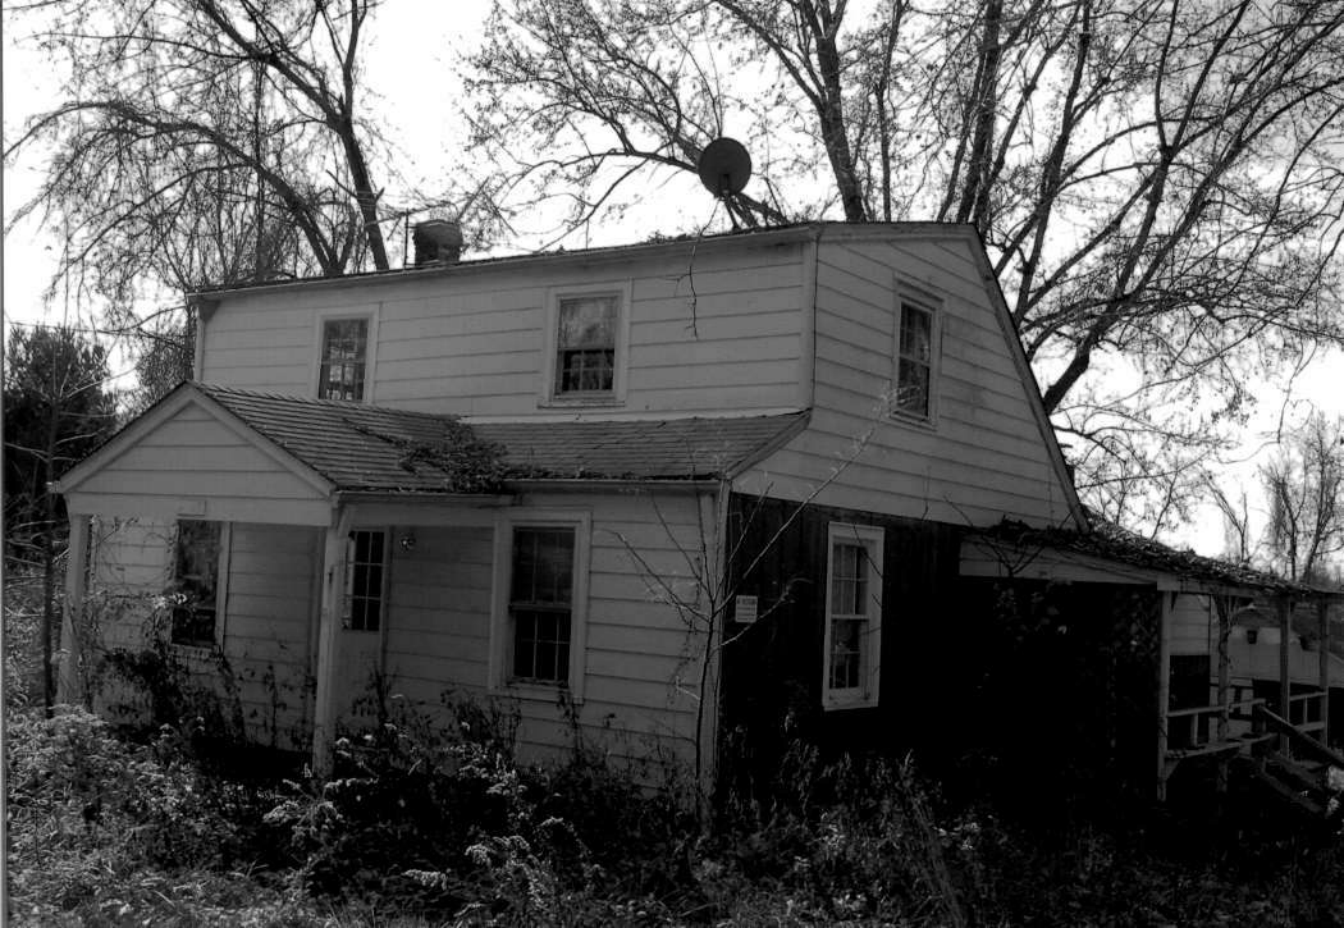
1 of 4

House, east and north elevations

The east elevation has a door in the center of the first story that is metal and has nine lights over two panels. There is a wood six-over-six sash to each side, with architrave that has a small ovolo backband. There is a one-bay, one-story porch in the center with a concrete deck, plain wood posts, and a gable roof with an east-west ridge. There is a large shed-roofed dormer that has two smaller six-over-six wood sash and the same architrave as the first story. There is an interior brick chimney on the south end. On the north elevation of the main block the first story has a typical six-over-six sash to the east and a pair of modern one-over-one sash to the west. The second story has a typical six-over-six sash. The ell has a door in the east bay that has three lying lights over three lying panels, and the west bay has a modern one-over-one sash. The addition has no opening.

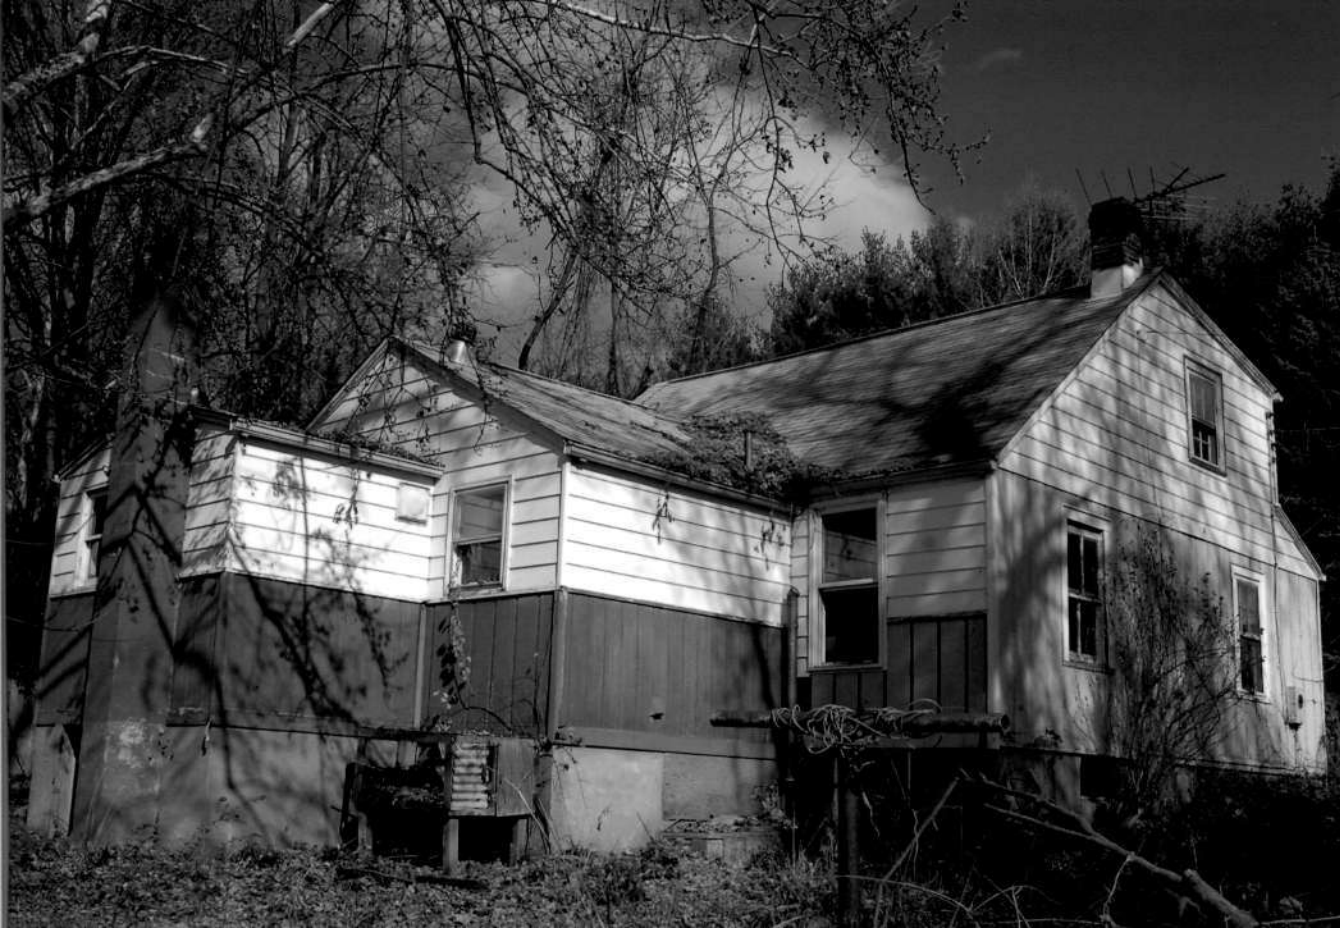
House, west and south elevations
2 of 4

The west elevation of the addition has a small opening in the foundation, leading to a crawl space. The first story has a modern one-over-one sash to the north and an exterior, parged CMU chimney to the south. The ell has a modern one-over-one sash to the south of the addition. The main block has a modern wood one-over-one sash to the south of the ell, on the first story. The basement has a door in the south bay with four lights over three lying panels, with four steps down to it. The south elevation has no opening in the addition or the ell. The main block foundation has a two-light sash in the west bay. The first story has a two-over-two wood sash in the west bay, with typical architrave, and a typical six-over-six sash in the east bay. The gable end also has a typical six-over-six sash.

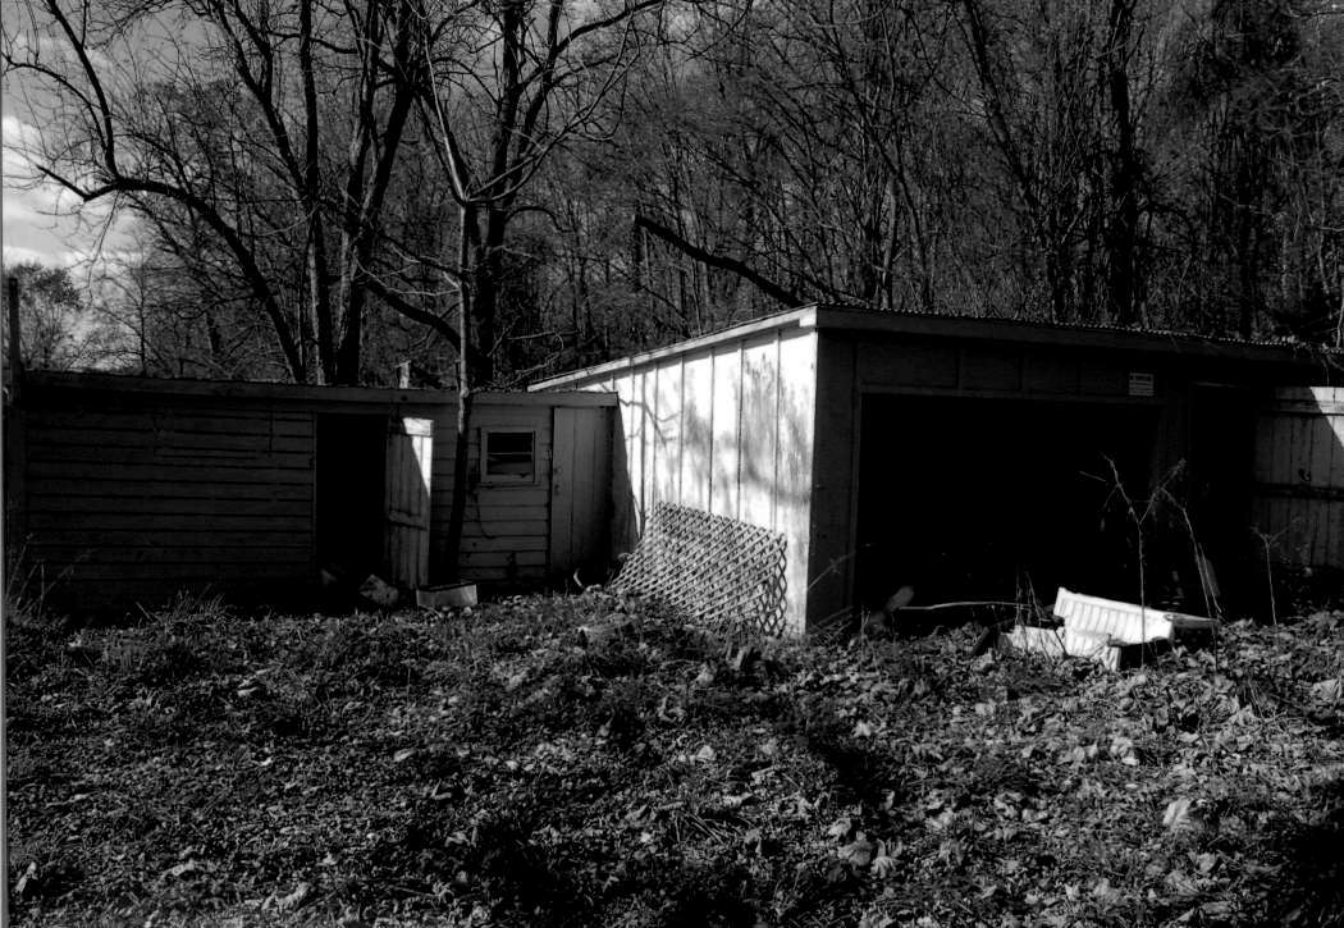
3 of 4

Corn crib and small garage,
south and east elevations

There is a small garage about 30 feet northwest of the house that is one story and two bays by one bay. It has plywood siding with battens and a flat roof with corrugated metal. The east elevation has a wide opening to the south and a vertical-board door to the north. There are no openings on the north, south, or west elevations. The south wall is built with 3 by 3 studs, while the rest of the building has 2 by 4s. There is a shed and corncrib attached to the south wall of the garage, and set back to the west side. It is a one-story, two-bay by one-bay frame structure with a shed roof that has inverted-v-seam metal. The east elevation has slats on the south half, with a slat door, and weatherboards to the north, with a two-light sash and a vertical-board door to the north. This structure has been enlarged to the west with plywood.

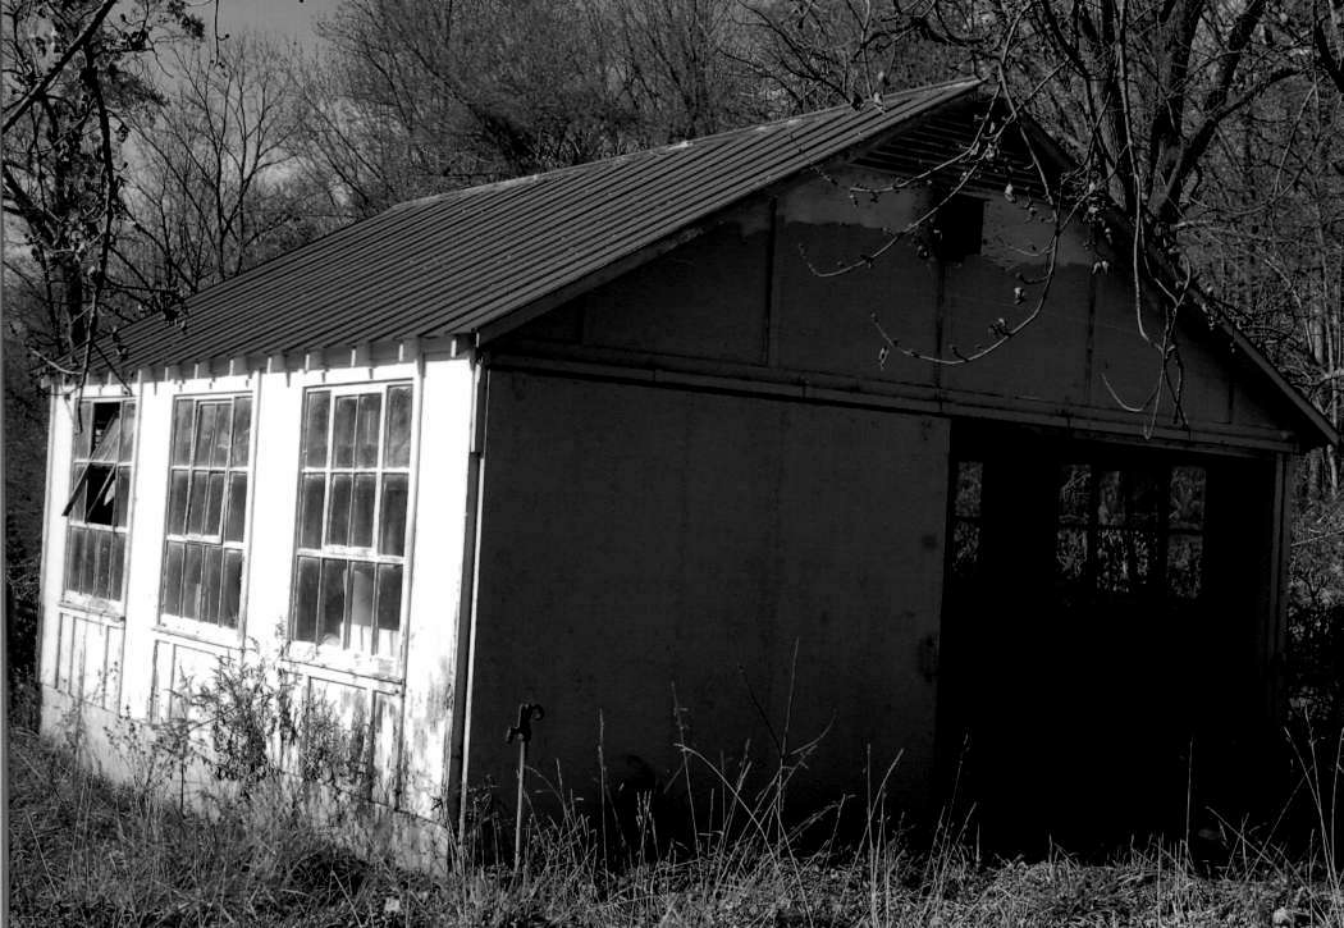
4 of 4

Large garage, south and east
elevations

There is a large garage about 40 feet west of the house, and just southwest of the corncrib. It is a one-story, two-bay by three-bay frame structure with a CMU foundation, plywood with battens, and a gable roof with an east-west ridge and inverted-v-seam metal. The east elevation has no opening to the south and a large door on rollers to the north. The north and south elevations each have three large 12-light fixed wood sash that contain a four light casement that opens in and is hinged at the bottom. The west elevation has a re-built door in the south bay and no opening in the north bay. The building is stick-built with 2 by 4s.
