Waters-Moore House  
9910 Harmony Road  
Laurel vicinity

Inventory No. HO-977

historic Waters-Moore House

FIRST FLOOR PLAN -- MEASURED & DRAWN BY KEN SHORT -- DECEMBER 2008

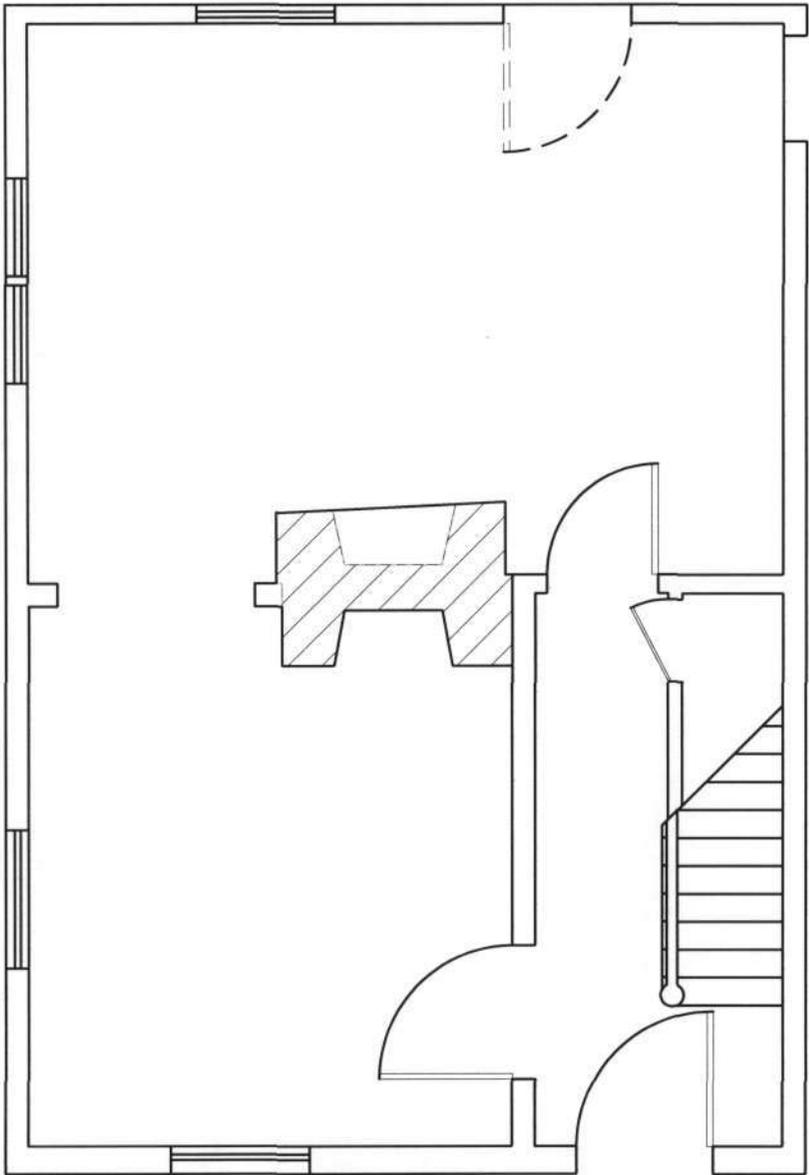
ADDITION NOT SHOWN

ADDITION  
NOT SHOWN

NEW OPENING  
AND SASH

PORCH NOT SHOWN

The interior of the house has a side-passage plan with the passage only a single pile in depth, with one room to the west of the passage and a large room at the north end of the main block. The east addition is one large room while the north addition has several rooms in it. The passage has a straight run of stairs on the east wall that ends at a landing, and then turns to the west. The stairs have a turned newel post that is about 3-1/2 inches in diameter, is slightly tapered, and has an urn or vasisform profile. It is painted currently, as are the turned balusters, the plain open stringer, and the ovoid railing that sits on top of the newel post. The risers and treads have been replaced, with the original risers probably still in

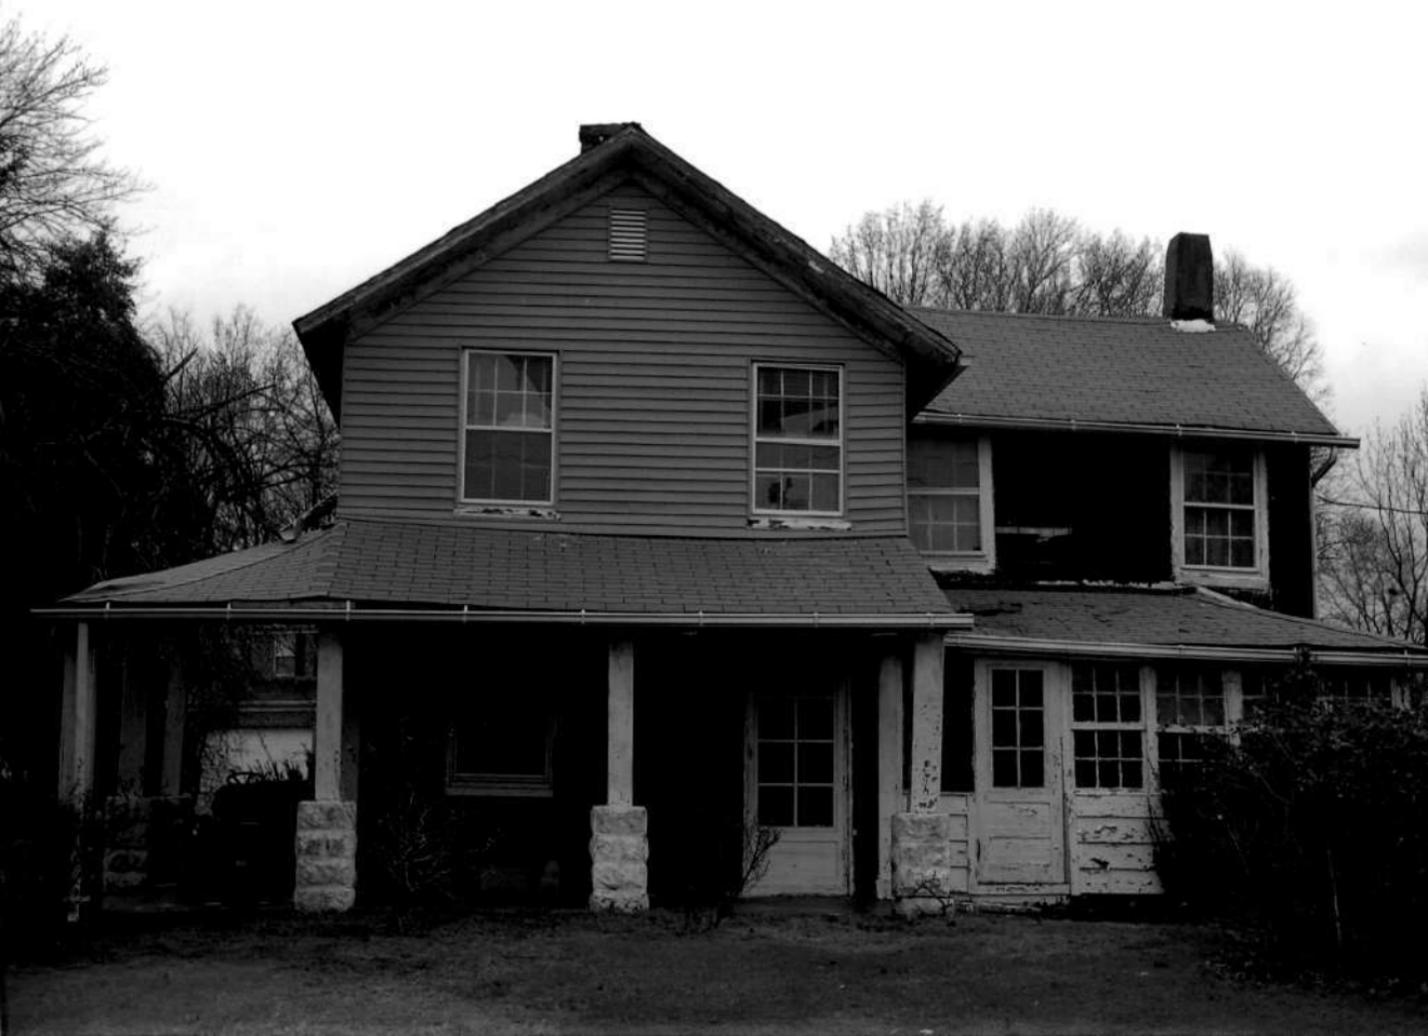
1 of 6

South elevation

The south elevation of the main block has a six-over-six sash in the west bay of the first story, with a narrow mitered frame that has a beaded interior edge, and there are shutter hinges. There is a four-

panel door in the east bay, with sunken fields and ogee-and-bevel panel moulds. There is a one-story porch that has four rock-faced concrete block piers supporting boxed wood posts. The porch has a concrete deck, a wood slat soffit, and a shed roof with asphalt shingles. The porch wraps around the west side of the house. The second story has two six-over-six sash, and there is a vent in the gable end. The eaves are boarded, and the boards follow the pitch of the rafters. The south elevation of the addition is set back from the south elevation of the main block, and there is a one-story shed-roofed porch on the first story of the addition. The porch has an asphalt shingle roof and is enclosed. There is a door with six lights over two lying panels to the west and four six-over-six sash to the east, with weatherboards below. The east elevation of this enclosed porch has three six-light sash above weatherboards. The second story of the addition has two six-over-six sash with wide mitered surrounds. The eaves are boarded on the addition, and the boards follow the pitch of the rafters.

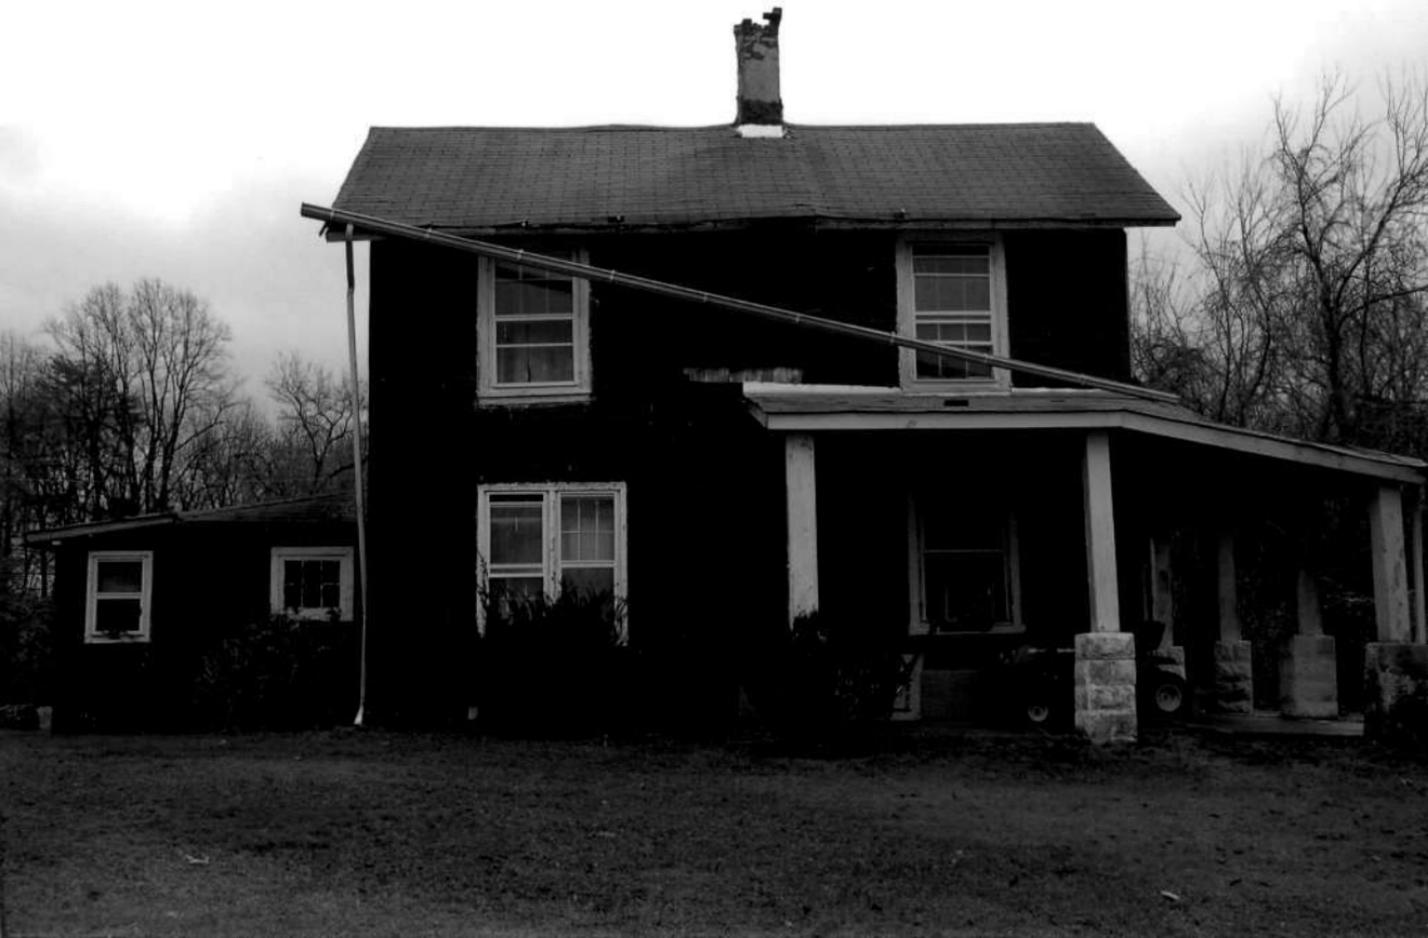
2 of 6

West elevation

On the west elevation of the main block, the first story has paired six-over-six sash in the north bay, and there is a single six-over-six sash with head-cut trim in the south bay. The porch covers the south bay. The second story has two six-over-six sash with head-cut trim. On the north elevation the main block has a six-over-six sash in the west bay on both the first and second stories. There is no opening in the east bay of the second story, and there is a vent in the gable end.

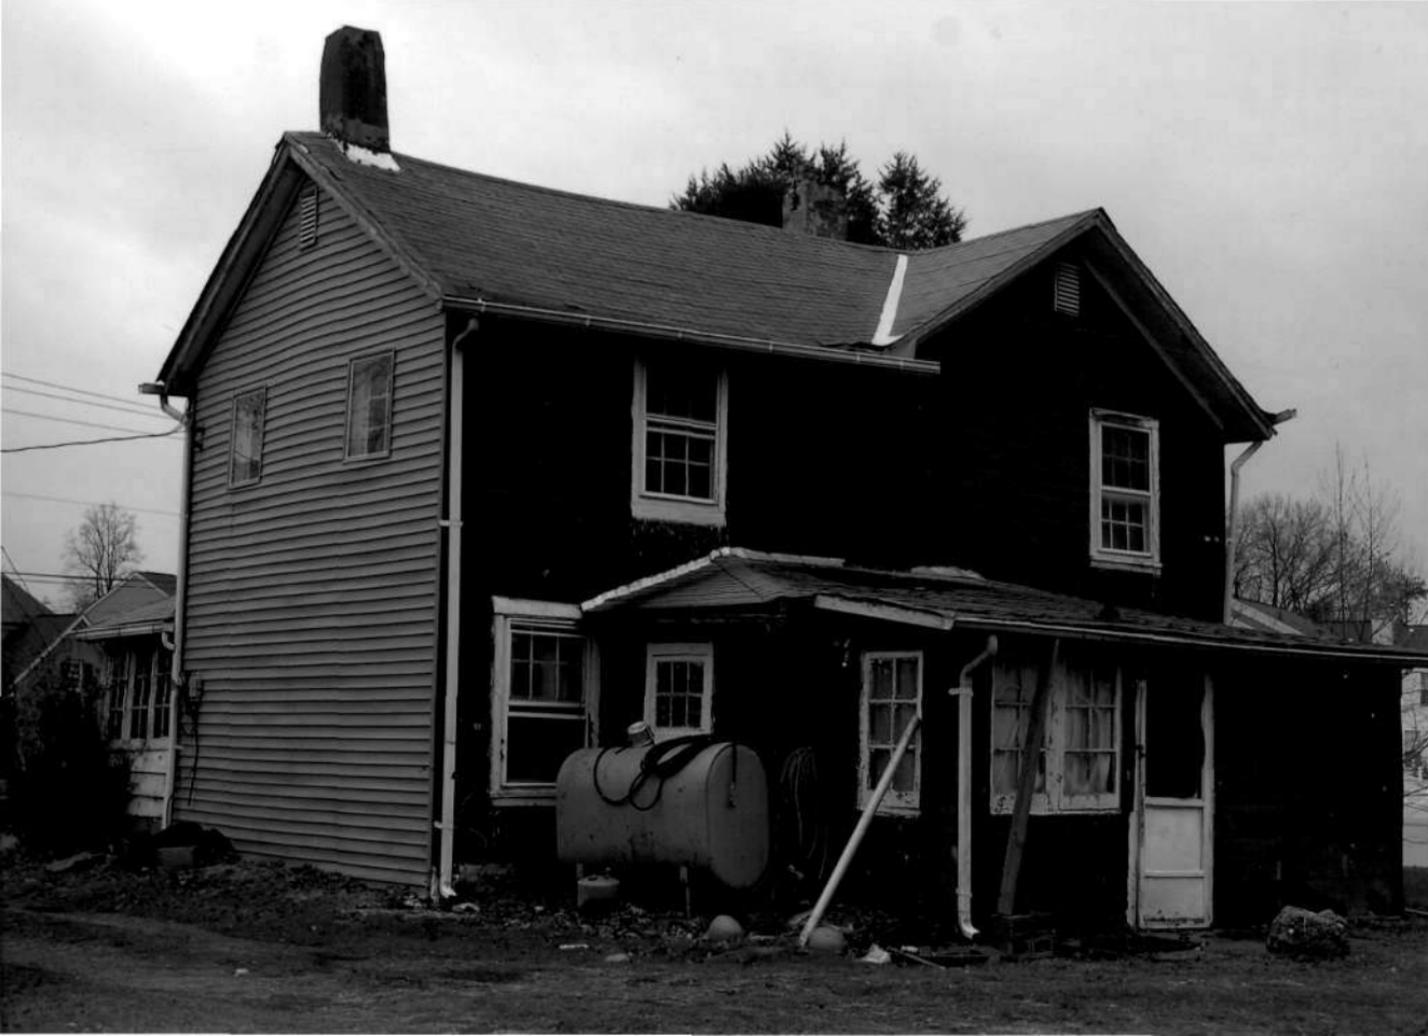
3 of 6

East and north elevations

The north addition is attached to the east bay of the first story and covers much of the east addition. This north addition is two bays by three bays, and the west elevation has a new one-over-one sash in the north bay and a six-light sash in the south bay, with head-cut trim. The north elevation has a pair of six-light casements to the east, a storm door in the center, and no opening in the west bay. The east elevation of the addition also has a six-light sash, with head-cut trim, in the south bay, and has a tall six-light casement in the north bay. The north bay is recessed back from the face of the south bay about 18 inches. The north elevation of the east addition has a six-over-six sash with wide mitered trim in the east bay of the first story. The second story has a single six-over-six sash set in the center of the addition. The east elevation of the east addition has aluminum siding, and the wall bows out in the center. The first story has no openings, and the second story has two six-light casements. The gable end has a vent.

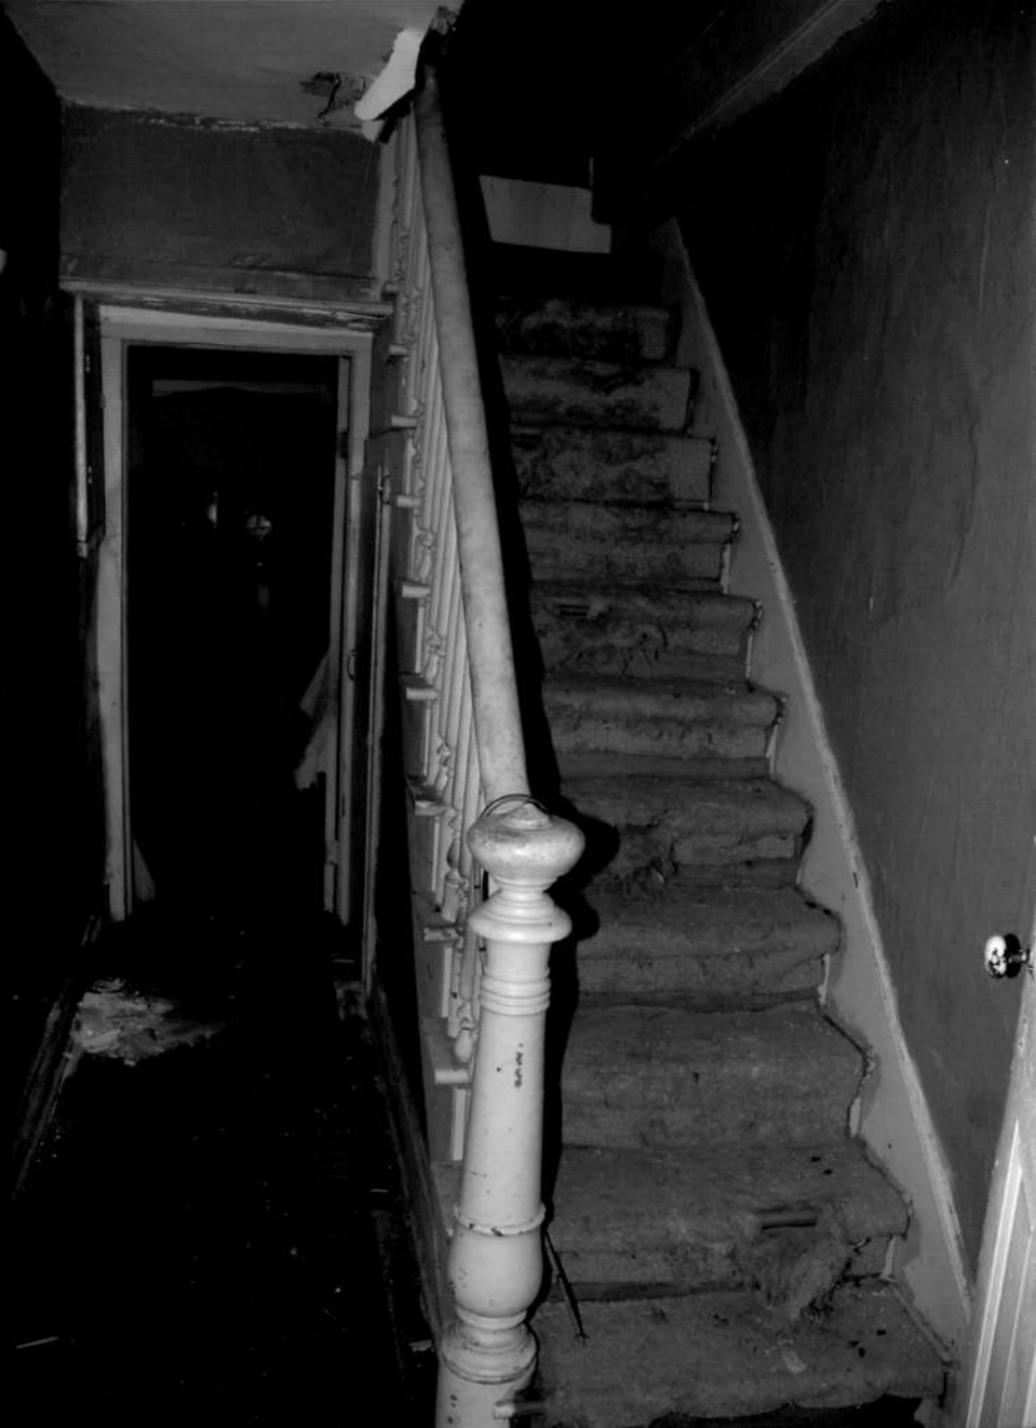
4 of 6

Stair passage, view north

place beneath the replacements. The flooring is 2 1/2-inch pine that runs north-south. The walls and ceilings have plaster on lath. The stair is constructed with cut nails, and there is a closet beneath the stair with a thin plywood door. This doorway appears to have been cut through at a later date. The west wall of the passage, at the north end, has a closet set high on the wall with a beaded-edge vertical-board door. The back of the closet is partially the brick of the fireplace, and the walls have sawn lath with cut nails. There is a four-panel door on the west elevation, set to the south, that has sunken fields, quirked ogee-and-bevel panel moulds, cast iron butt hinges with five knuckles and what appears to be pins, and a plain cast iron rim lock with a mineral knob on the passage side and a porcelain knob on the room side. The room side of the door has plain, flat, sunken panels with no panel moulds. The front or south door matches the west door, with a porcelain knob on the exterior and a metal knob on the interior. The cast iron rim lock is marked "NORWALK LOCK CO." The north door has two panels and probably dates to the 1910s or 1920s.

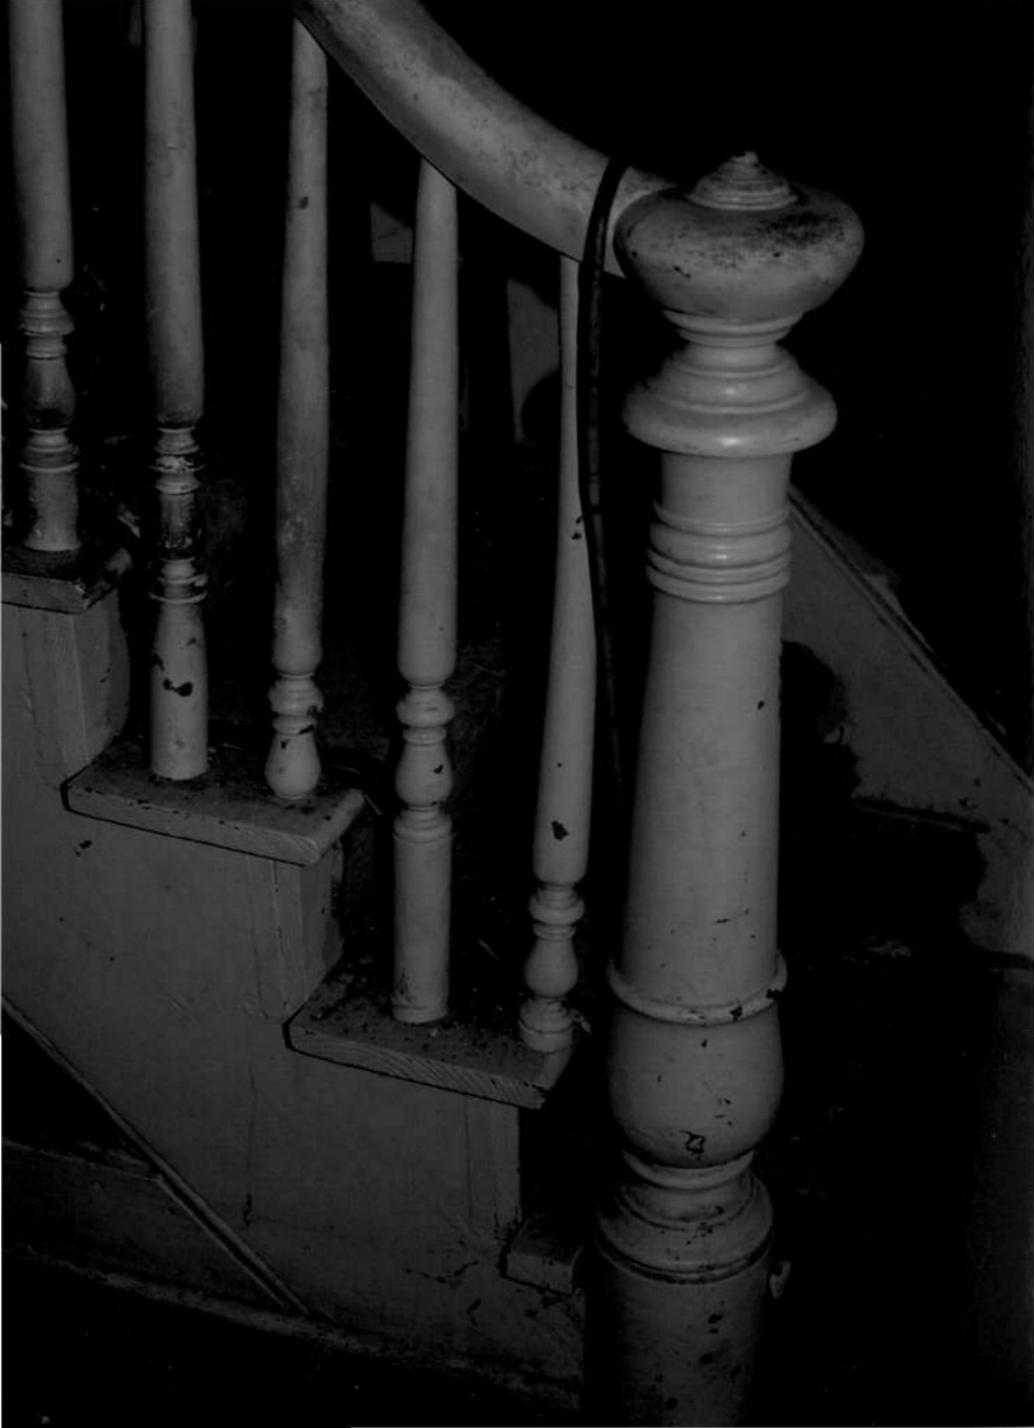
5 of 6

Stair mural

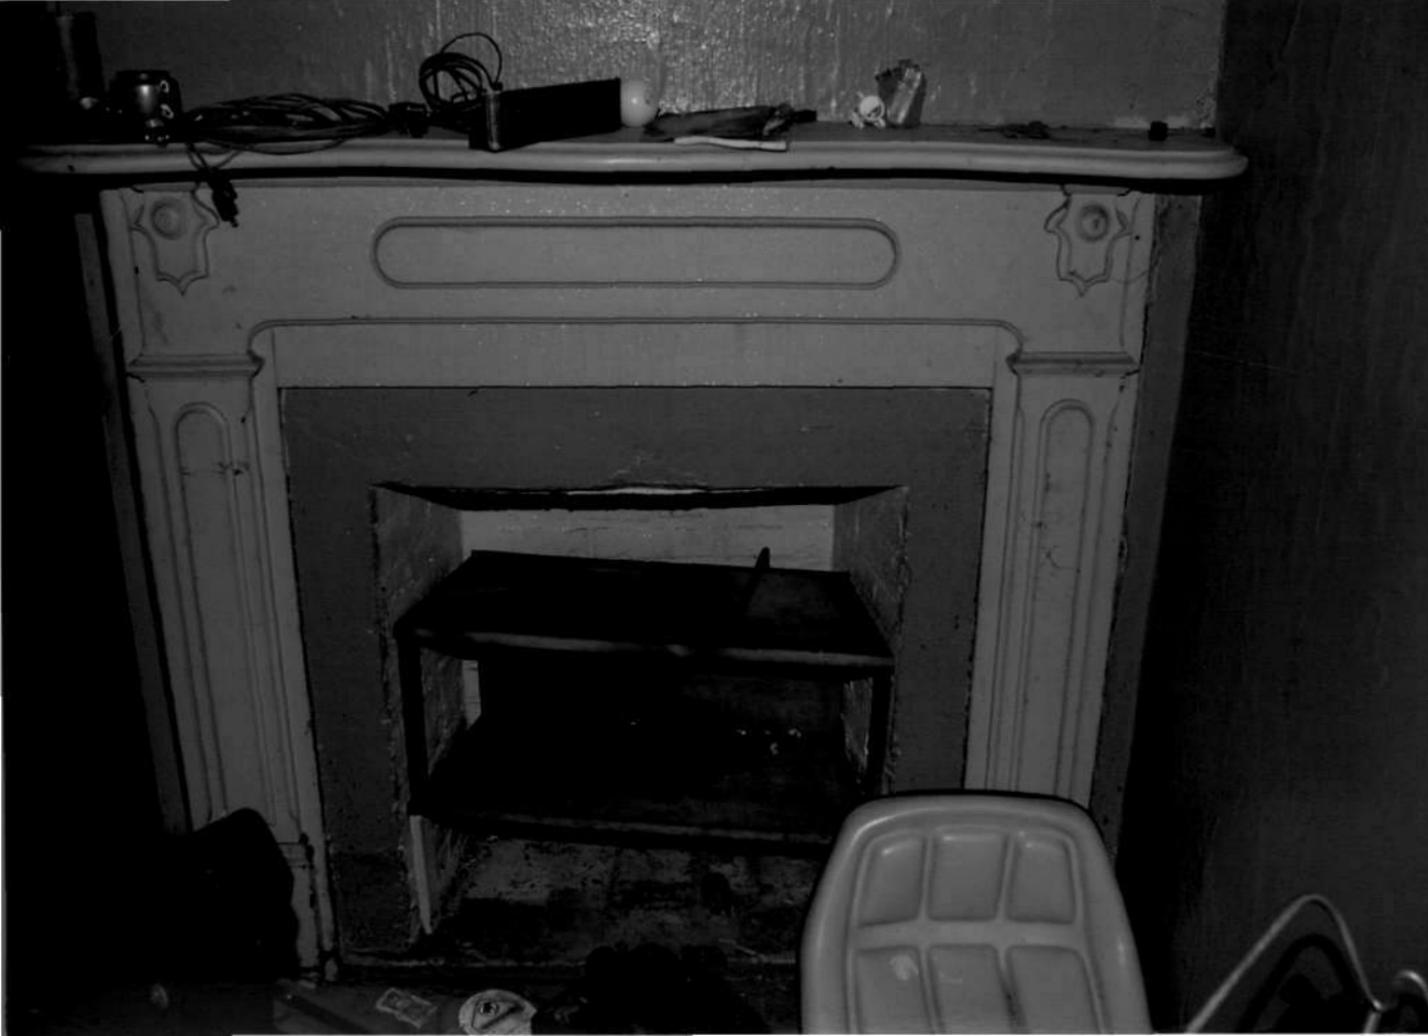
6 of 6

Southwest room master

The southwest room has carpeting over linoleum, has plaster on wood lath on the walls and ceiling, and has head-cut trim. The six-over-six sash have ovolo muntins, 10-inch by 12-inch lights, no parting beads, and are mortised and tenoned, and pinned at the corners. There are metal pins through the side stiles, with holes drilled in the jamb in several places for the pins to pass into and hold the sash open. The north wall has a fireplace set to the east that has a parged surround and painted brick jambs. The hearth is now wood, and appears to have replaced an earlier hearth. There is a wood mantel that has chamfered pilasters with applied plaques. The frieze also has an applied plaque with round ends, and there are applied shields at each end of the frieze. The bed mould has a small torus above a cavetto and bevel, and there is a scalloped shelf. To the west of the fireplace is a wide opening that never had doors.
