HO-981

12701 Livestock Road
West Friendship vicinity

Maryland Historical Trust Maryland Inventory of Historic Properties Form

Inventory No. HO-981

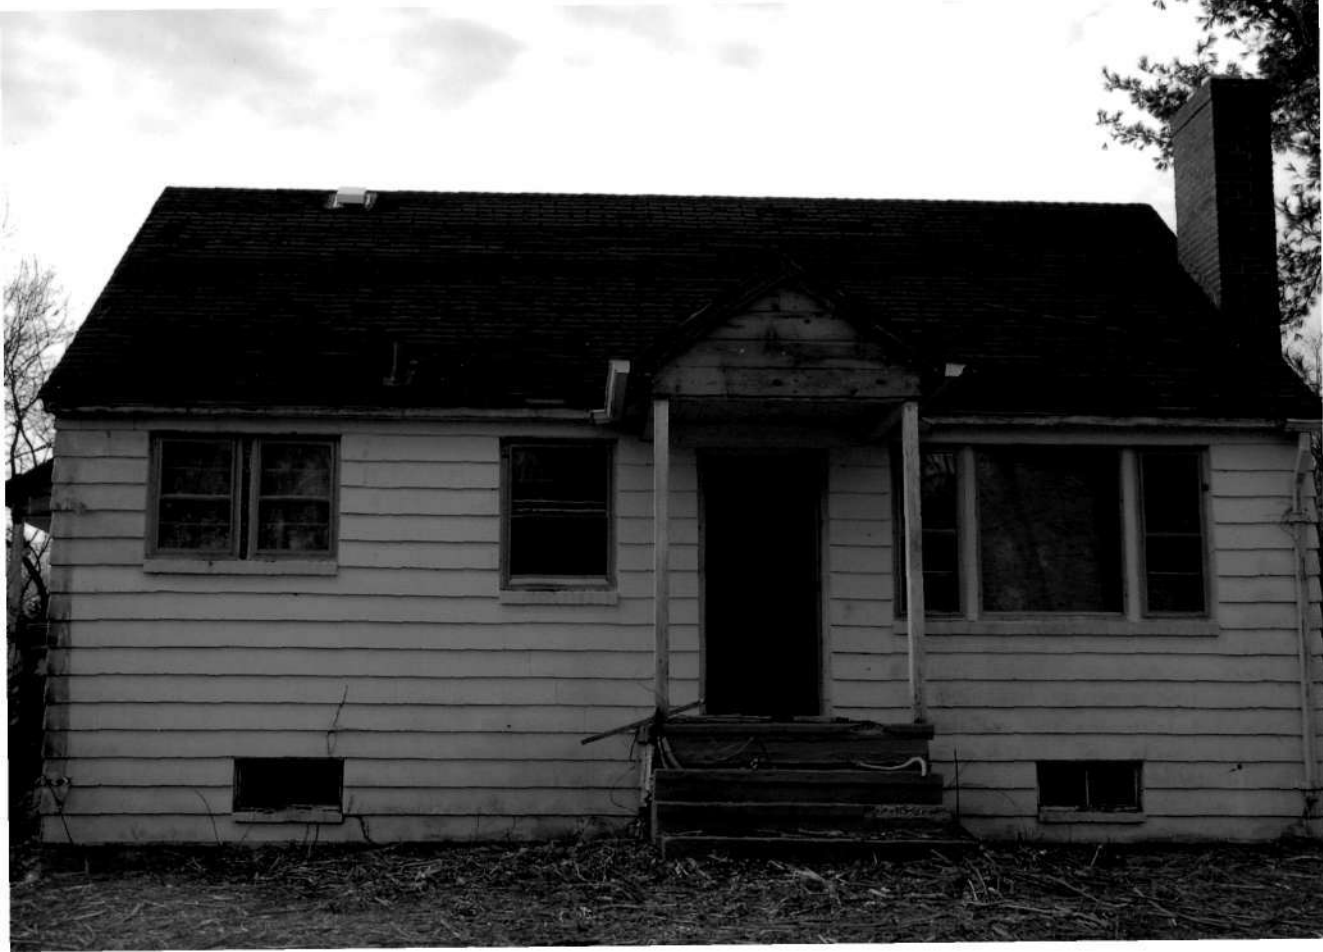
1 of 3

The east elevation has a doorway in the north-center bay with a porch in front that has three steps below the concrete deck and a gable roof supported by two square wood posts. The south bay has paired two-over-two metal sash, the south-center bay has a one-over-one metal sash, and the north bay has a large picture window flanked by a two-over-two metal sash on each side.

East elevation

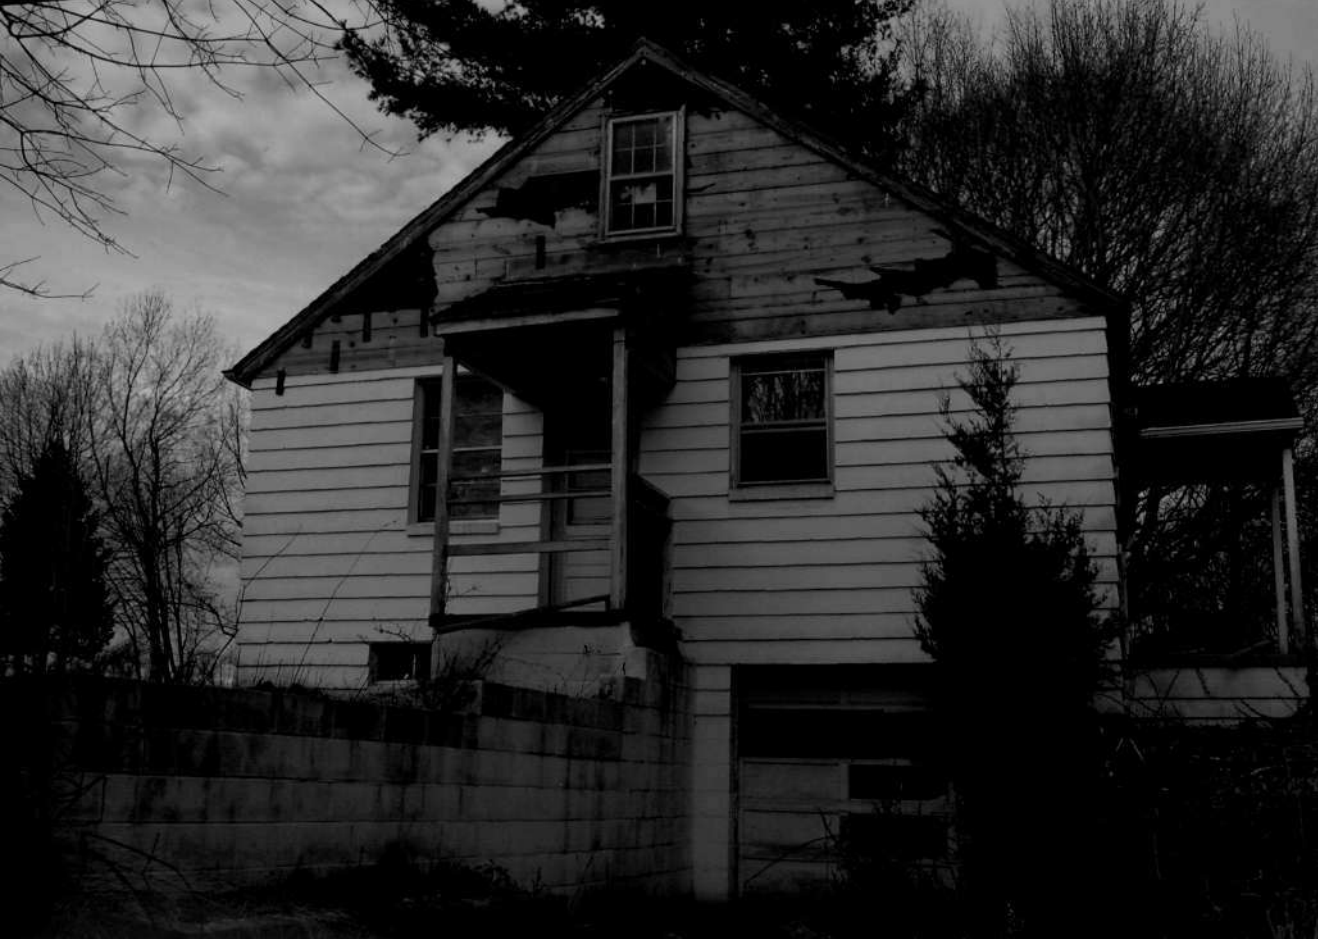
2 of 3

The south elevation is excavated in the east bay, with CMU retaining walls on each side, and a roll-up garage door in the east bay of the basement. The first story has a door in the center with three lying lights over two lying panels, and there is a porch in front of it with a concrete deck and a shed roof supported by two square wood posts. There is a one-over-one metal sash to each side and a six-over-six sash in the gable end. The gable wall is frame, and the siding has been removed.

South elevation

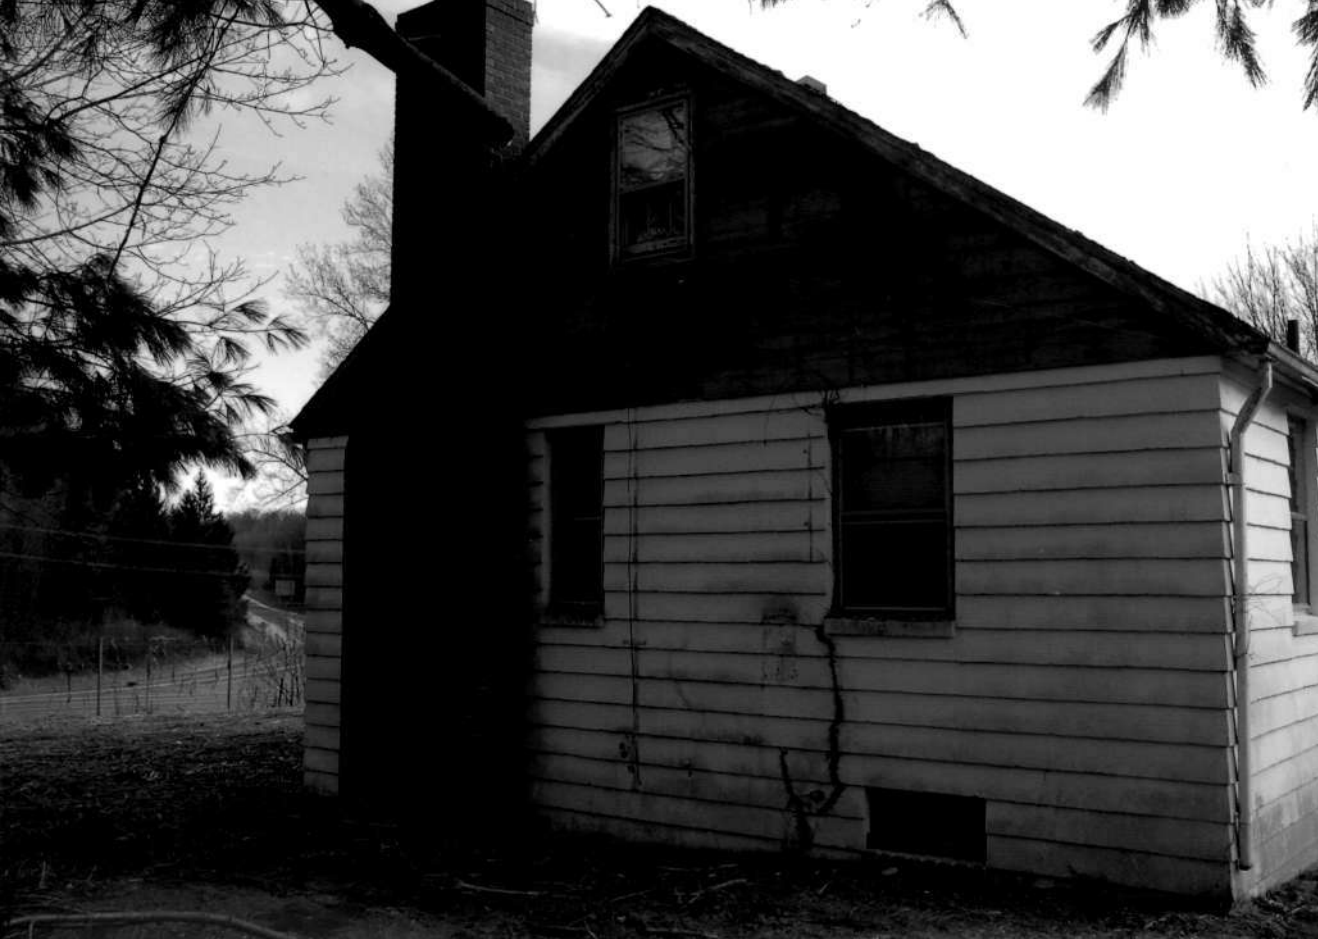
3 of 3

The west elevation has three two-over-two metal sash, with the center sash being smaller than those in the end bays. The north elevation has an exterior brick chimney to the east, a narrow two-over-two metal sash set just east of center, and a one-over-one metal sash in the west bay. There is a six-over-six sash in the gable end. The gable wall is frame, and the siding has been removed.

North + west elevations
