Section 2

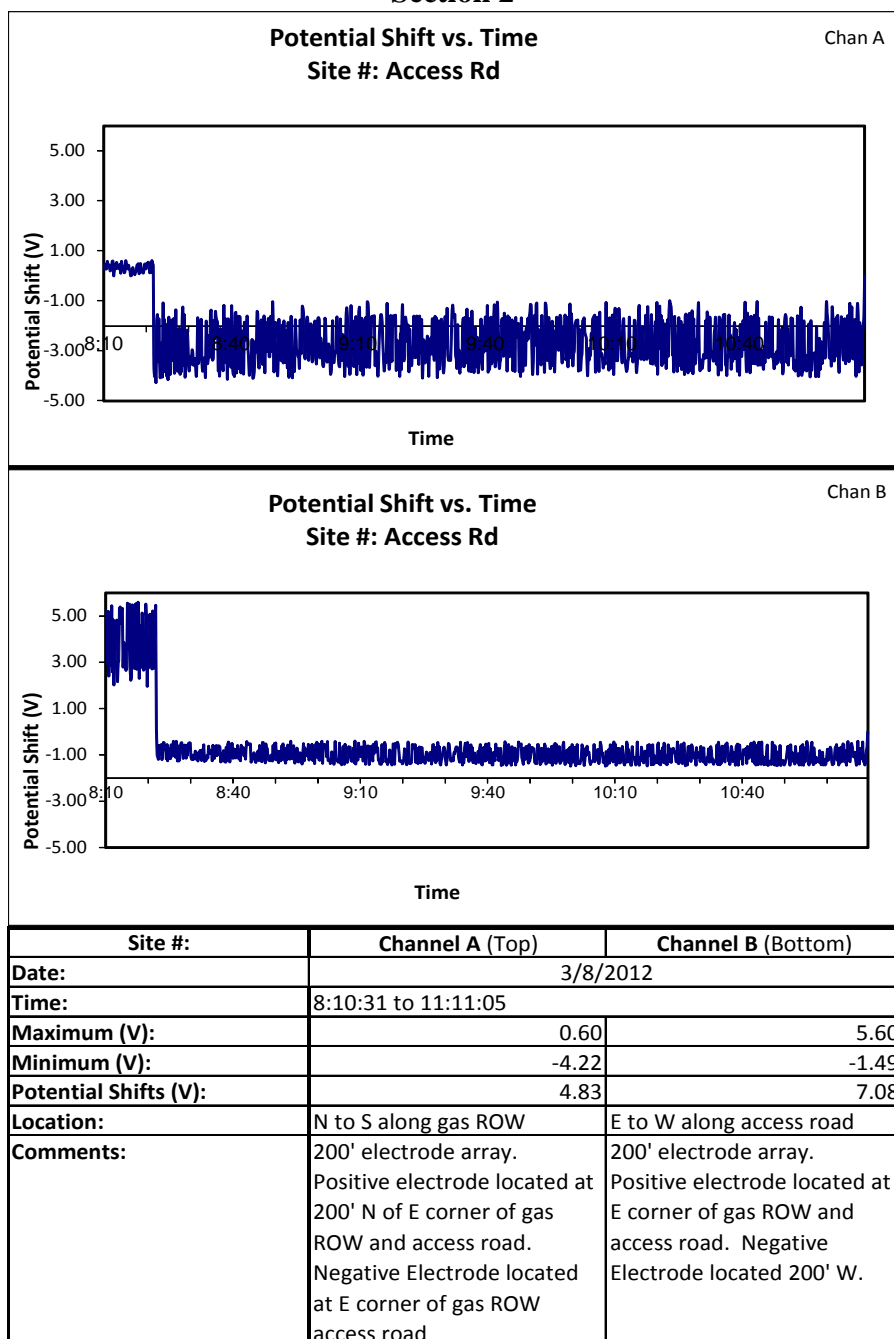
Figure 44 - Results of Stray Current Test #3 on the Access Road near Alpha Ridge Landfill

An unknown event was recorded approximately 22 minutes after the data logger recording started. It is possible that something may have occurred at the TRANSCO Williams ICCP rectifier / ground beds located nearby. The overall pattern of the data in both plots carries the typical signature of stray current gradients associated with operation of DC power.
