Table 1. Data Summary of Current Interference Test for Site 2 - Cycled Rectifier

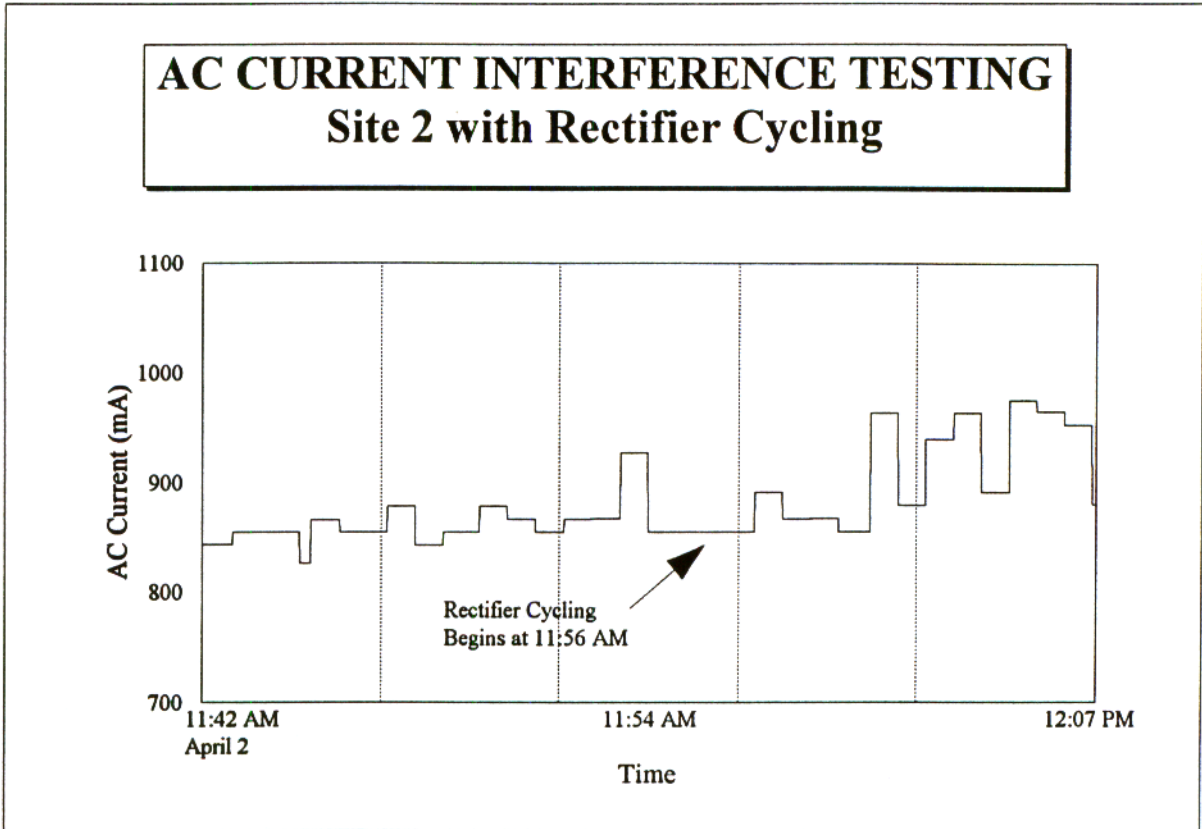
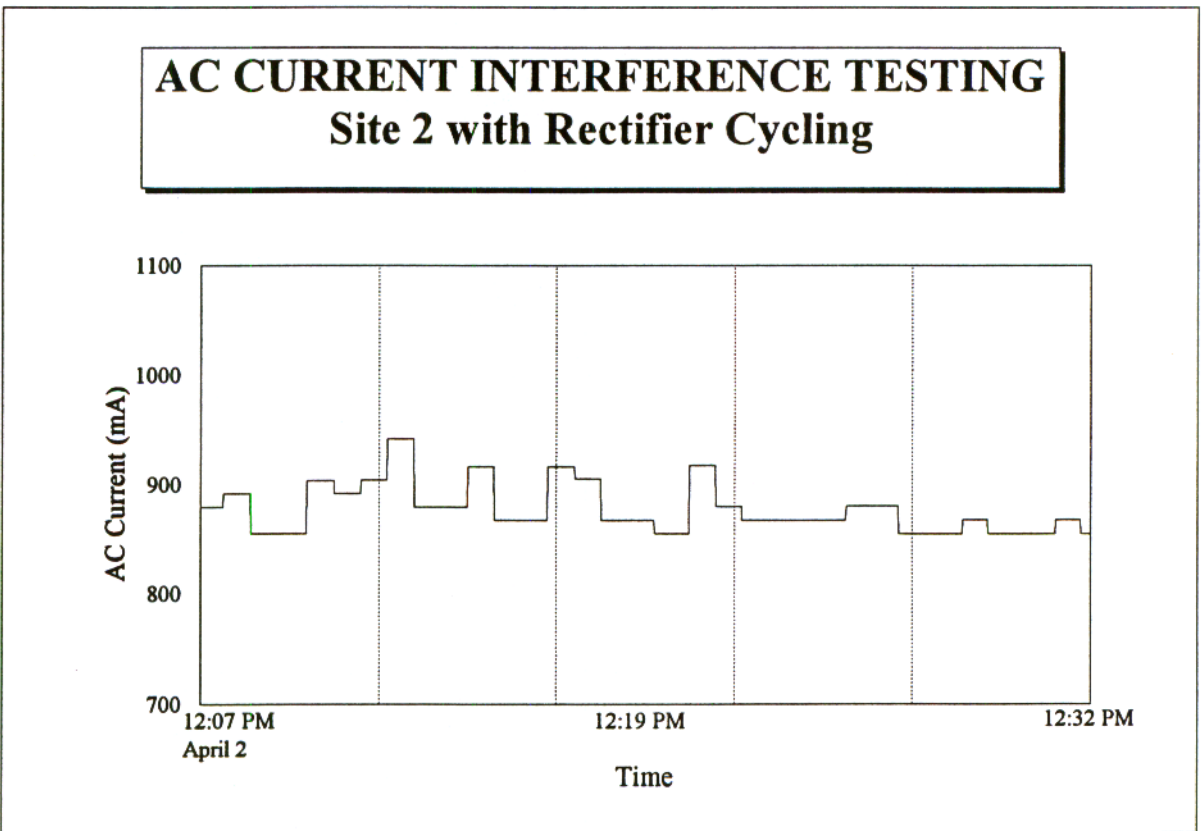
**Figure 7. Detailed AC Current Interference Test Results - Site 2 (Cycled)
11:42 AM through 12:32 PM**
