Figure 16. Stray Current Survey (AM) for Site 2

Figure 17. Stray Current Survey (PM) for Site 2

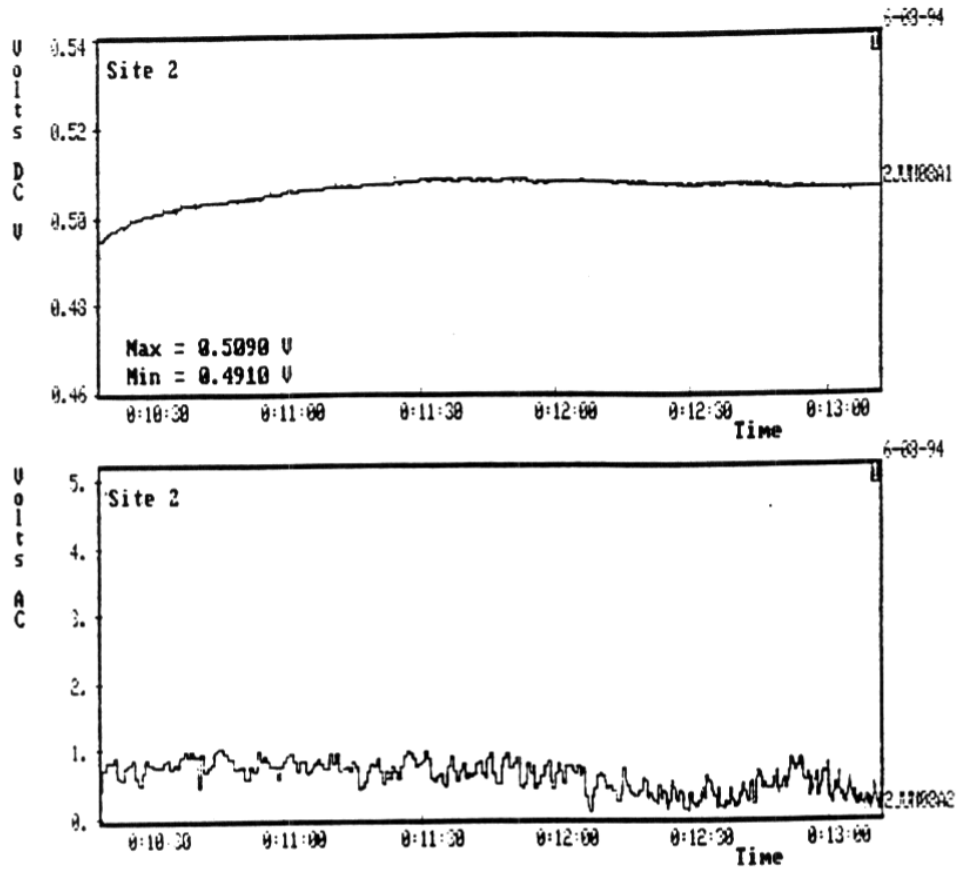
Date: 6/08/94

Time: 10:20A - 1:10P

Effective Groundbed Width (ft): 200

Stray Current Shifts (mV): DC 18mV;

Comments: Near MH 8474 (Sta. 85+21)

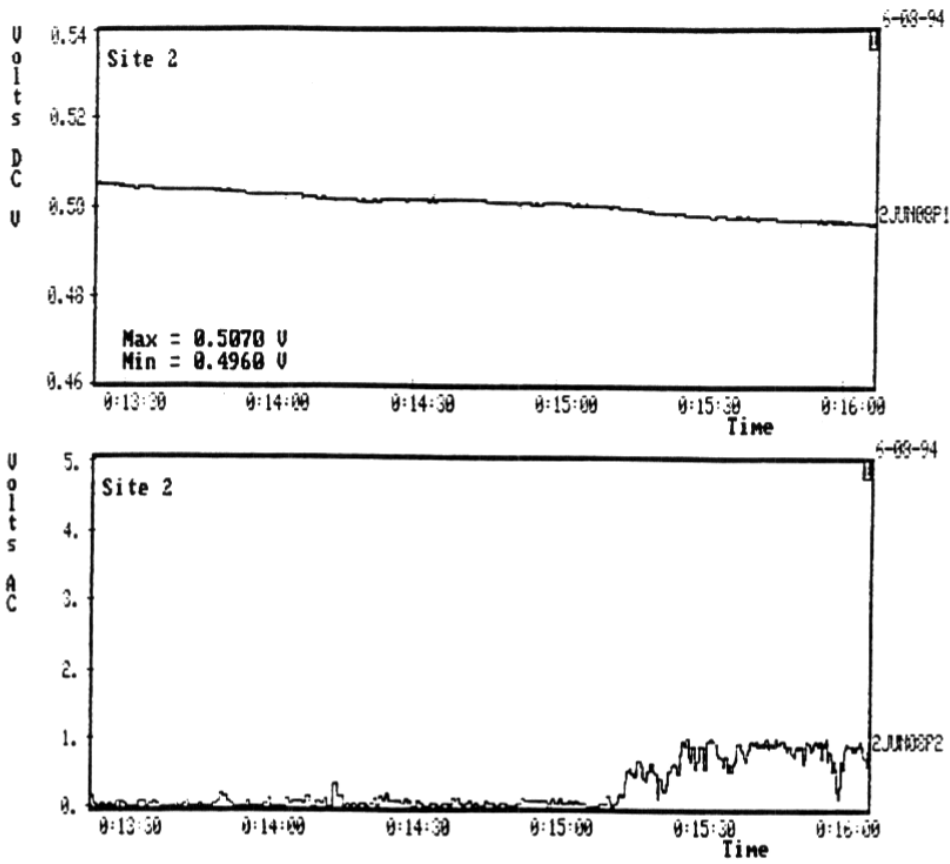
Date: 6/08/94

Time: 1:20P - 4:05P

Effective Groundbed Width (ft): 200

Stray Current Shifts (mV): DC 11mV;

Comments: Stray current reversed itself, possibly taking new path.
