Figure 74 - Stray Current Test Results for contract 8W

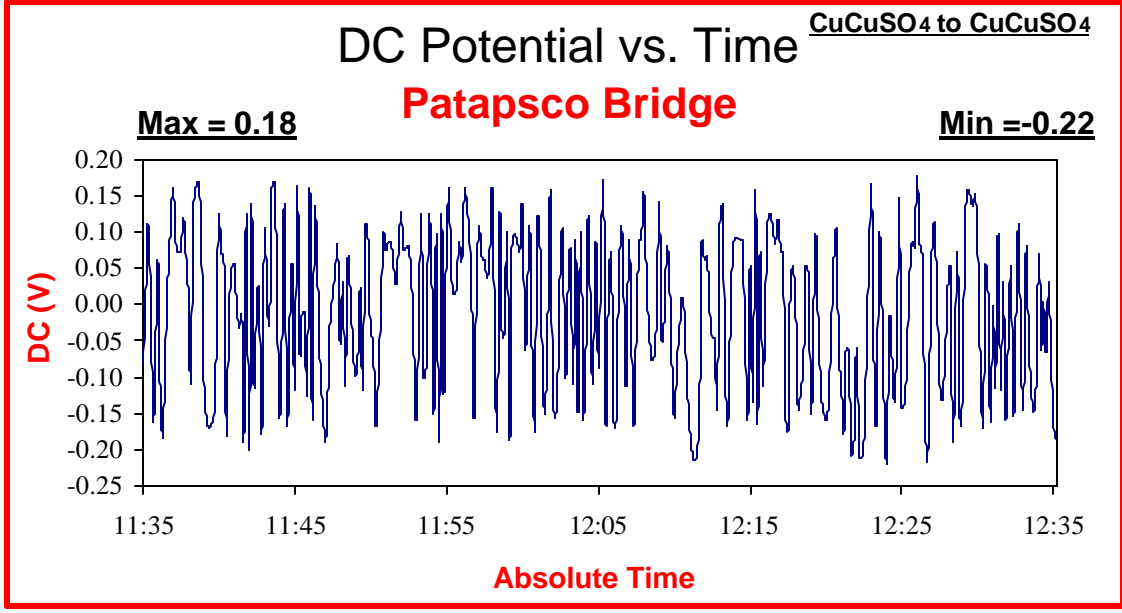
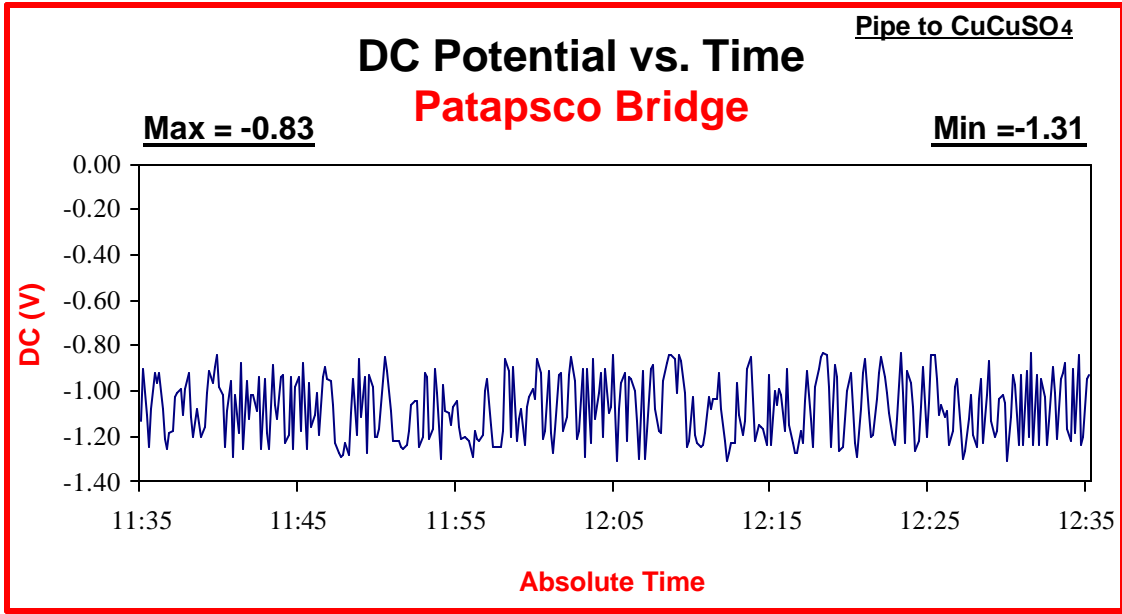
| | CuCuSO <sub>4</sub> to CuCuSO <sub>4</sub> | Pipe to CuCuSO <sub>4</sub> |
| <b>Approximate Station #:</b> | (00+00) | (00+00) |
| <b>Date:</b> | 3/29/2005 | 3/29/2005 |
| <b>Time:</b> | 11:35:06 | 11:35:06 |
| <b>Maximum (V):</b> | 0.18 | -0.83 |
| <b>Minimum (V):</b> | -0.22 | -1.31 |
| <b>DC Potential Shifts (V):</b> | 0.40 | 0.48 |
| <b>Location:</b> | 20 ft. West from the bridge | |
| <b>GPS Location:</b> | N 39° 17.722', W 76° 46.744' | |
