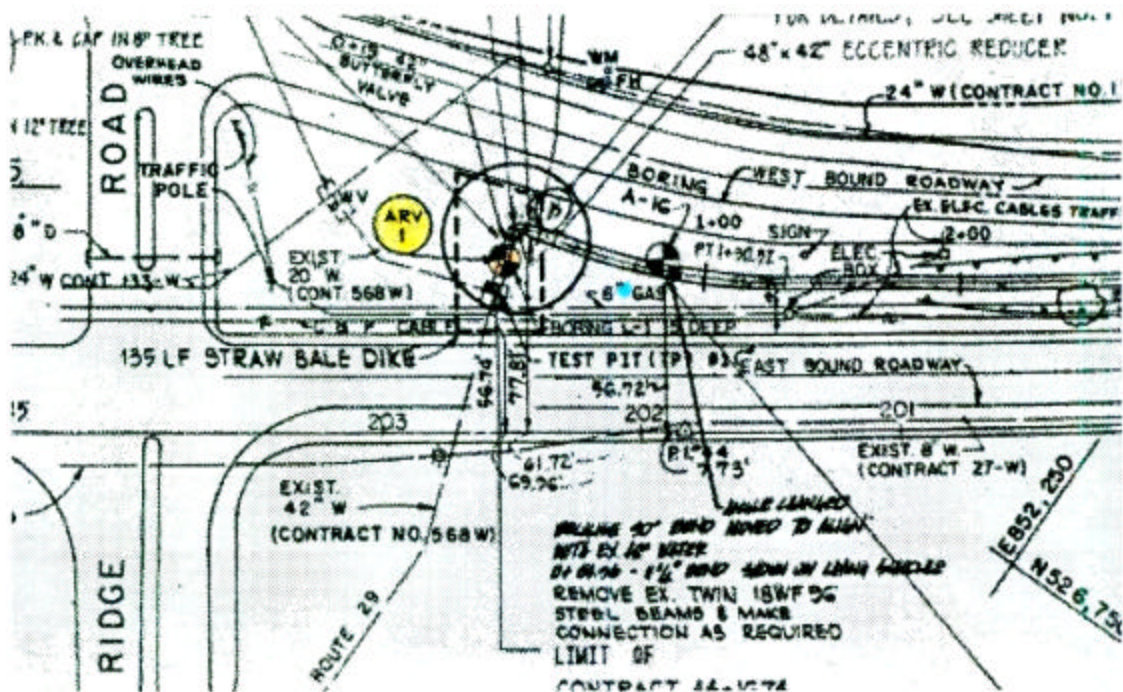
Test Setup:	DC volts between ARV-1 and Cu/CuSO ₄ ; Session 1: Cu/CuSO ₄ 50'E of ARV-1; Session 2: Cu/CuSO ₄ 50'E and 13'N of ARV-1
Legend:	<ul style="list-style-type: none"> ● Pipe Hookup ● Cu/CuSO₄ Electrode

Figure 4. Location Map for Site 1

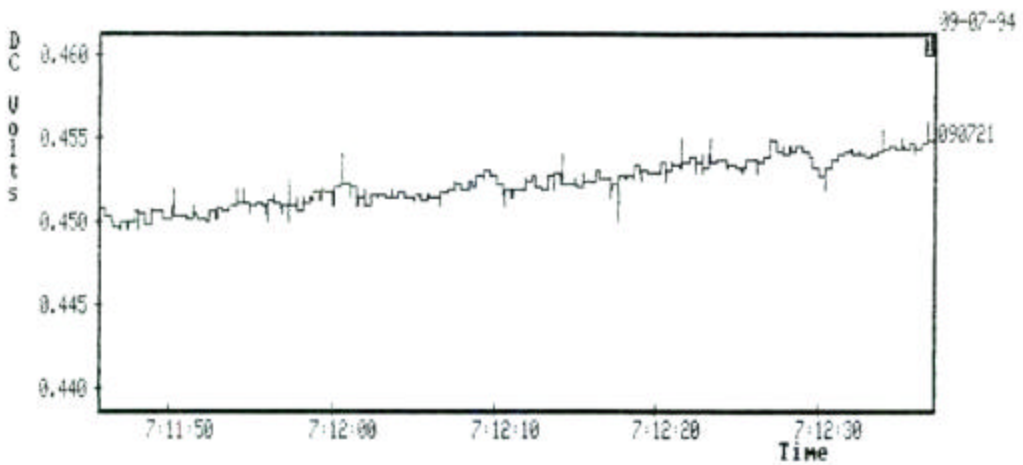
Date: 9/7/94

Time: 9:55AM - 12:40PM

Stray Current Shifts: 0.189 μ A; (DC Potential Shifts - 12mV)

Current through Pipe: 9.18mA

Comments: Very busy traffic intersections; nearby Amoco service station; O'Donnell car dealership

Figure 5. Current Interference Tests for Site 1

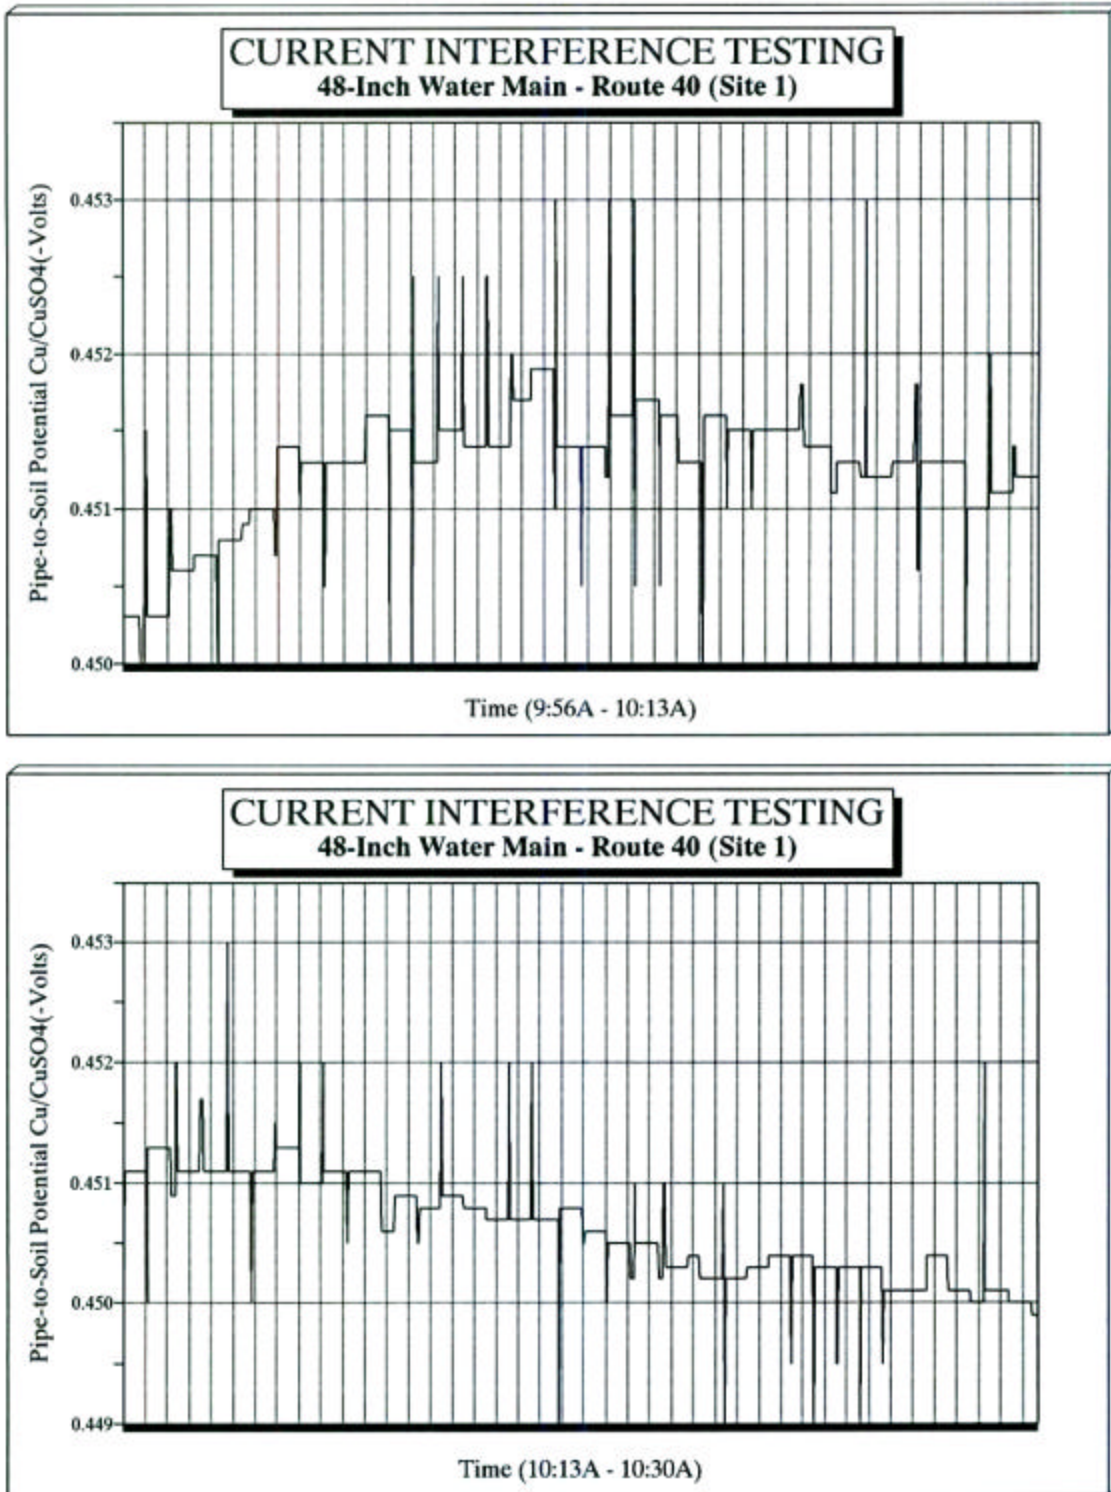
Figure 6. Detailed Current Interference Test Results for Site 1 from 9:56AM – 10:30AM

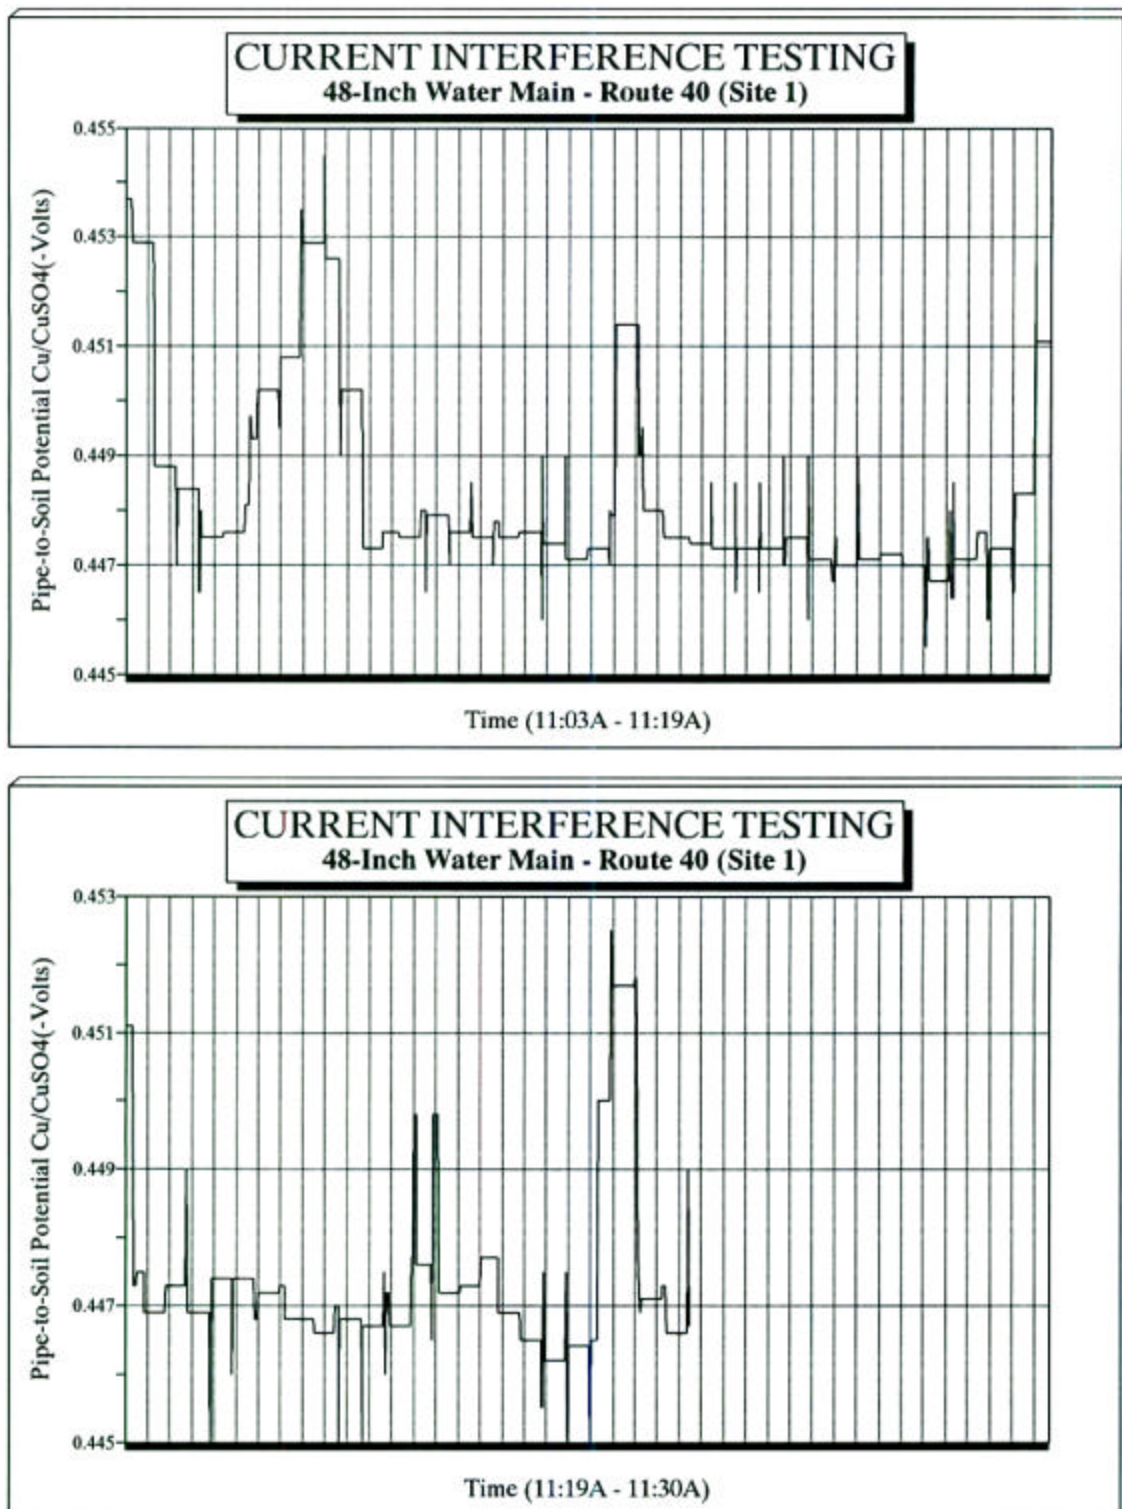
Figure 8. Detailed Current Interference Test Results for Site 1 from 11:03AM – 11:30AM

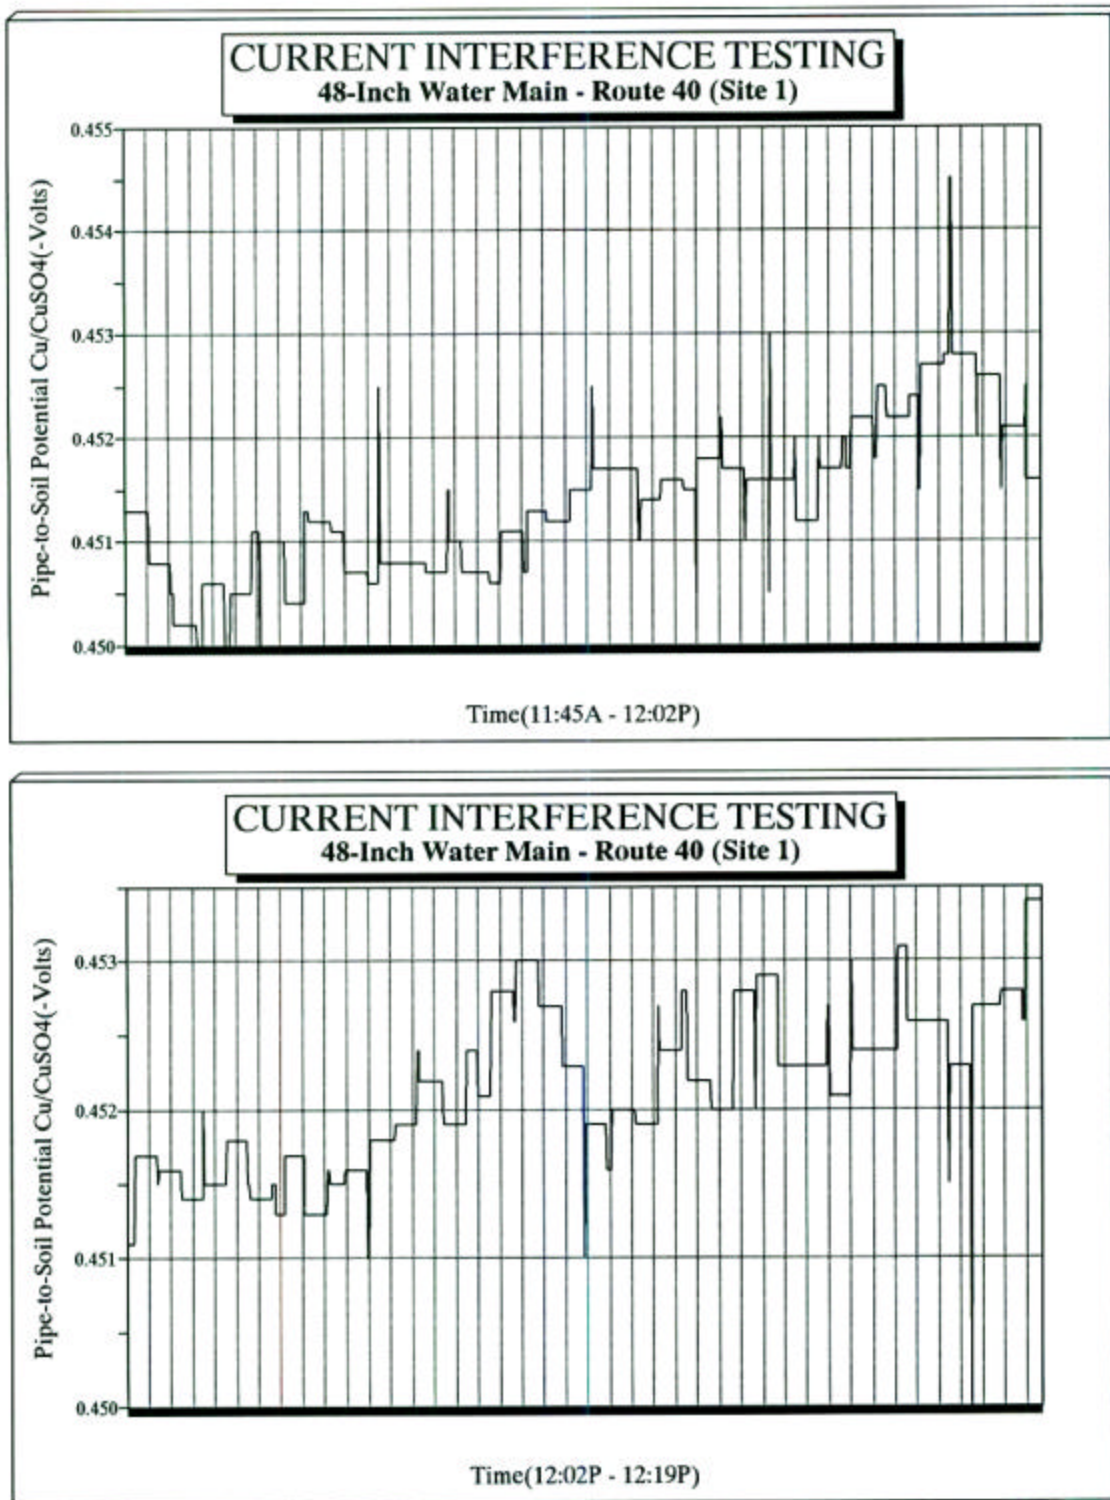
Figure 9. Detailed Current Interference Test Results for Site 1 from 11:45AM – 12:19PM

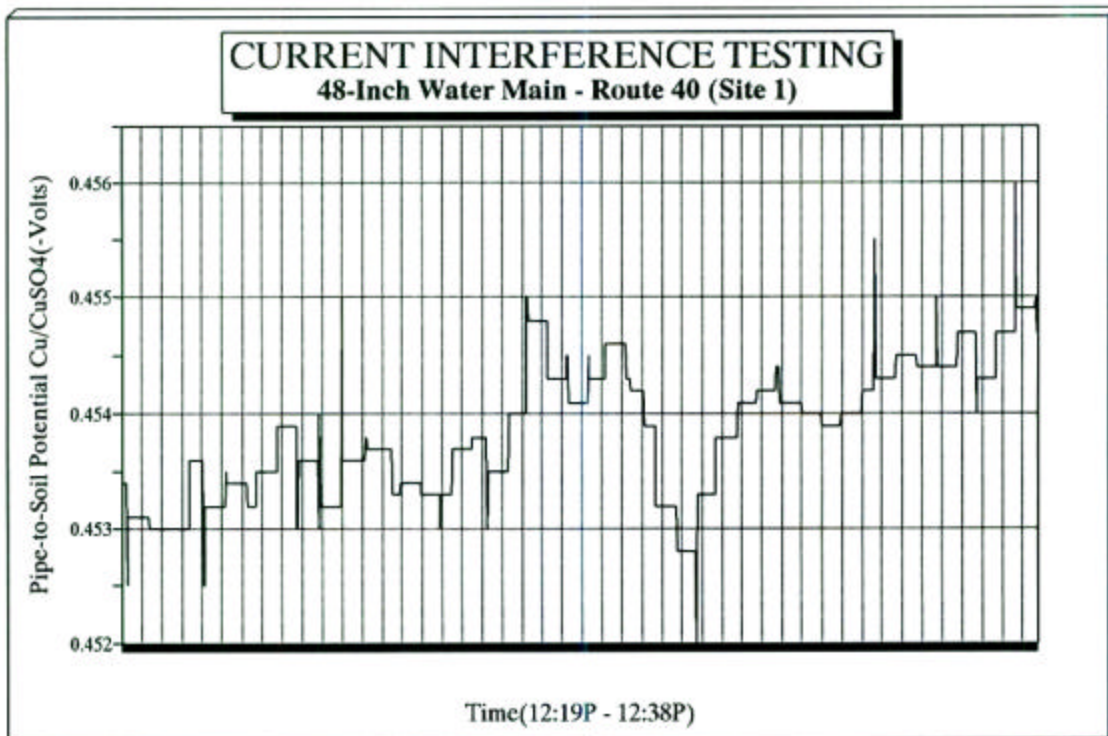
Figure 10. Detailed Current Interference Test Results for Site 1 from 12:19PM – 12:38PM
