## **Dower Drive and East Leisure Court**

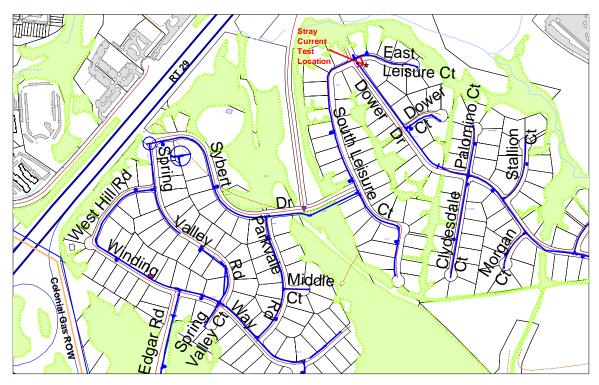
Stray current tests were conducted near the intersection of Dower Drive and East Leisure Court. A map and photograph of the location are shown below in Figure 53 and Figure 54, respectively. Measured stray currents indicate a maximum peak-to-peak potential shift of 0.67 volts on the north-south axis.

Figure 53 – Stray current test location near Dower Drive and East Leisure Court

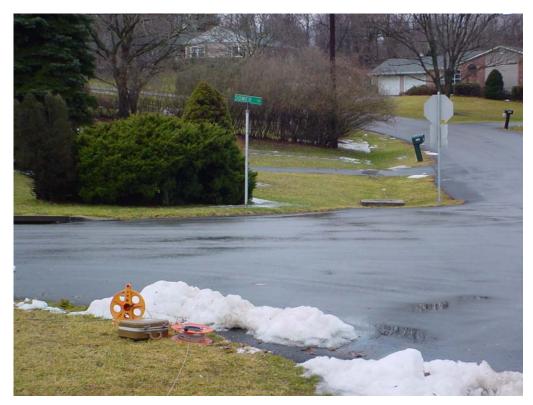
Figure 54 – Measuring stray currents near Dower Drive and East Leisure Court
