Spring Valley Road and Winding Way

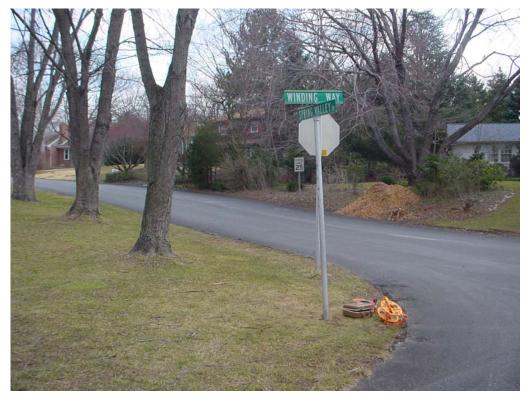
Stray current tests were conducted near the intersection of Spring Valley Road and Winding Way. A map and photograph of the location are shown below in Figure 61 and Figure 62, respectively. Measured stray currents indicate a maximum peak-to-peak potential shift of 0.74 volts on the east-west axis.

Figure 62 – Measuring stray currents near Spring Valley Road and Winding Way
