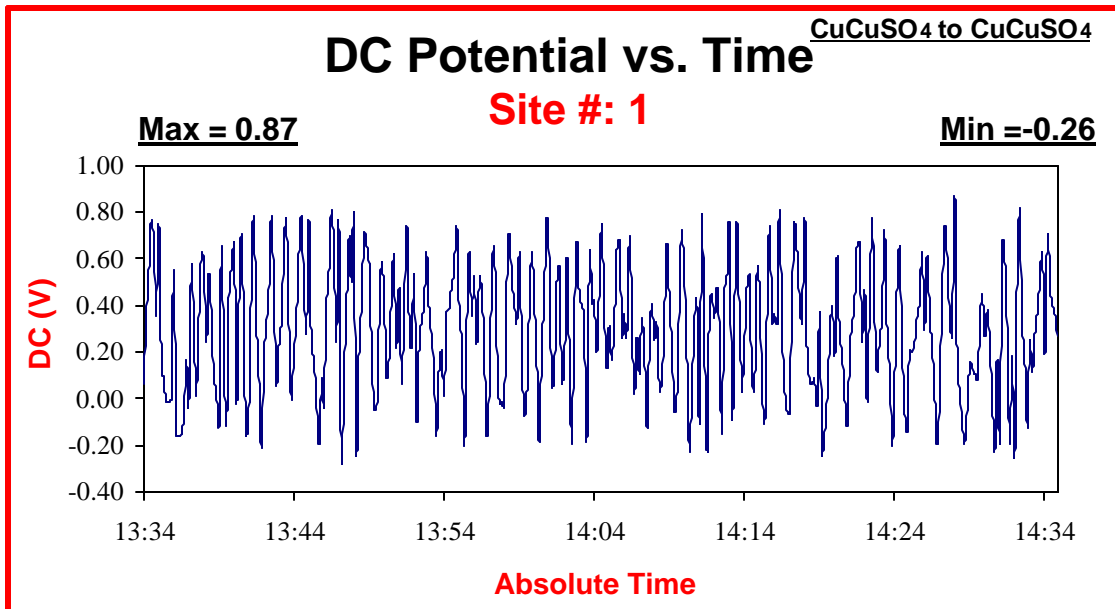
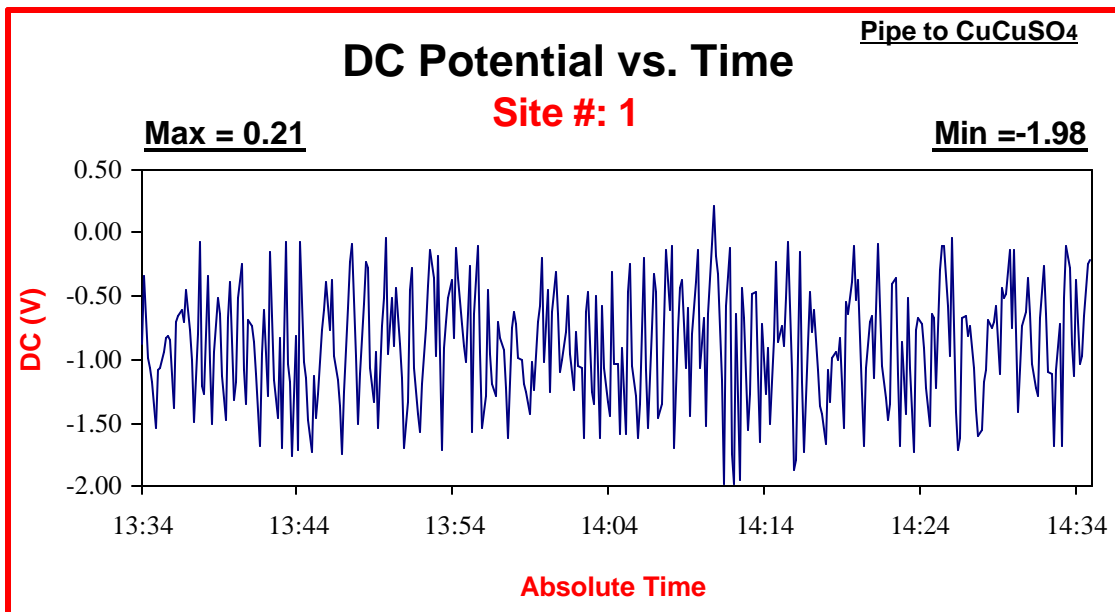
Figure 217 - Stray Current Test Results for site 1, near Test Station 1

<u>CuCuSO<sub>4</sub> to CuCuSO<sub>4</sub></u>	<u>Pipe to CuCuSO<sub>4</sub></u>
<b>Approximate Station #:</b>	(02+25)	(02+25)
<b>Date:</b>	4/1/2005	4/1/2005
<b>Time:</b>	13:34:02 AM	13:34:02 AM
<b>Maximum (V):</b>	0.87	0.21
<b>Minimum (V):</b>	-0.26	-1.98
<b>DC Potential Shifts (V):</b>	1.13	2.19
<b>Location:</b>	End of Cedar Avenue	
<b>GPS Location:</b>	N 39° 10.323', W 76° 47.596'
