Figure 42. Stray Current Survey (AM) for Site 15

Figure 43. Stray Current Survey (PM) for Site 15

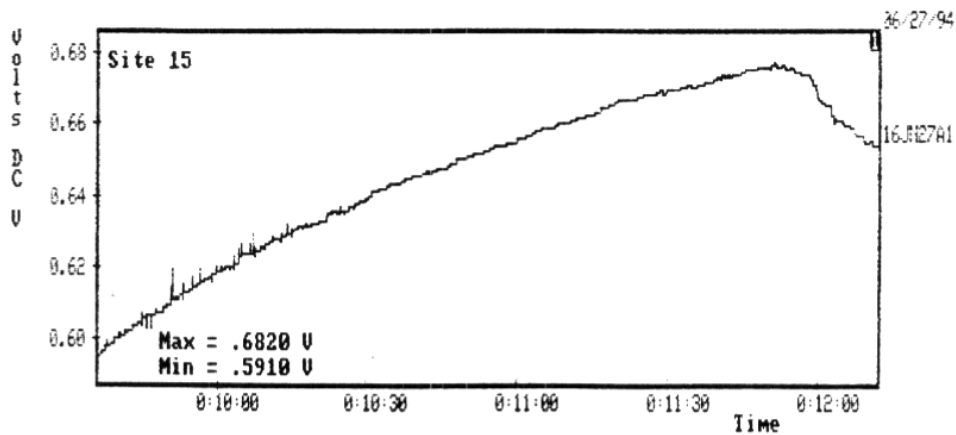
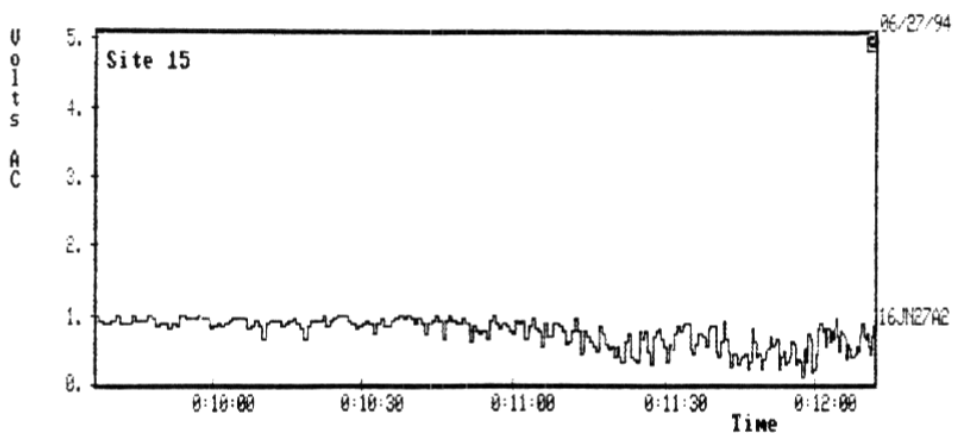
Date: 6/27/94

Time: 9:35A - 12:10P

Effective Groundbed Width (ft): 200

Stray Current Shifts (mV): DC 91 mV;

Comments: Site located at intersection of Mayfield Rd. and Rt. 108.

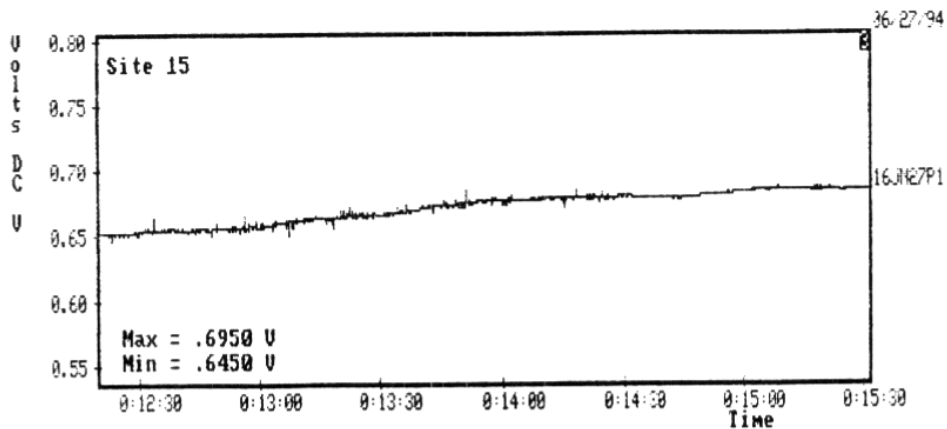
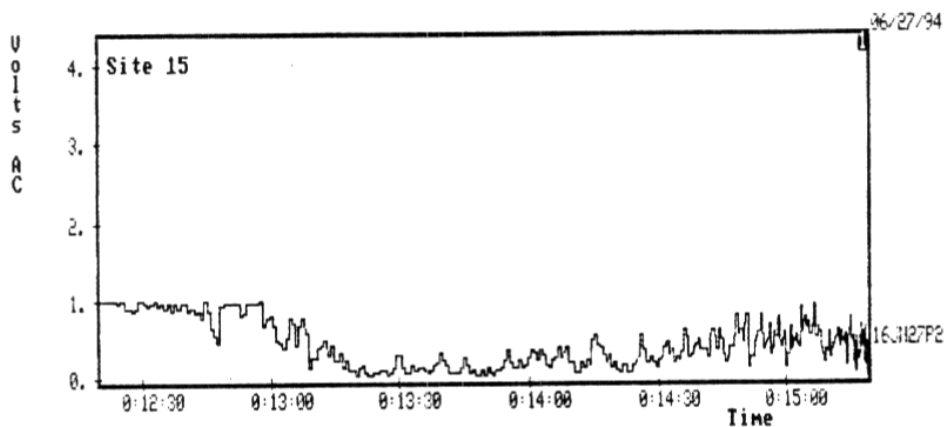
Date: 6/27/94

Time: 12:20P - 3:40P

Effective Groundbed Width (ft): 200

Stray Current Shifts (mV): DC 50 mV;
