Figure 11. Location Map for Site 4

Figure 12. Current Interference Survey for Site 4

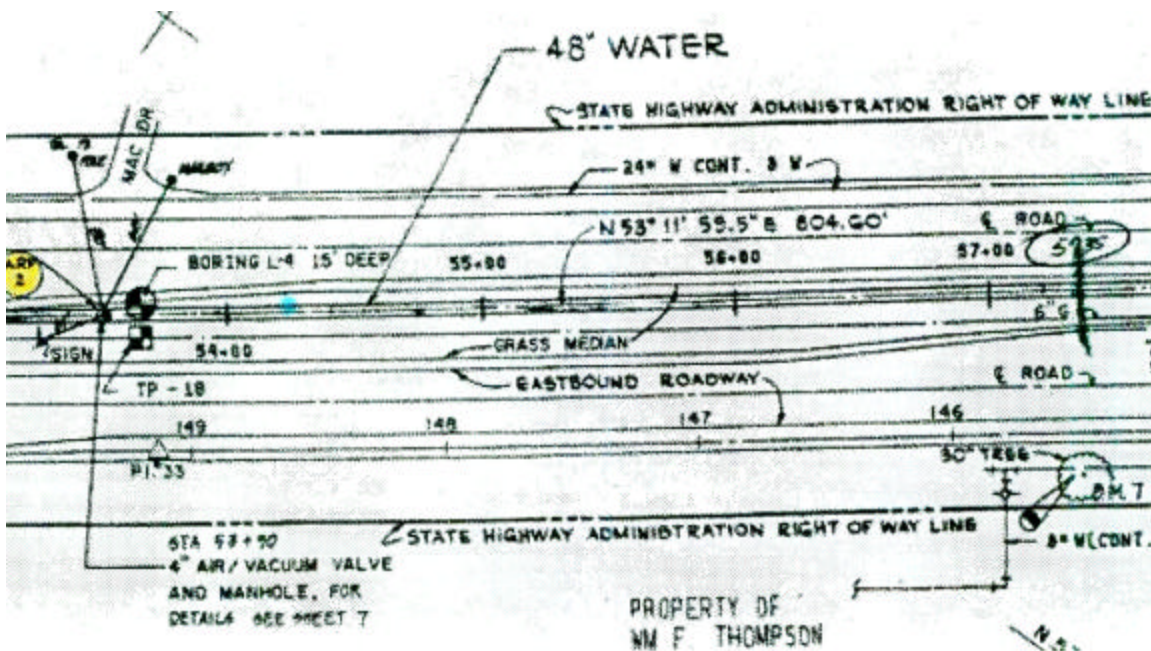
Test Setup: DC volts between Cu/CuSO₄ and ARV-2; Cu/CuSO₄ 40'E of ARV-2.
