**HOWARD COUNTY DEPARTMENT OF PUBLIC WORKS
CORROSION CONTROL TEST STATION
FIELD DATA SURVEY FORM**

Location: 02+80 Date Surveyed: 07/06/2007
South of US Rt. 29 NB Ramp Surveyed by: AS/MJ
 T/S #: 3 Contract #: 44-3844
 T/S Type: CS Pipe Size: 30"
 Was the T/S located? YES / NO _____

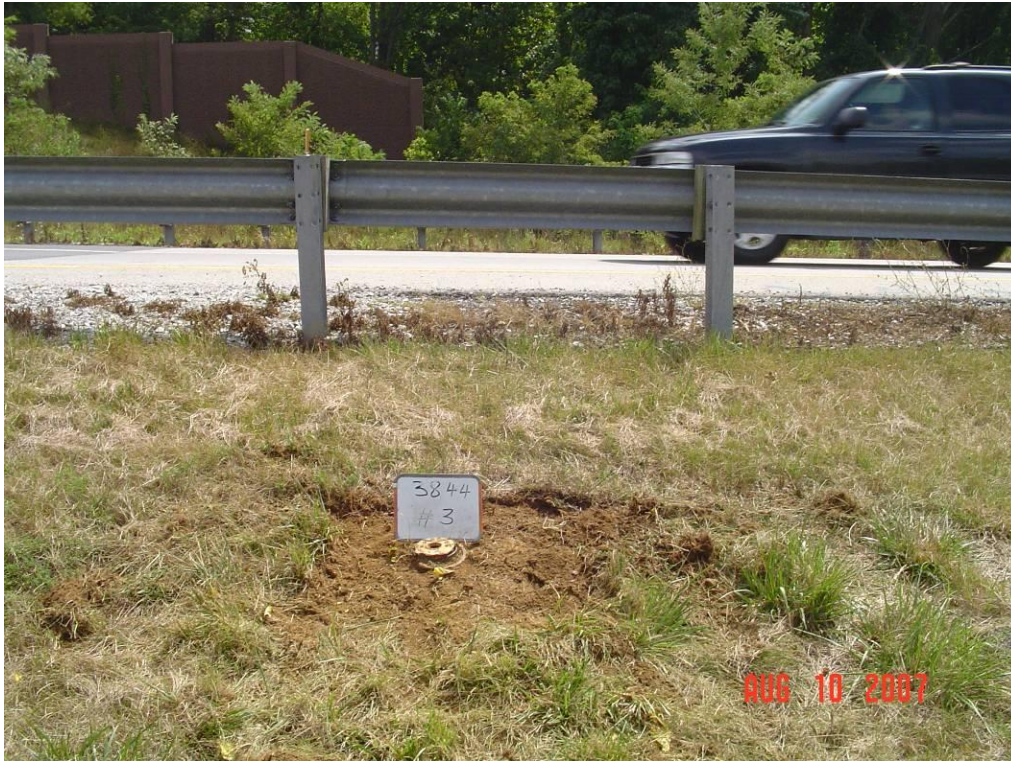
Figure 65 – General area of Test Station 3844-3

| Other: | Located approximately 10ft. from the guardrail. Test station cover is corroded. |

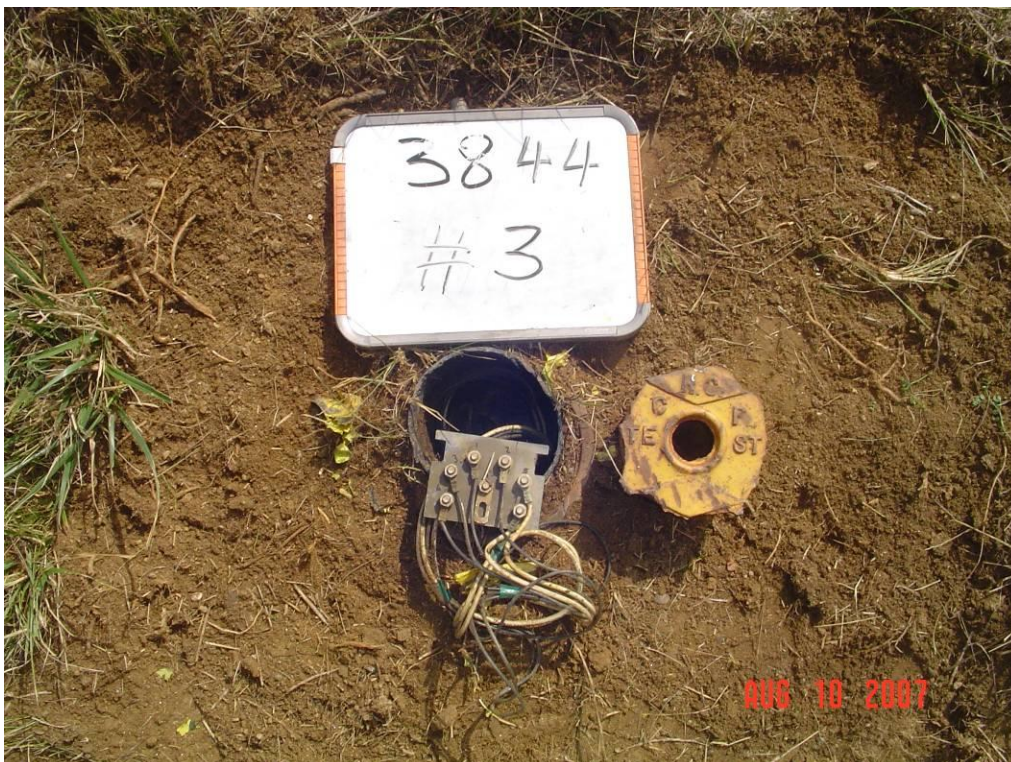
Figure 66 - Test Station 3844-3 close-up

| Test Box: | Cover is corroded |

| Comments/Recommendations: | Casing appears to be isolated from the pipe. |
