**HOWARD COUNTY DEPARTMENT OF PUBLIC WORKS  
CORROSION CONTROL TEST STATION  
FIELD DATA SURVEY FORM**

Location: 08+24 (N) Date Surveyed: 3/18/2005  
US Rt. 29 Surveyed by: AC/MJ  
T/S #: 08 Contract #: 44-3868  
T/S Type: IJ w/ Anodes Pipe Size: 16"

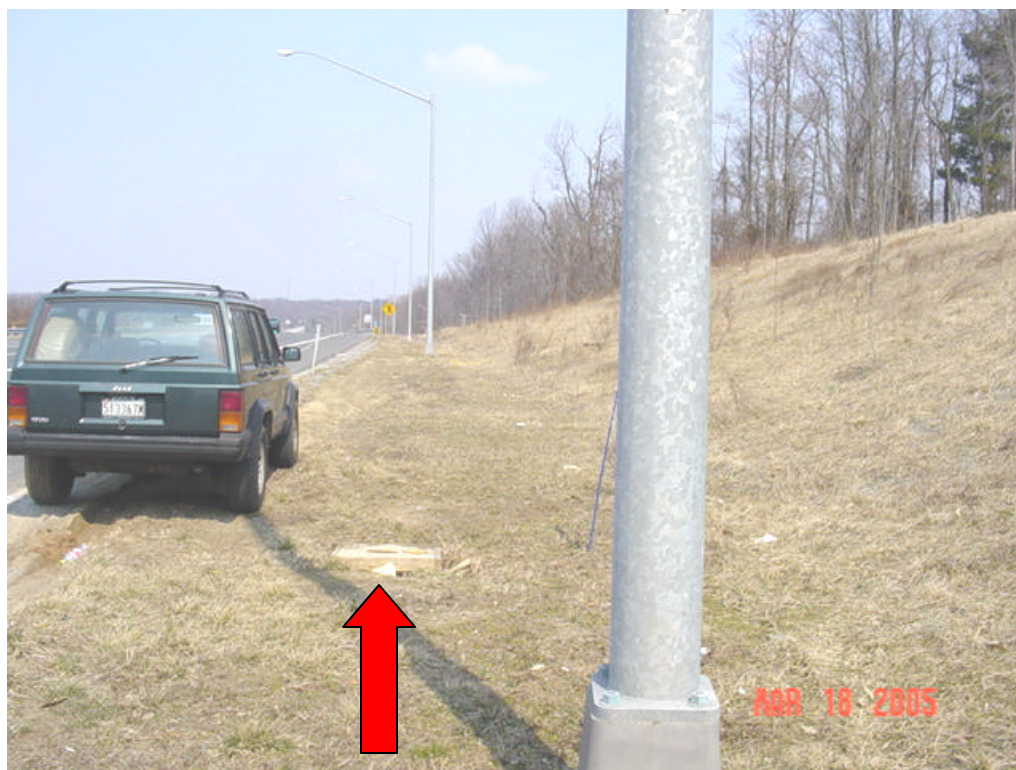
**Figure 102 – Location of Test Station 8 - Rt.29 N**

Test Box : Good  
Terminal Board : Good  
Wires : Two Loose Wires (#10 Black)  
Other : \_\_\_\_\_
