**HOWARD COUNTY DEPARTMENT OF PUBLIC WORKS
CORROSION CONTROL TEST STATION
FIELD DATA SURVEY FORM**

Location: 08+24 (N) Date Surveyed: 05/30/2007
 US Rt 29 Surveyed by: AS/MJ
 T/S #: 08 Contract #: 44-3868
 T/S Type: IJ w/Anode Pipe Size: 16"
 Was the T/S located? YES / NO YES

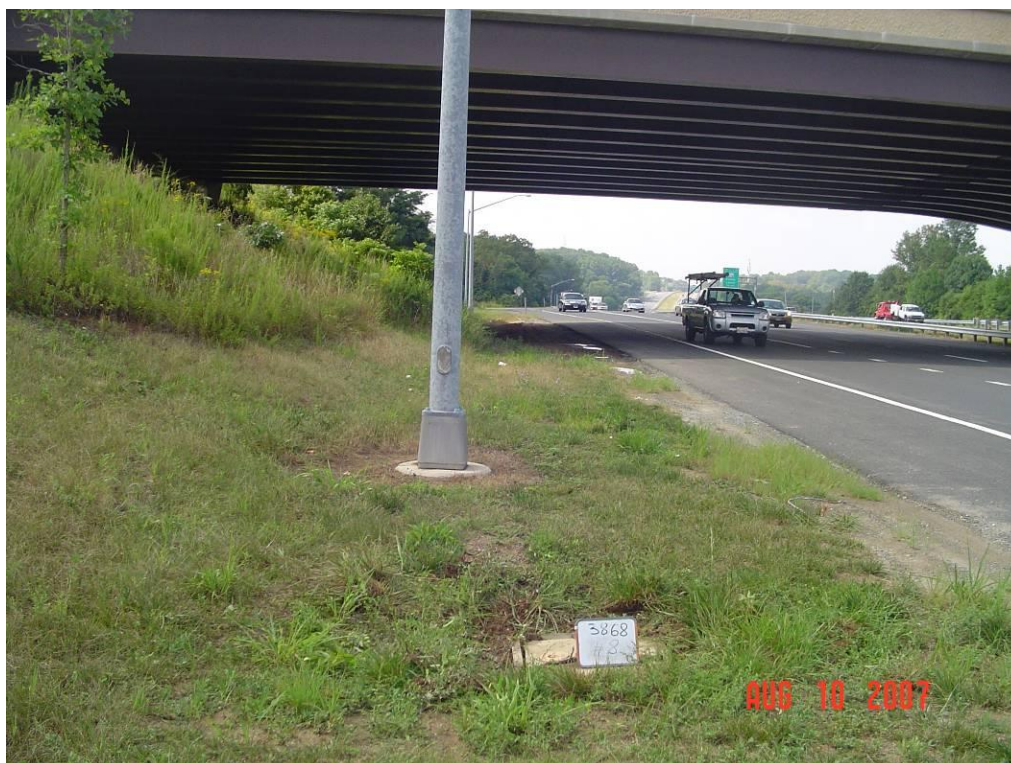
Figure 88 – Location of Test Station 8 - US Rt 29 N

Test Box:	Good
Terminal Board:	Good
Wires:	#4 wire is broken. Broken concrete pad
Other:

Test Box:	_____
Terminal Board:	_____
Wires:	#4 wire is broken
Other:	_____
Comments/Recommendations:	IJ test confirms the isolation between two pipes
