## HOWARD COUNTY DEPARTMENT OF PUBLIC WORKS CORROSION CONTROL TEST STATION FIELD DATA SURVEY FORM

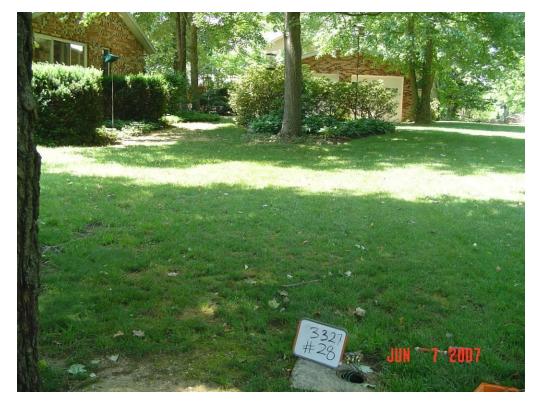
Figure 167 – Location of Test Station 28

8.								
P/Cu-CuSO <sub>4</sub> = Pipe to Copper-Copper Sulfate Reference Electrode P/Zn = Pipe to Zinc Reference Electrode "On" = Reading with Anode(s) connected "Off" = Reading with Anode(s) disconnected Anode = Current output Anode(s)  TESTING THE EFFECTIVENESS OF INSULATING JOINTS								
Groundbed:								
Connected to (B/W):				V-11 (1/1)		Desistance (alone)		
ONI	Current (A)		1 22	Voltage (V)		Resistance (ohms)		
ON: OFF:			1.33		11.14 0.66		7.88	
DELTA:			1.33		10.48			
<u> </u>								
TESTING IR DROP								
IR Drop		F /	-1/	<b>I</b> Z	\	Between	Resistance	
Calibrations INITIAL		<b>E</b> (r	nv)		\I (mA)	Terminals	(ohms)	
FINAL				Δ	Æ (mV)			
DELTA				Direction:				
REPAIRS MADE								
Test Box: Cleared the grass covering the test box								
Terminal Board: Wires:								
Other:								
Comments/Recommendations: IJ appears to be functioning properly.								
to minients/Neconninentations. 15 appears to be functioning properly.

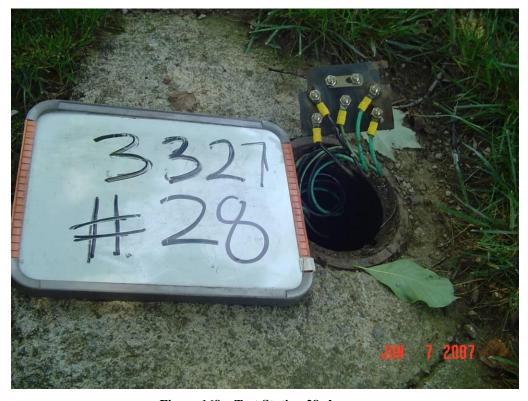
Figure 168 – Test Station 28 close up

FIELD DATA SURVEY FORM								
Location:	90+57			Date Surveyed	<b>l:</b> 06/07	06/07/2007		
	5852 Deei	Deer Ridge Lane		Surveyed by:	AS/N	AS/MJ		
T/S #:	28					3327		
T/S Type:				Pipe Size: 36"				
Was the T/S located? YES / NO YES								
TEST STATION CONDITION								
Test Box: Covered with grass								
Terminal Bo								
Wires:	Good							
Other:								
SURVEY DATA						Anada		
Test Wire Size/Description		Color	P/Cu-CuSO₄ (V) "On""Off"			/Zn (V) n""Off"	Anode (mA)
