**HOWARD COUNTY DEPARTMENT OF PUBLIC WORKS
CORROSION CONTROL TEST STATION
FIELD DATA SURVEY FORM**

Location: (00+21) Date Surveyed: 07/06//2007
Rt. 40 at Patapsco Bridge Surveyed by: AS/MJ
 T/S #: 2 Contract #: 8-W
 T/S Type: IJ w/Anode Pipe Size: 24"
 Was the T/S located? YES / NO YES

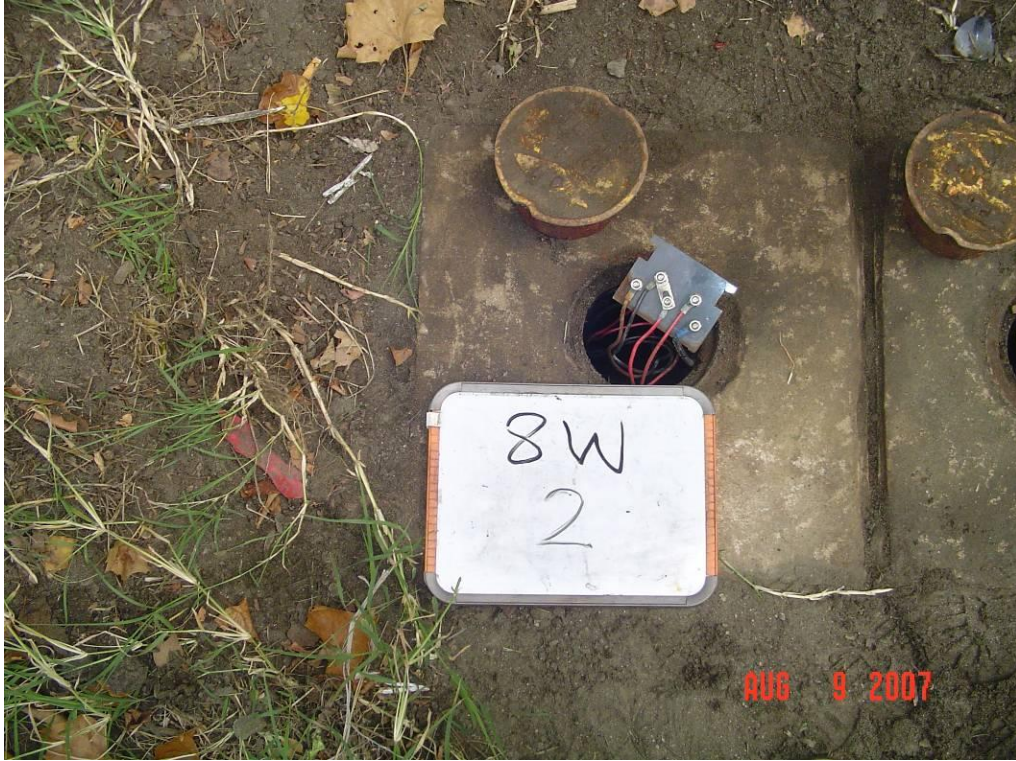
Figure 59 - Test Station 8W-2 close-up

Test Box:	Buried under soil
Terminal Board:	Good
Wires:	Good
Other:

Test Box:	Cleared soil
Terminal Board:	
Wires:	
Other:	
Comments/Recommendations:	IJ appears to be working
