HOWARD COUNTY DEPARTMENT OF PUBLIC WORKS CORROSION CONTROL TEST STATION FIELD DATA SURVEY FORM

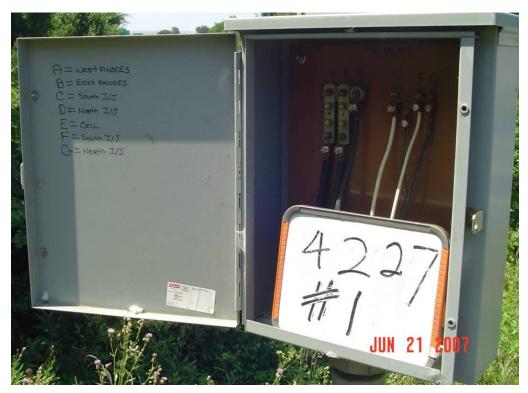
Figure 231 - Test Station 4227-1 close-up

Comments/I					astic washe	rs usea in	ne terr	ninai boar	u were		
obstructing a	node/pipe el	iectrical cont	act. They	y were	removed.
