HOWARD COUNTY DEPARTMENT OF PUBLIC WORKS CORROSION CONTROL TEST STATION FIELD DATA SURVEY FORM

Location:	ocation: 12+75					Date Surveyed:			06/21/2007			
								/MJ				
T/S #: 3						Contract #: 44-42		227	227			
T/S Type: IJ w/Anode						Pipe Size: 48"						
Was the T/S located? YE			S/NO YES									
TEST STATION CONDITION												
Test Box:		Above	ove ground									
Terminal Board: 7 ter			rminals in good condition									
Wires: Good		Good	t t t t t t t t t t t t t t t t t t t									
Other:												
SURVEY DATA												
Test Wire				P/C	Cu-Cu	SuSO ₄ (V)		P/Zn (V)		Anode		
Size/Description			Color		"On""Off"			"On""Off"

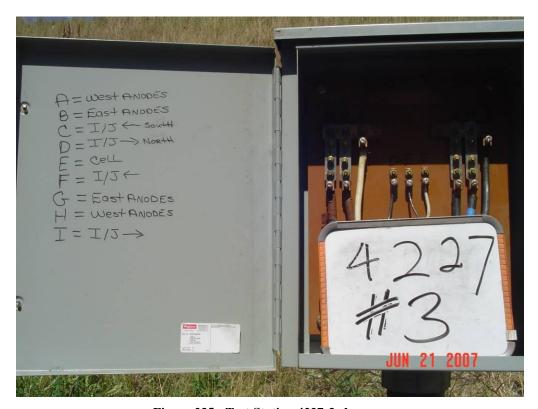
Figure 235 - Test Station 4227-3 close-up

Terminal Board:												
Wires:												
Other:												
Comments/Recommendations: It appears that connectors C and I are not connected to the anodes												
due to the plastic washers used on the bus-bar. They were removed. IJ appears to be failing.
