## Howard County Traffic Signal Inspection Summary Report:

**Signal Number:** 016  
**Location:** Little Patuxent Parkway at Governor Warfield Parkway  
**Inspection Date:** April 11, 2018

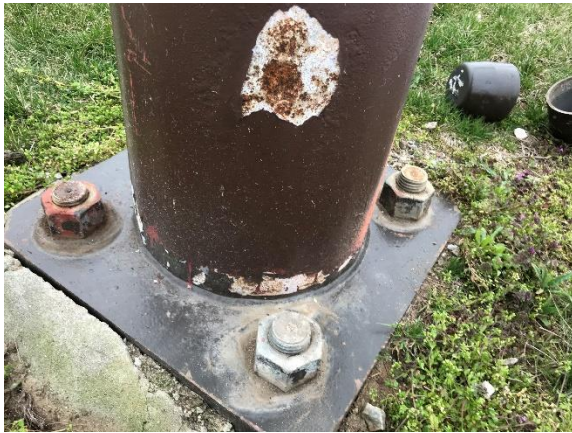
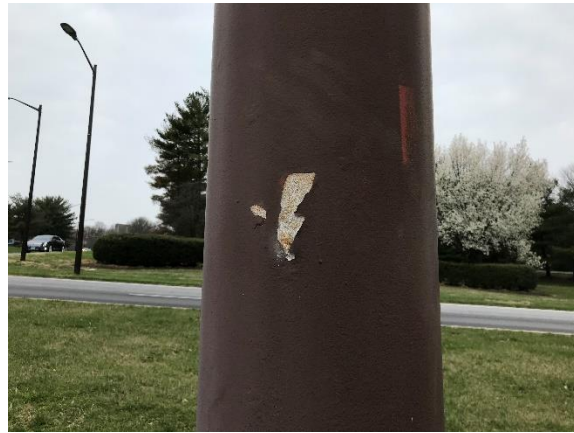
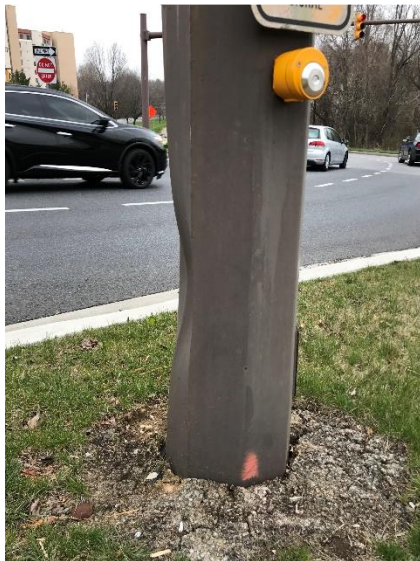
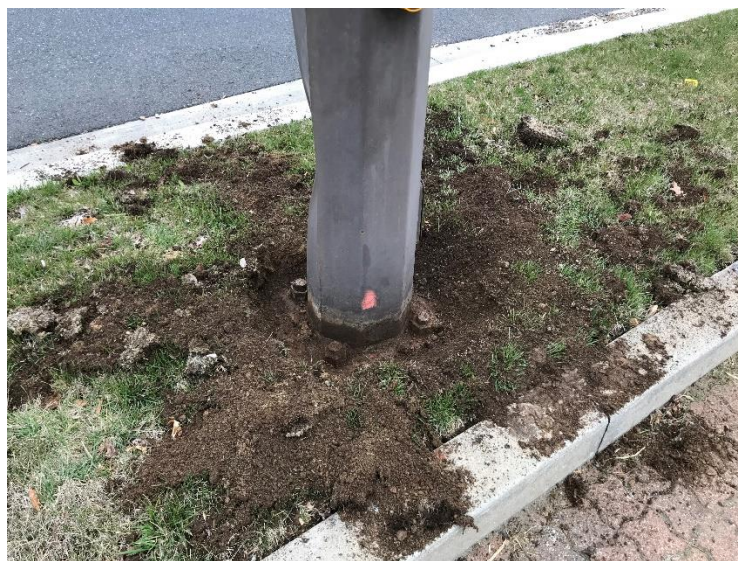
Poles and paint coating in overall fair condition, with small areas of paint coating failure and surface rust beginning to form. Recommend cleaning, prime, and re-paint. South Median structure has significant vehicle impact damage. Structure was evaluated and determined to be ok. Base plate was also buried and had to be dug out.
