Howard County Traffic Signal Inspection Summary Report:

Signal Number: 023

Location: Little Patuxent Parkway at South Entrance Rd.?

Inspection Date: April 11, 2018

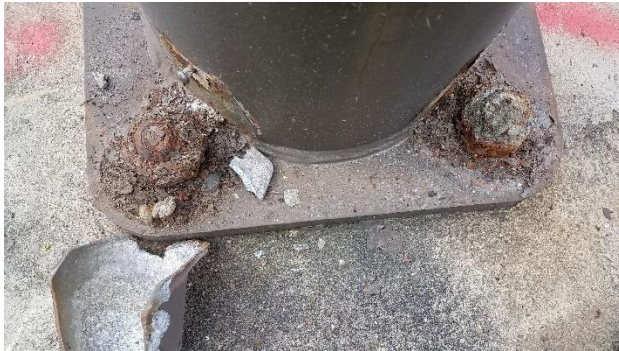
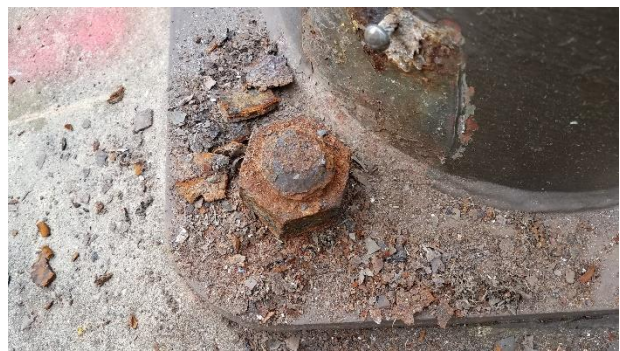
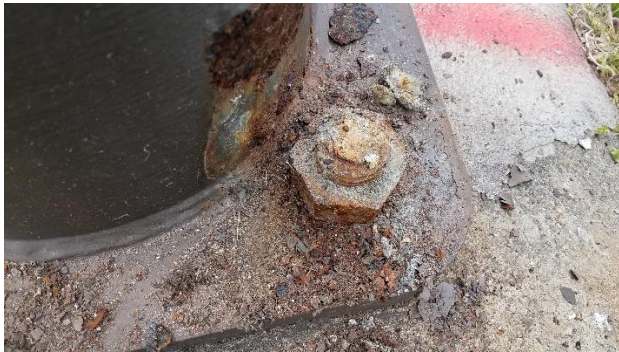
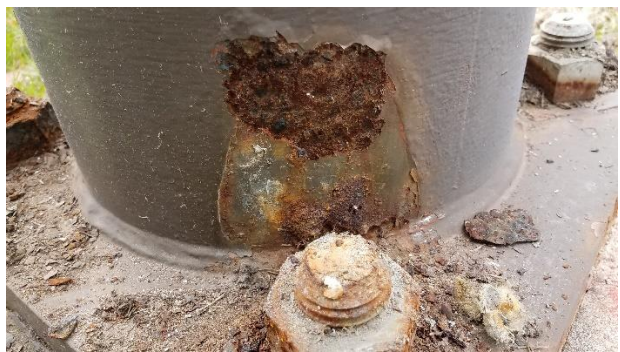
Poles in overall fair condition. Paint coating is in good condition. Both structures have some moderate rusting around the base plate area and tightening nuts. Recommend media blast, prime, and re-paint.
