## Howard County Traffic Signal Inspection Summary Report:

**Signal Number:** 037

**Location:** Little Patuxent Parkway at Rouse Parkway/Columbia Mall

**Inspection Date:** April 11, 2018

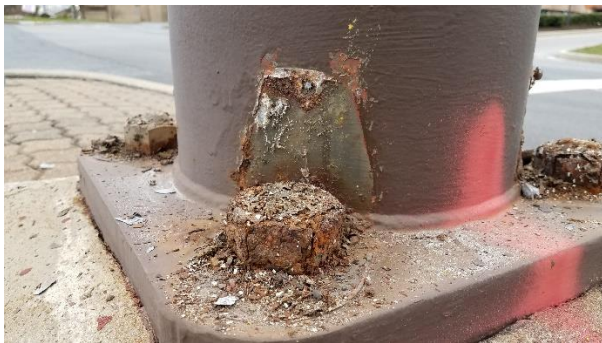
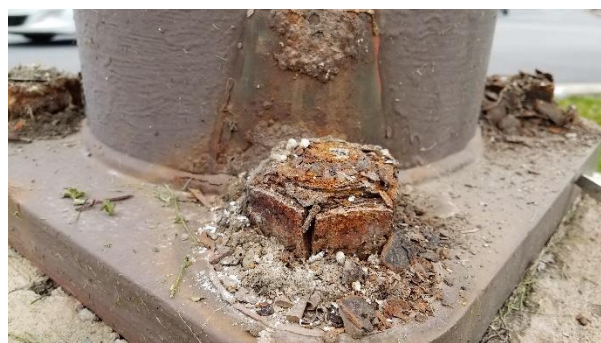
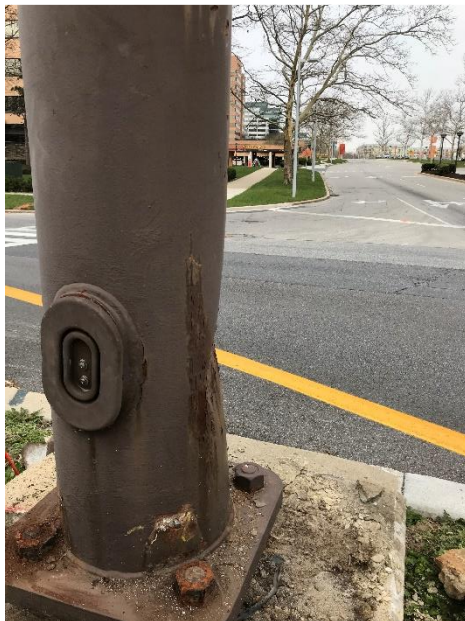
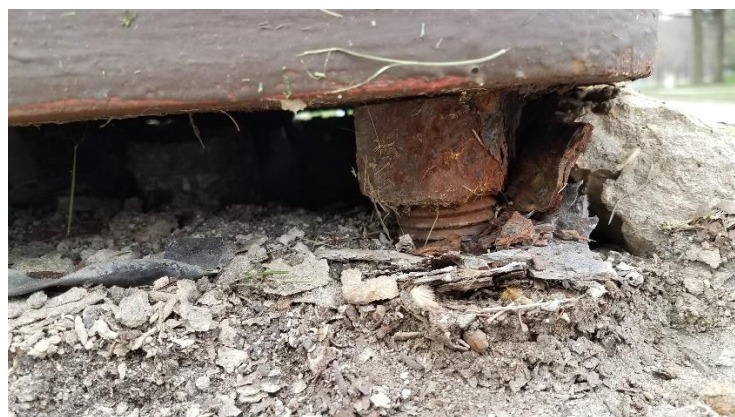
North Median structure has significant deterioration of the tightening nuts. South Median structure has significant rusting and deterioration of the leveling and tightening nuts, and has vehicle impact damage.
