Test Station 3

HOWARD COUNTY DEPARTMENT OF PUBLIC WORKS
CORROSION CONTROL TEST STATION
FIELD DATA SURVEY FORM

Location: (12+75)
Date Surveyed: 10/10/2005
Surveyed by: MJ/CS
T/S #: 3
Contract #: 44-4227
T/S Type: IJ/Anode
Pipe Size: 48"

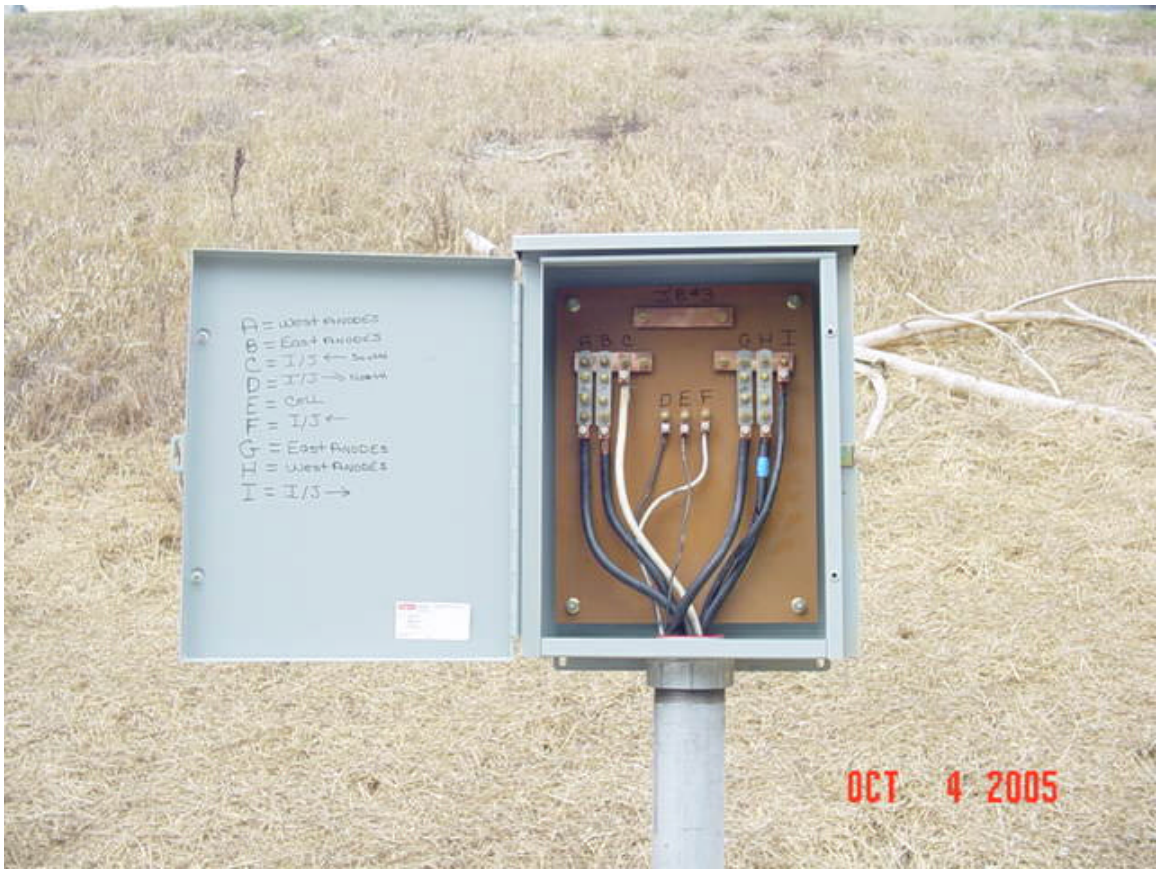
Figure 8 – Test Station 3

Test Box : Above ground - metal
Terminal Board : 7 terminal - Good
Wires : Good
Other :
