**MARYLAND HISTORICAL TRUST
DETERMINATION OF ELIGIBILITY FORM**

Property Name: Montjoy Farm Inventory Number: HO-145
 Address: 9097 Executive Park Drive City: Ellicott City Zip Code: 21042
 County: Howard USGS Topographic Map: Savage
 Owner: Estate of M.L. Dawson Lee, Jr. Is the property being evaluated a district? yes
 Tax Parcel Number: 260 Tax Map Number: 30 Tax Account ID Number: 243105
 Project: Montjoy Complex Agency: _____

Description of Property and Eligibility Determination: (Use continuation sheet if necessary and attach map and photo)
CAPSULE SUMMARY

Prepared by: Ward Bucher Architects

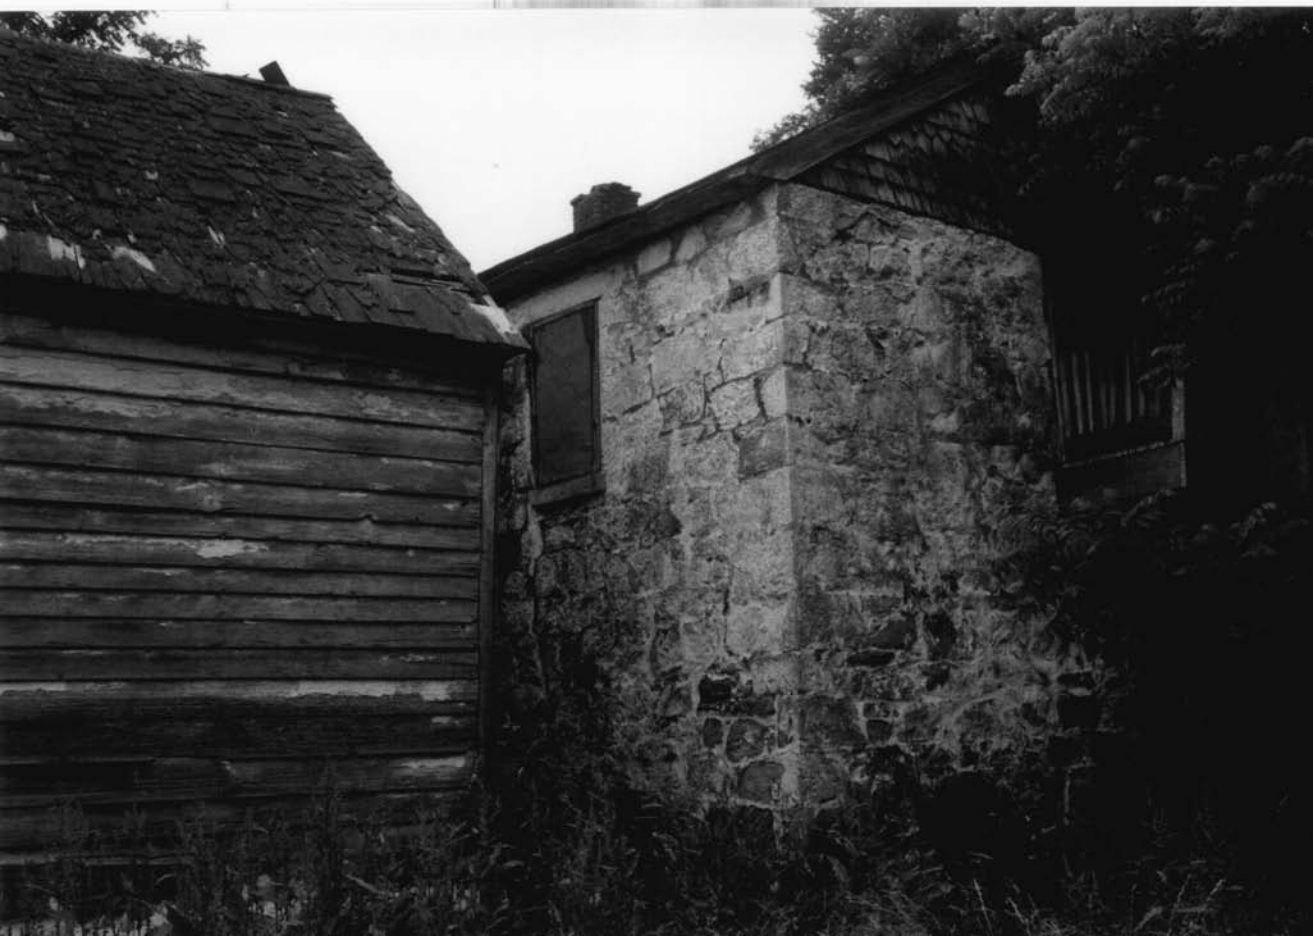
26/46

Unfortunately, during the winter of 2002-2003 the side gabled roof and the north wall collapsed, taking down the second floor and making the structure extremely unstable and unsafe. There is a large crack and pronounced bow in the east wall. According to photographs taken prior to the collapse, the north wall had a door on the first story and a window on the second story. A large kitchen hearth, with an internal brick chimney, occupies the east wall. Unfortunately, the interior of the structure was not documented before it collapsed and now it is not possible to gather evidence to determine the construction date or use of the second floor. The first floor was certainly used as a kitchen as is clear from the presence of the large cooking fireplace on the east wall; although there is no definitive proof, the second story may have housed slaves or servants. Lath and plaster finishing is visible in the second-story ruins, and furnishings are present, indicating use as living space at some point in time. The date of the building is unclear. Its orientation suggests that it was part of the planned domestic complex consisting of house, kitchen, and smokehouse, and it probably at least dates to the early 1850s and the construction of the house.

Smokehouse (left) and collapsed stone kitchen,
west elevations

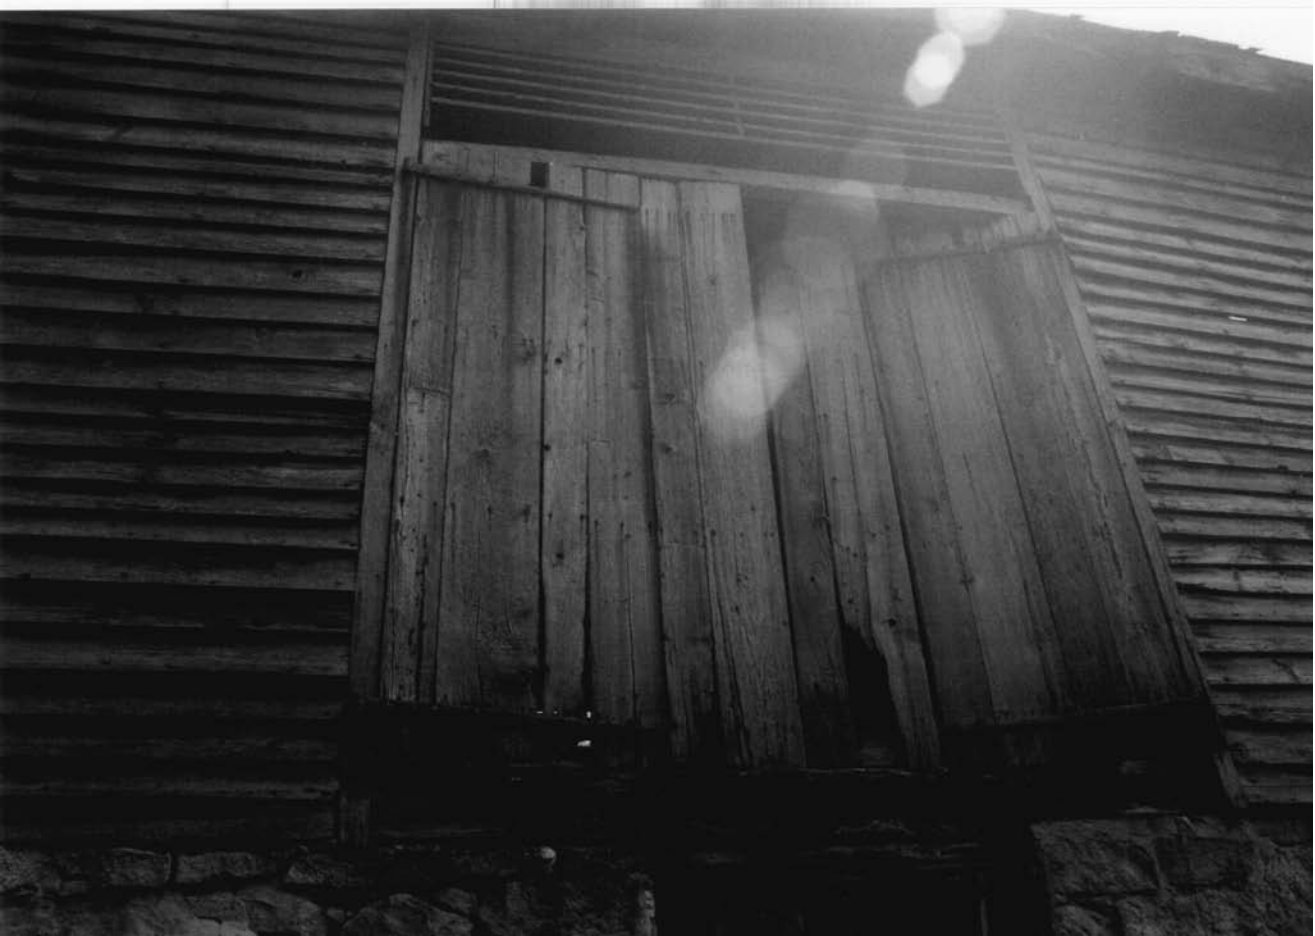
34/46

This interesting barn is located southeast of the main house, adjacent to a bank barn, and will be dismantled and moved by the Howard County Conservancy before the site is developed. The barn measures approximately 30 x 50 feet and is raised on an eight-foot stone foundation. The north elevation has a door flanked by a window on either side in the basement level, and large double doors in the center bay above in the frame part of the structure. The south elevation has double doors in the center bay flanked by a door on one side and a window on the other in the basement level, and large double doors in the center bay above in the frame portion of the building. The east and west facades of the building each have a single window centered in the basement and two rectangular wood vents in the frame part of the building. The west façade has a double door high in the gable. The exterior of the building is sheathed with clapboards.

Three-bay barn, north west elevation

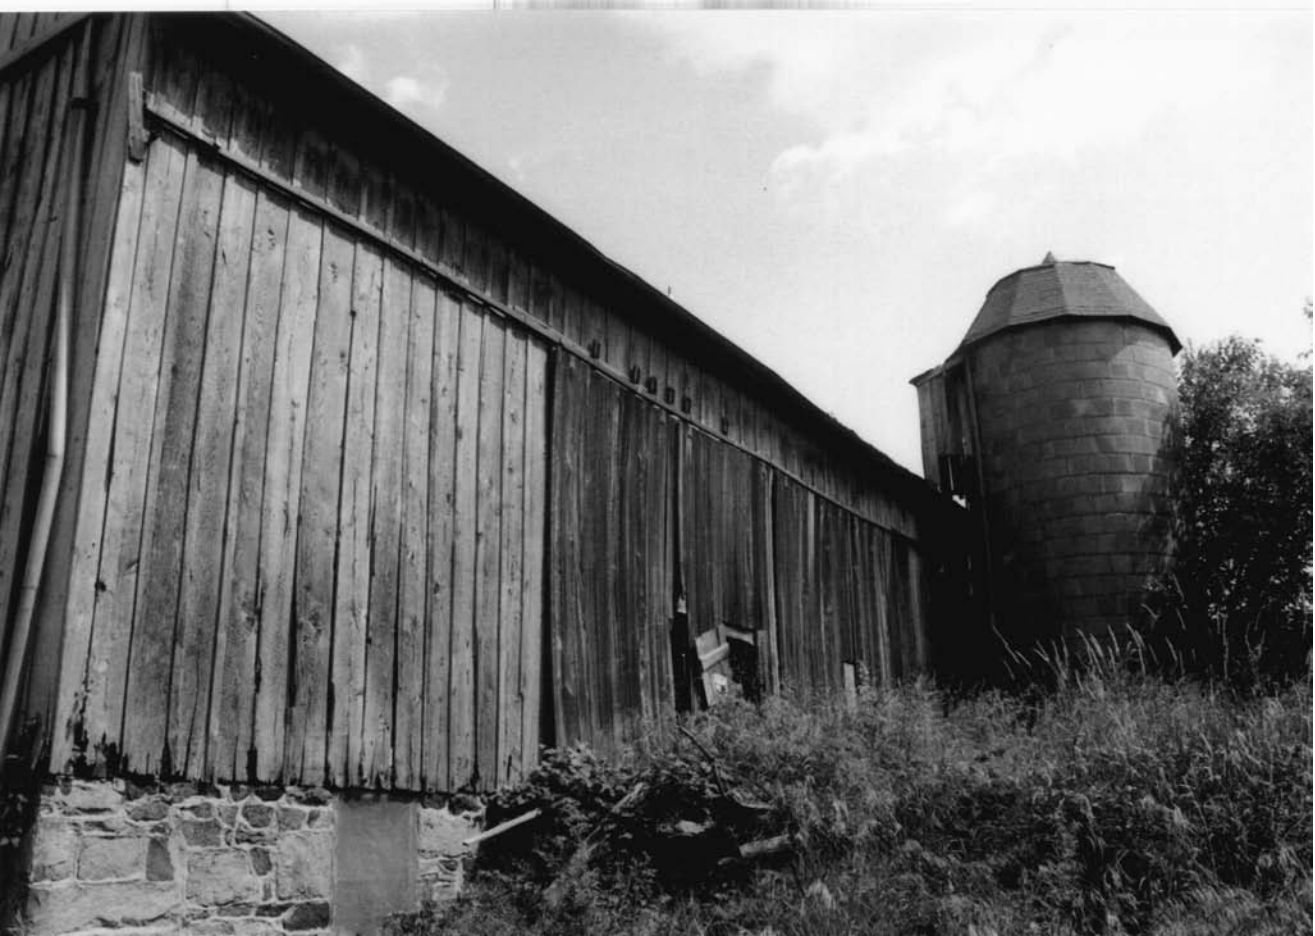
37/46

Dating evidence in the barn is sparse. The ties of the two bents are notched at regular intervals for studs that would have run to the floor and partitioned the interior space into three distinct areas. The notches are now empty and the studs missing except for the end of one stud, which remains nailed into a notch with wrought nails. Wide boards comprise the flooring and are mostly covered with hay, but in one small visible spot, they appear to be face nailed with a wrought nail. The large double doors on the north façade are also constructed with wrought nails, seemingly finer in workmanship than the wrought nails found in the smokehouse door, and have large wrought iron strap hinges. The use of wrought nails, particularly in the floor and the stud, would seem to argue for a pre-1810 construction date. Later technologies are also present, including cut nails used to nail a stud into an upbrace on the north side, but these could be later repairs. Some wall studs of the south wall appear to be reused. The east wall has been entirely rebuilt in the late nineteenth century.

Three-bay barn, interior framing system

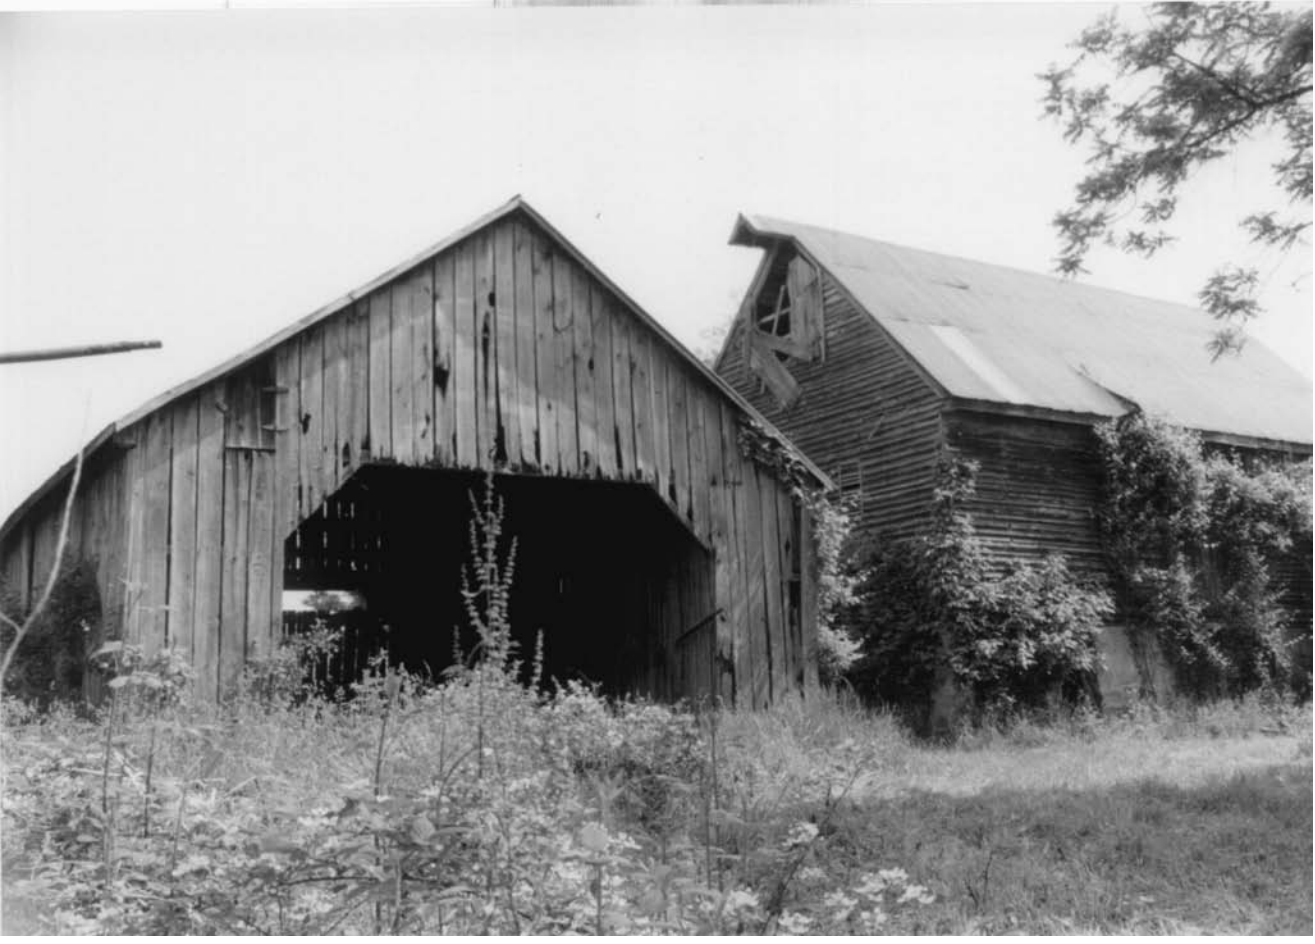
42/46

The frame drive-through granary measures 28 feet by 35 feet. An 18-foot central opening has granary storage compartments on each side that measure 5 inches in width and 11 feet 10 inches in height. There are wood double doors on the north elevation, a metal roof, and vertical wood siding. Rafters are mitered and nailed. Cross members are circular sawn. They have pegged joints and are spaced every 8-1/2 feet. The drive-through granary appears to date to either the late nineteenth or early twentieth century. It stands in good condition.

Drive-through granary - NE corner
