HISTORIC PRESERVATION CERTIFICATION APPLICATION
REQUEST FOR CERTIFICATION OF COMPLETED WORK

1. **Name of property:** Burgess Tenant House (Burgess Estate Complex)(Sam Caplan House)
Address of property: Street 8454 Main Street
City Ellicott City County Howard State Md Zip 21043
Is property a certified historic structure? yes no If yes, date of certification by NPS: 4/29/88
or date of listing in the National Register: _____

Burgess Tenant House HO-338
8454 Main Street
Ellicott City, MD 21043
Part 3 Application

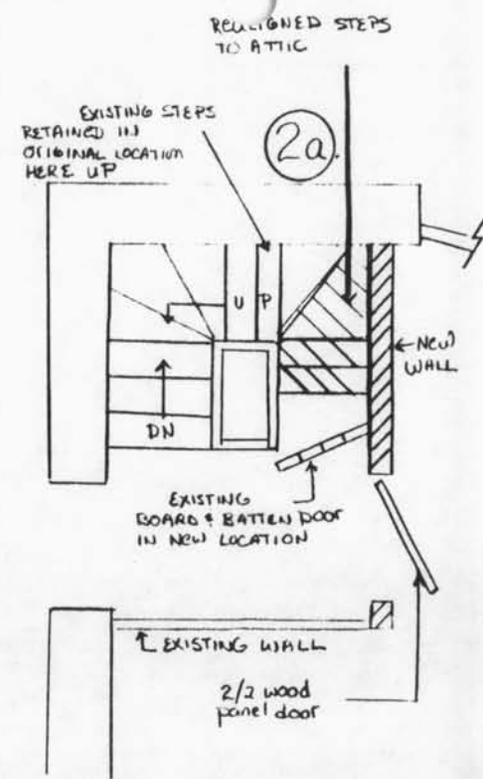
A-2

DETAIL OF PROPOSED 2ND FLOOR STAIR AND HALL CHANGE

Historic Pres. Certification Applic.
8454 Main Street, Ellicott City, MD
Second Floor--Before/After

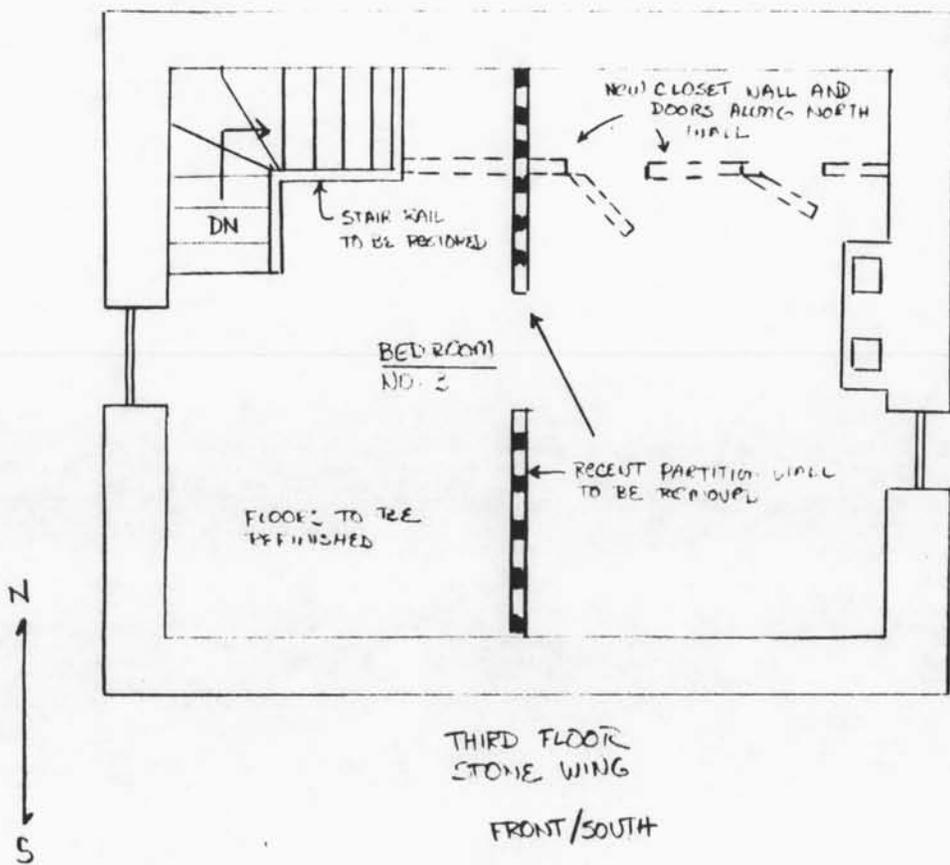
A-3

Third Floor--Before/After

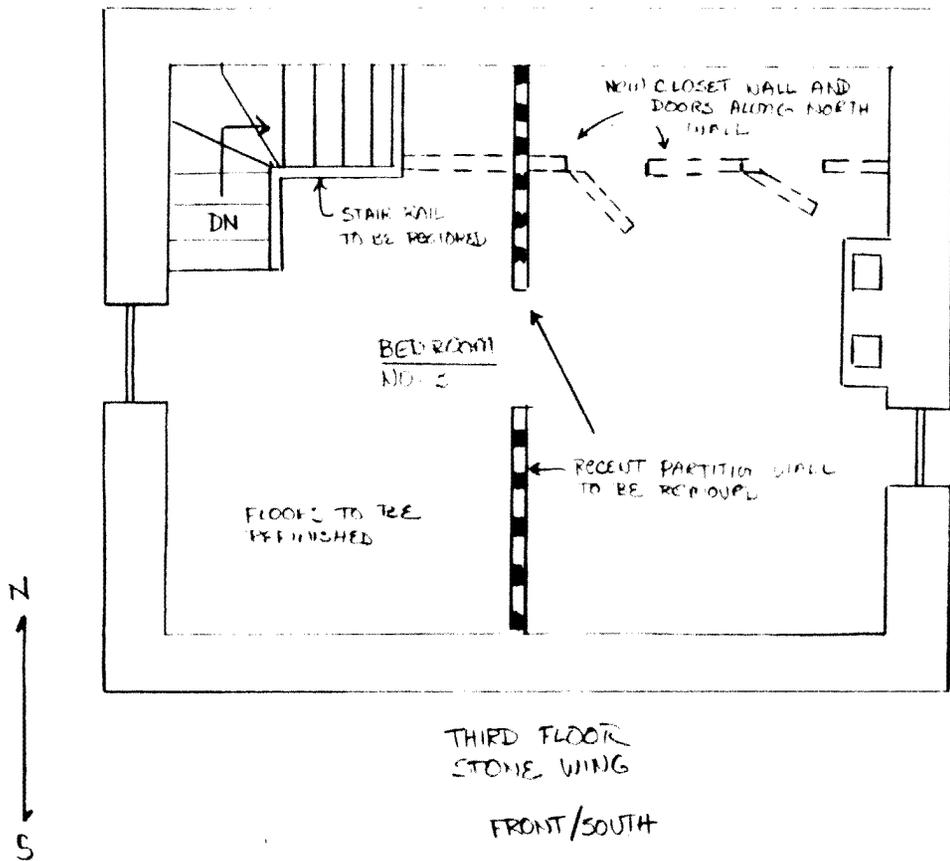
A-3

Third Floor--Before/After

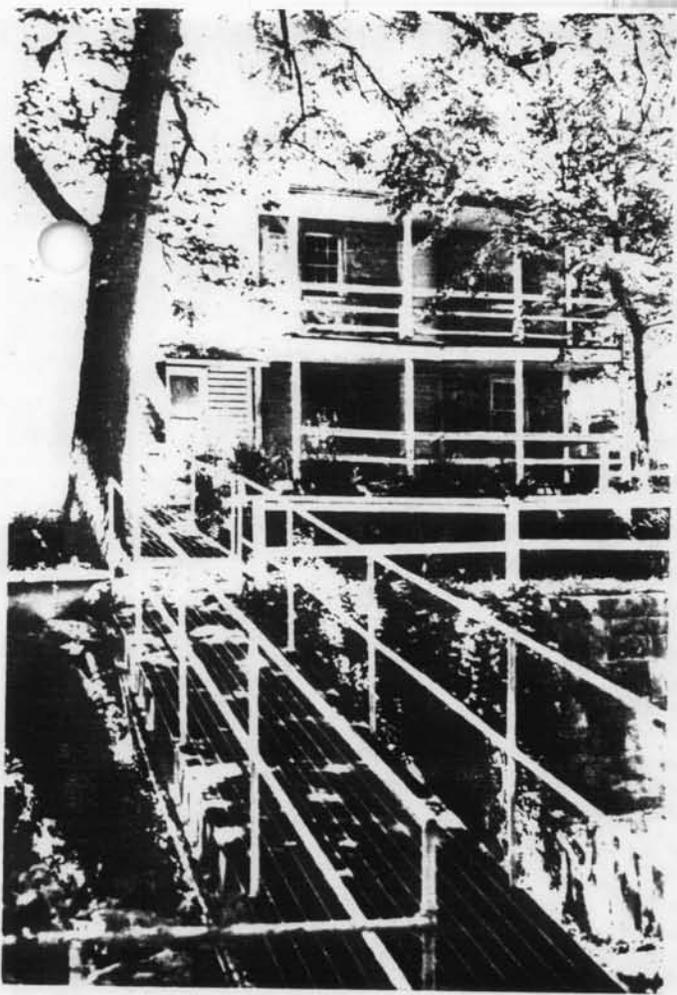
Fig A Early 19th c stone house
with Victorian wood addition to left.
Looking across from millrace (south
elevation)

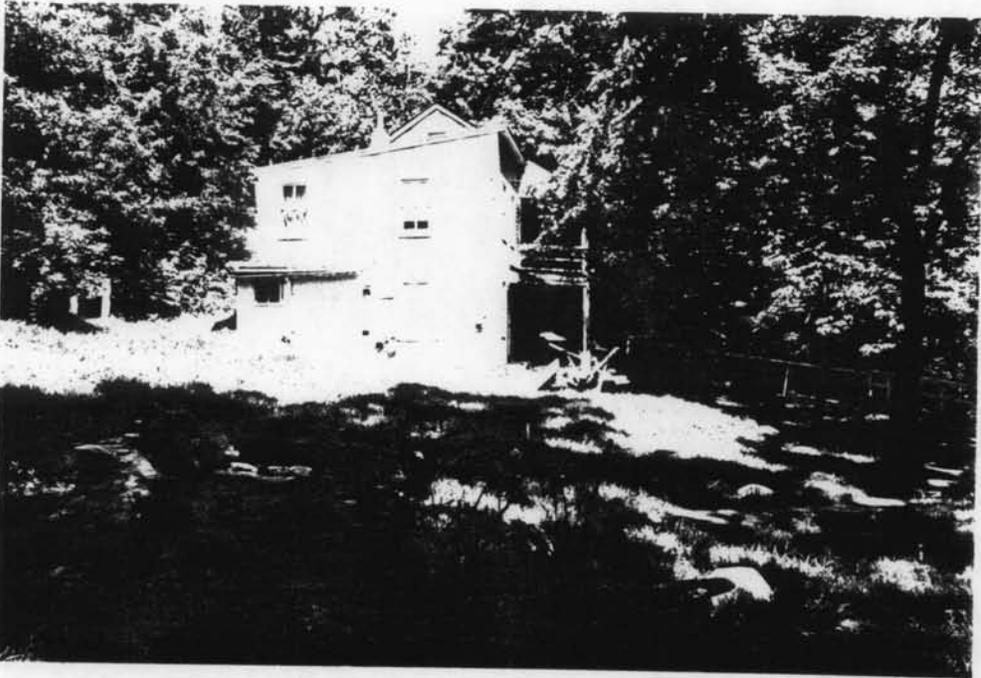
Fig B West elevation showing Victorian
wood addition and recent mud room.
Foundations in foreground are remains
of a small kitchen or storage building

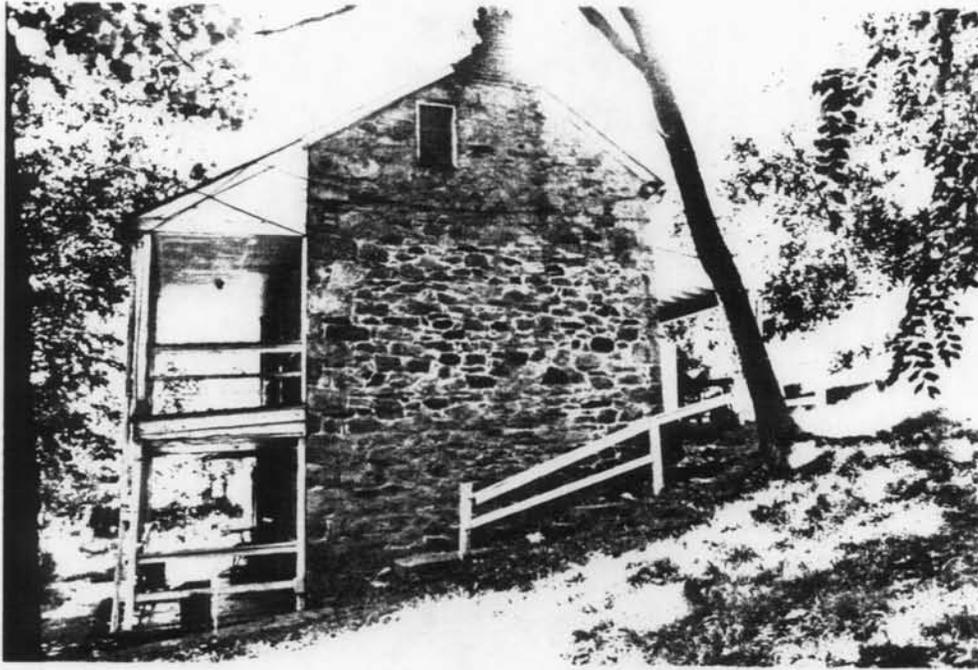
Fig C East elevation showing two-story front porch and one-story rear porch.

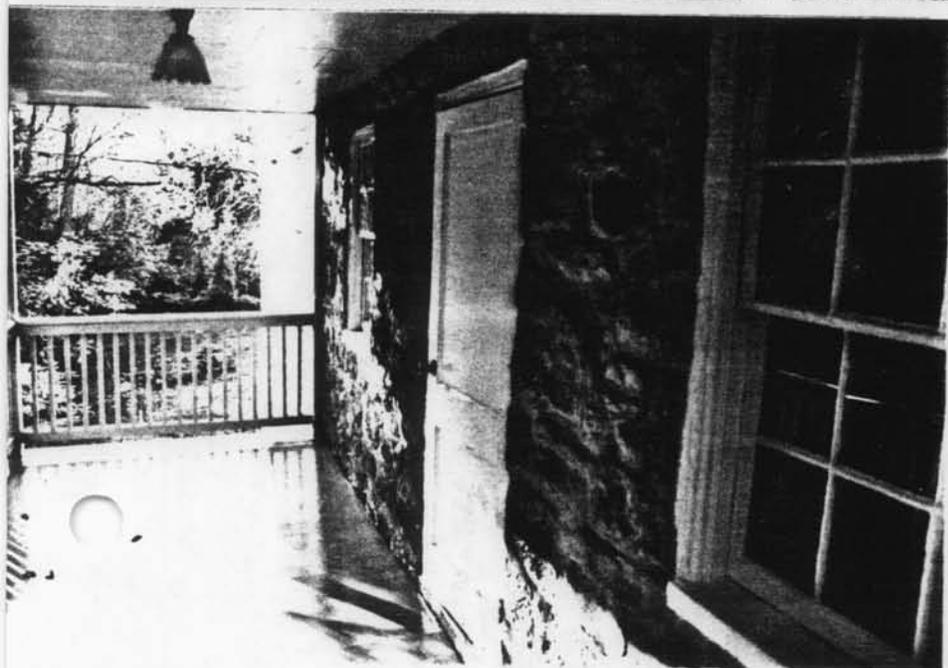
Fig. 6 Front elevation -- second floor. New flooring and wood ceiling to replace deteriorated one-- matches historic. Existing door retained.

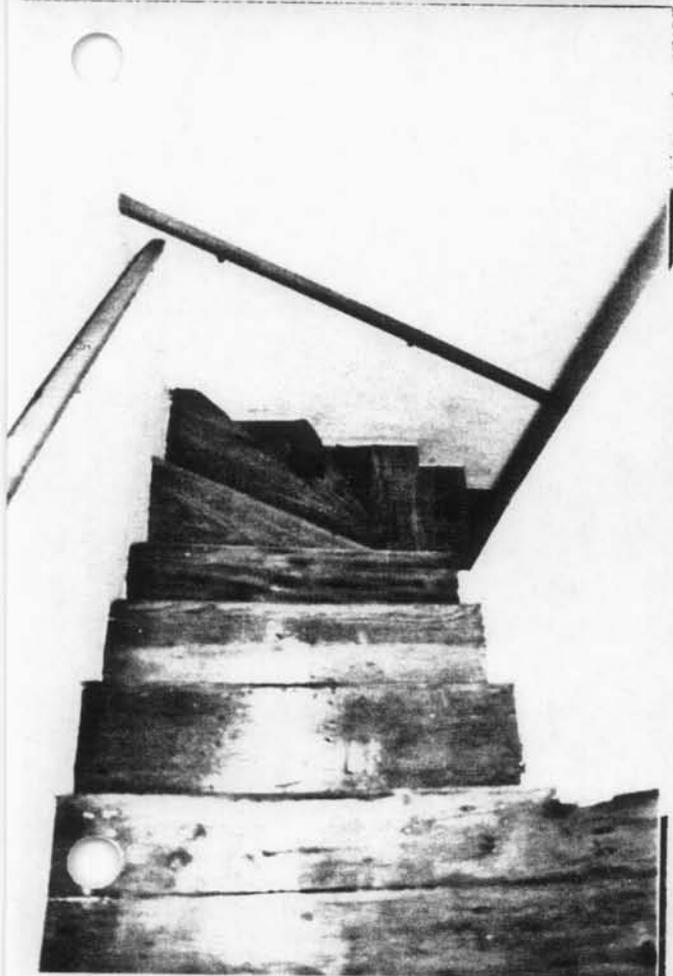
Fig. 19 Stairs from attic to the second floor. All steps shown in view are original and were restored in existing location. Only bottom several steps not shown in this view were turned 90 degrees.
