HOWARD COUNTY: PIPE BREAKS - FIELD DATA

DAY: 7/26/2011
 TIME: _____
 TIME OF BREAK: _____
 ENGINEER: Chuck Garrett

LOCATION: _____
 GPS LOCATION: 3830 Spring meadow Dr

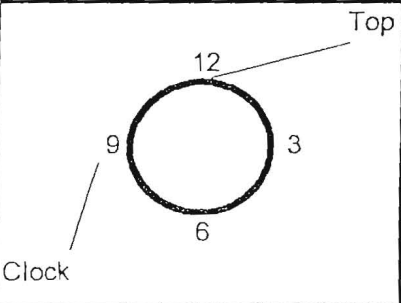
<div data-bbox="1068 1608 1291 1640" data-label="Section-Header"> <p>TESTING VIEW</p> </div>

3" Hole in Pipe

Repair Method: 6" Clamp ___ Weld ___ Cut ___ Other
