**HOWARD COUNTY DEPARTMENT OF PUBLIC WORKS
CORROSION CONTROL TEST STATION
FIELD DATA SURVEY FORM**

Location: 06+40 Date Surveyed: 06/20/2007
 T/S #: 4 Surveyed by: AS/MJ
 T/S Type: St w/Anode Contract #: 44-4227
 Pipe Size: 48"
 Was the T/S located? YES / NO YES

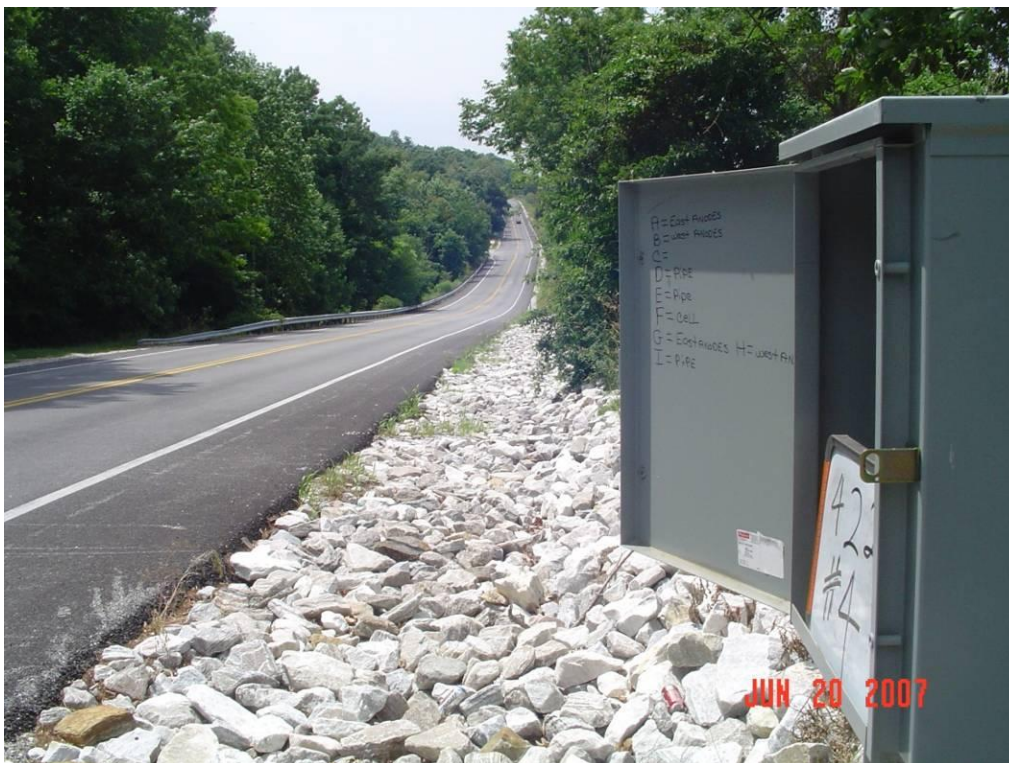
Figure 236 - Location of Test Station 4227-4

Test Box: Above ground
 Terminal Board: 7 terminals in good condition
 Wires: Good
 Other: _____

Test Box: _____
 Terminal Board: _____
 Wires: _____
 Other: _____
 Comments/Recommendations: It appears wire connected to terminal (I) is broken underground.
