HO-1170
Hennessy Farm
11800 Triadelphia Road
Private

Maryland Historical Trust Maryland Inventory of Historic Properties Form

Inventory No. HO-1170

historic Hennessy Farm

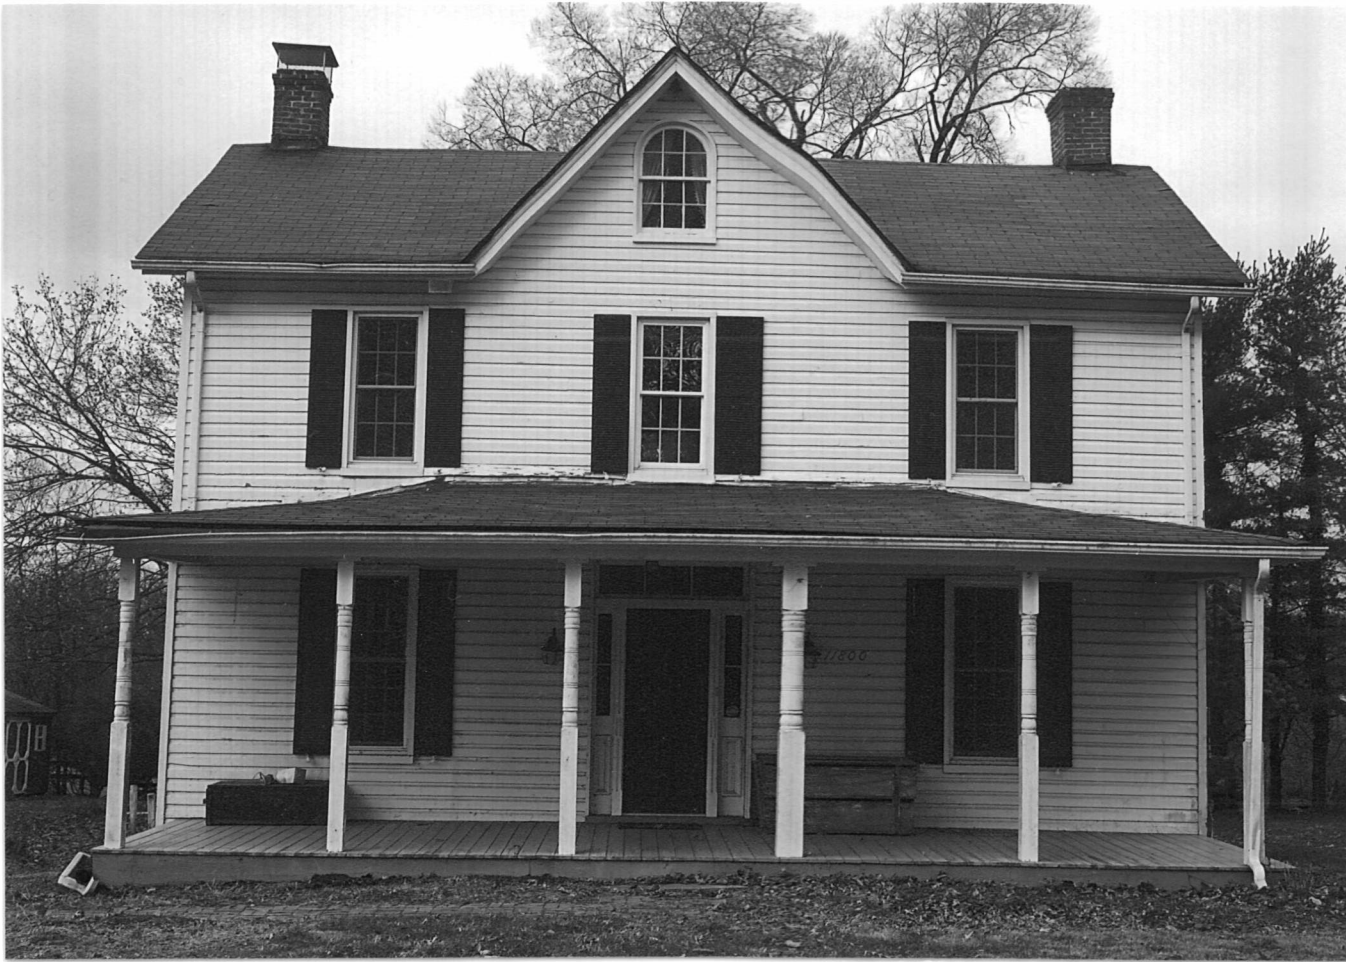
HO-1170
Hennessy Farm
11800 Triadelphia Road
Howard county, Maryland
Ken Short, Photographer
11-27-2018
MD SHPO
House, Southeast elevation
1/10

The house is a 2 ½-story, three-bay by two-bay frame structure with German siding, a rubble stone foundation, and a gable roof with a northeast-southwest ridge and asphalt shingles. There is an interior brick chimney on both gable ends. There is an ell on the northwest, set to the north, that is two stories and one bay by one bay. It has the same materials as the main block and the gable roof has a northwest-southeast ridge. There is an interior brick chimney on the northwest end of the ell. Attached to the ell on the northwest is a 1 ½-story addition that is one bay by one bay, with the same materials as the rest of the house, and with an exterior brick chimney on the northwest.

HO-1170_2018-11-27_01
House, southeast elevation

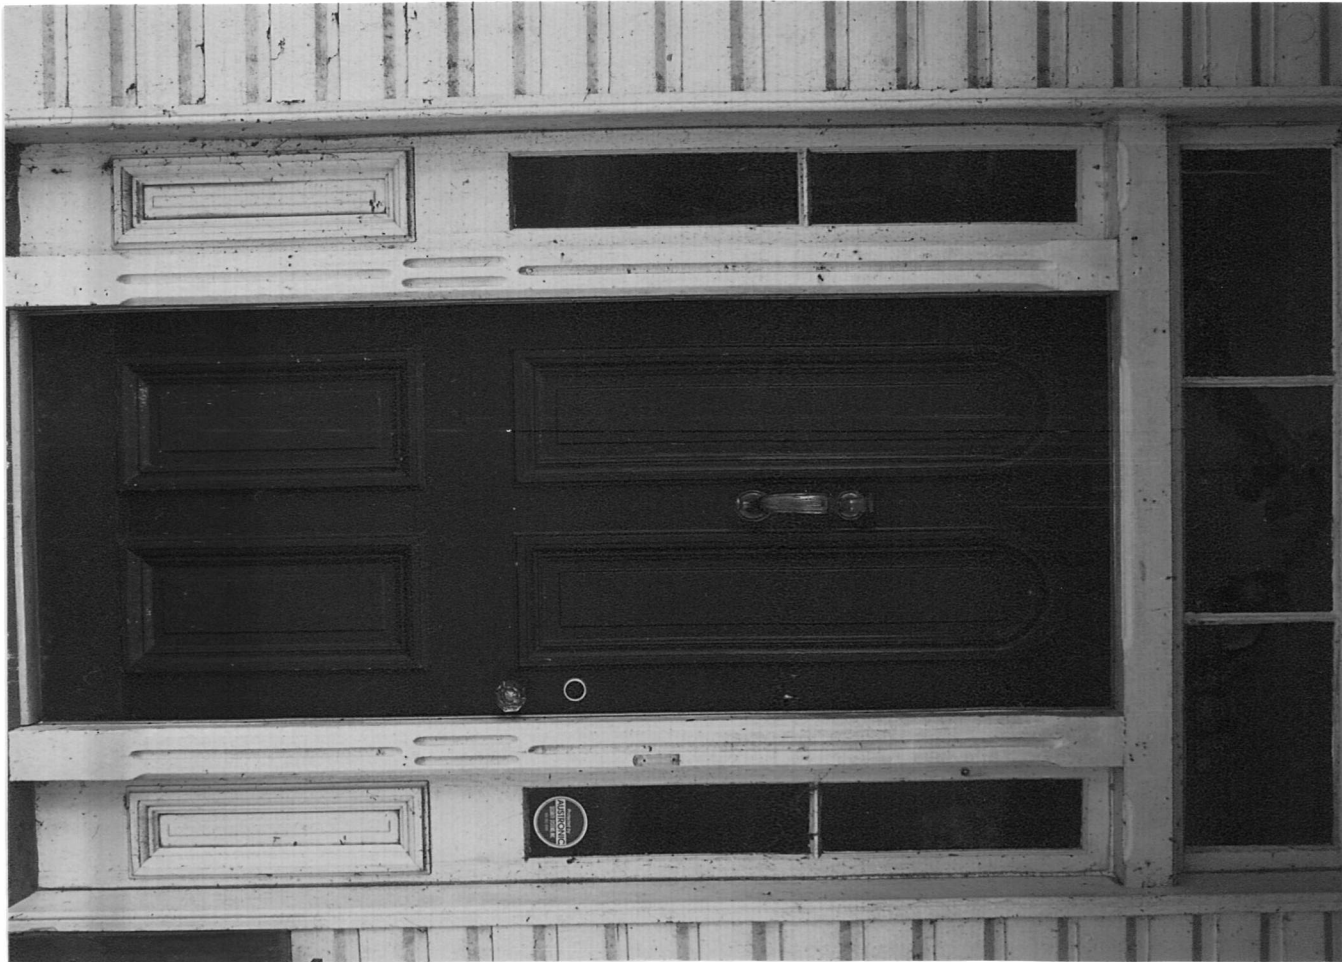
HO-1170
Hennessy Farm
11800 Triadelphia Road
Howard county, Maryland
Ken Short, Photographer
11-27-2018
MD SHPO
House, Southeast Elevation,
Front Door
2/10

HO-1170_2018-11-27_02
House, southeast elevation, front door

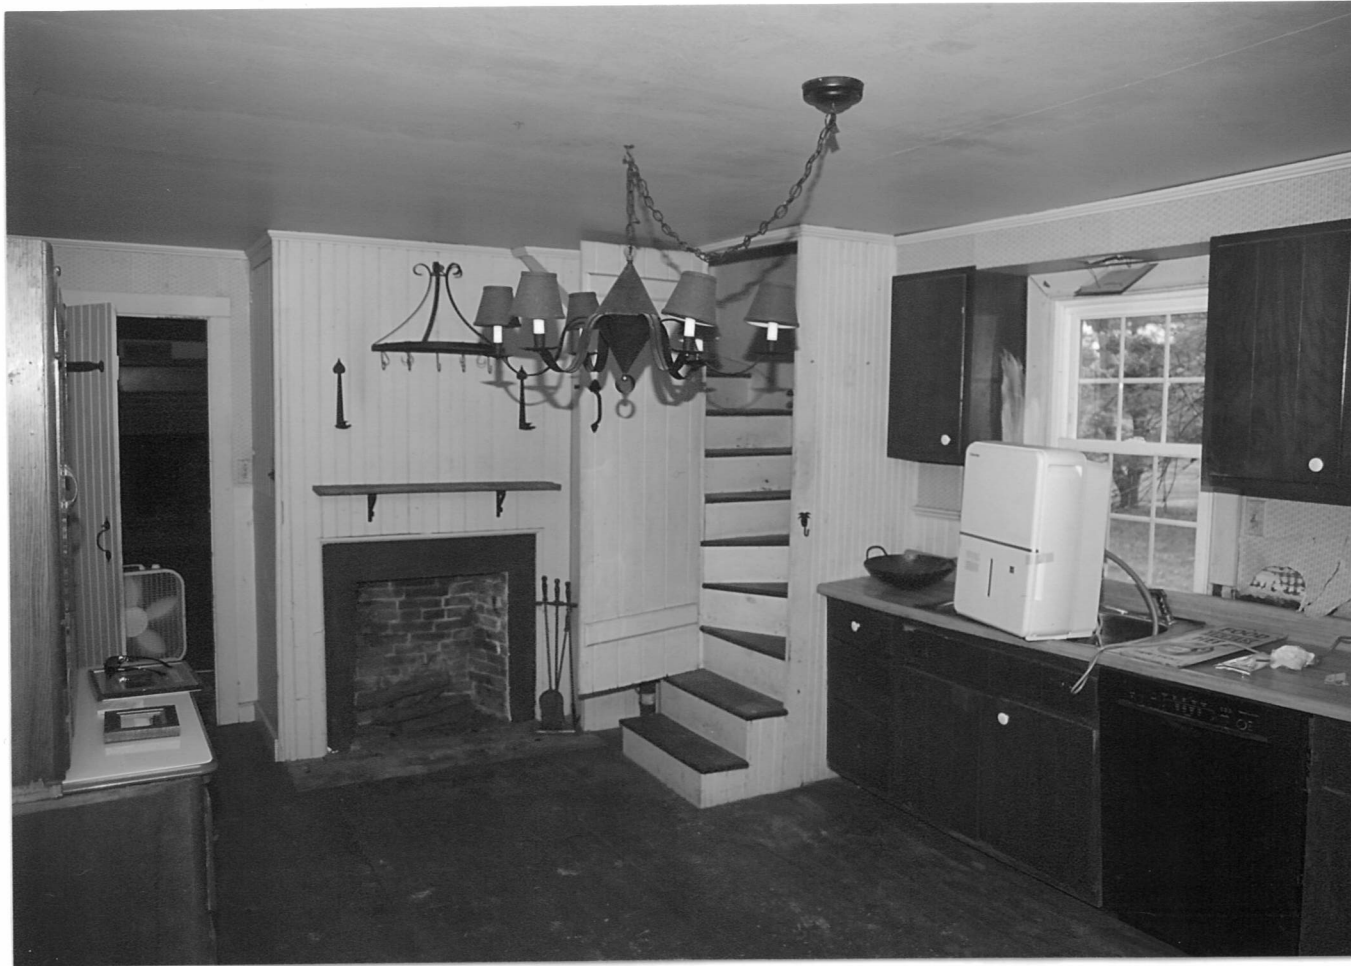
HO-1170
Hennessy Farm
11800 Triadelphia Road
Howard County, Maryland
Ken Short, Photographer
11-27-2018
MD STIPO
House, ell room, view north
7/10

HO-1170_2018-11-27_07
House, ell room, view north

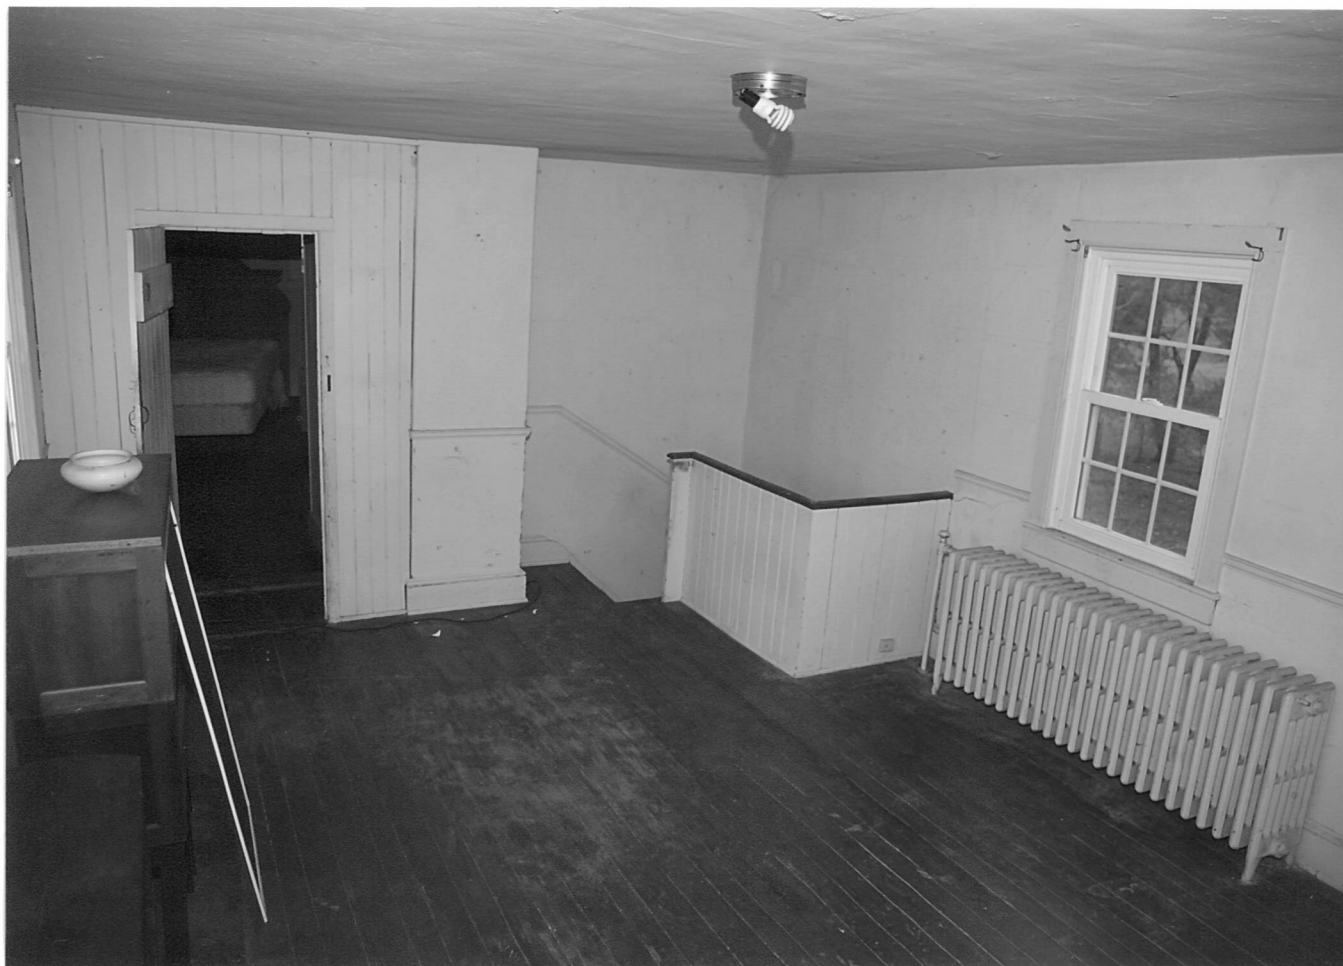
HO-1170
Hennessy Farm
11800 Triadelphia Road
Howard County, Maryland
Ken Short, Photographer
11-27-2018
MD STIPO
House, ell chamber, view north
8/10

HO-1170_2018-11-27_08
House, ell chamber, view north
