National Register of Historic Places  
Registration Form

historic name BRICK HOUSE ON THE PIKE (preferred)

street & number 9564 Baltimore National Pike N/A  not for publication

The building traditionally known as the Brick House on the Pike is a large two-story, side-passage, double-pile plan house constructed c. 1817, located on the north side of Baltimore National Pike, west of Ellicott City in Howard County, Maryland. A service wing extending from the east gable incorporates an earlier (possibly mid-18th century) structure; the wing was raised to 1½ stories in the early twentieth century. The interior of the main block remains essentially unaltered, with the majority of its original Federal style decorative detailing intact, including an arch in the stair passage with reeded columns and punch-and-gouge work detailing, a highly ornamental open-well stair, molded plaster cornices, mantels, six-panel doors, door and window architrave trim, and baseboards. Also on the property and contemporary with the main house are a stone stable/carriage house and a stone foundation, probably that of an ice house; in addition, there are three board-and-batten outbuildings dating from the late

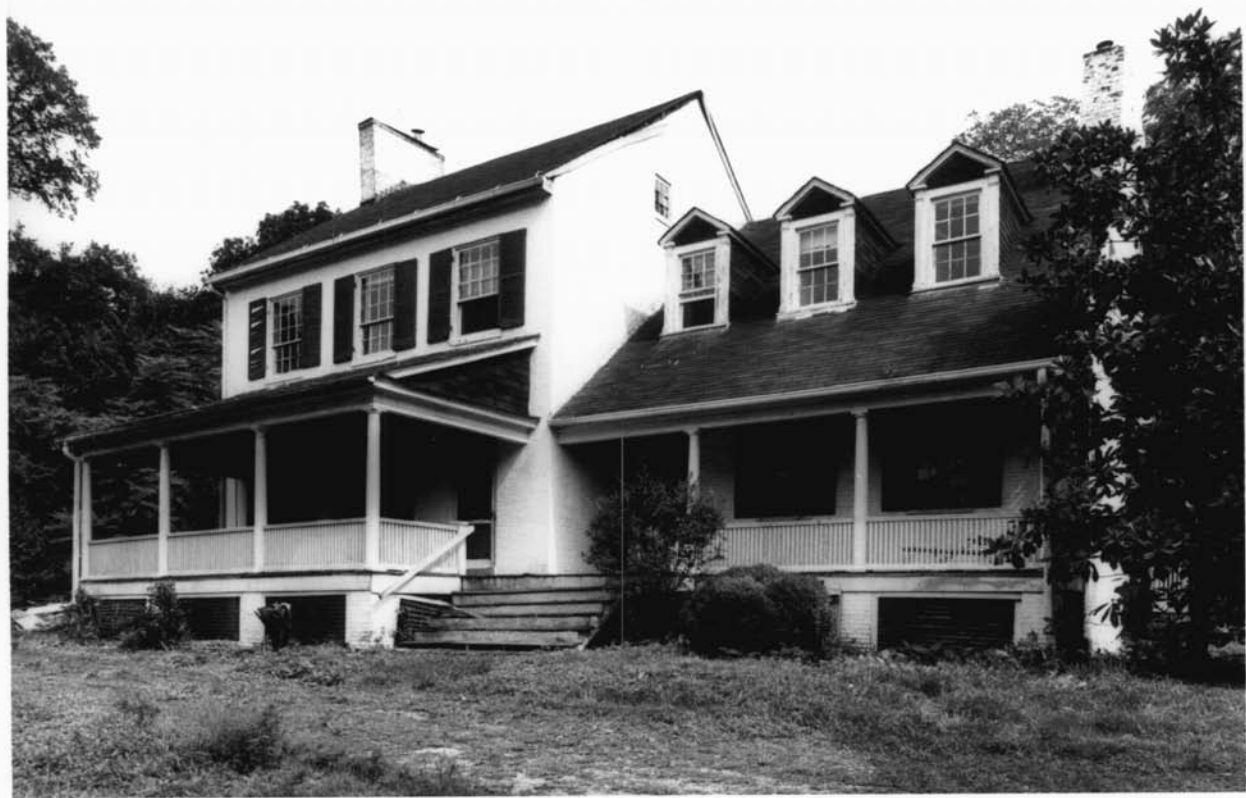
#1 OF 7

VIEW FROM SE

The Brick House on the Pike is sited atop a knoll facing south toward Baltimore National Pike. It is a large gable-roofed, brick dwelling, comprising three major periods of construction. In its present configuration, it comprises a two-story main block with a side-passage, double-pile plan; a 1½ story wing, two rooms deep, extends to the east. The south room of the present east wing appears to be the earliest portion, possibly dating from the mid-eighteenth century. This room measures approximately 26' wide by 17' deep, and likely stood as an independent structure, perhaps a 1½ story hall/parlor plan dwelling, when Caleb Dorsey acquired the property in the early 1770s. About 1817, the main block was added against the west gable of the earlier building; it is likely that the wing also was increased in depth at that time to provide a kitchen and service area. About 1907, the wing was raised in height, creating several bedrooms and a bath in the half-story, and a broad porch was added across the south facade.

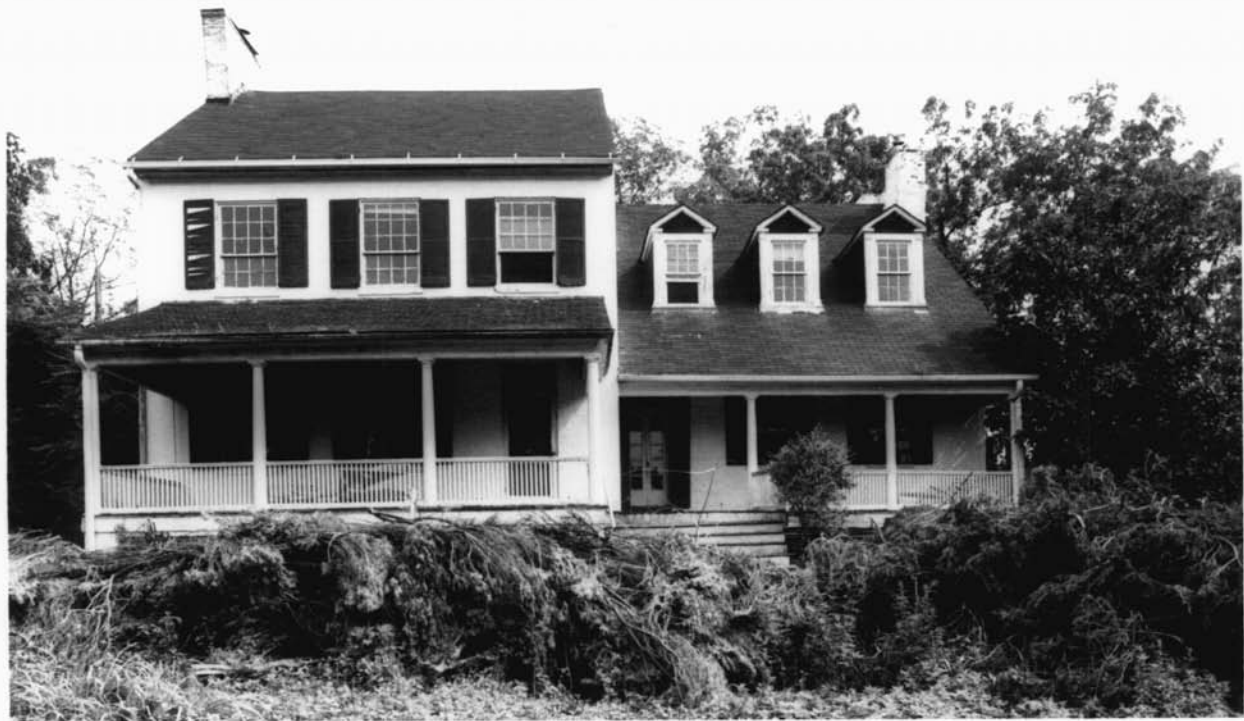
# 2 OF 7

SOUTH FACADE

The south facade of the main block is three bays wide, with the principal entrance located in the easternmost bay. The entrance comprises a six-panel door in a paneled jamb. The panels have shallow fields and quarter-round cutouts at the corners, a familiar characteristic of the Federal style in the region. Panel molds have a cyma recta profile. The door is surmounted by a fanlight featuring exceptionally refined tracery executed in metal. The threshold is cut stone. The remaining ground-floor bays hold large 12/12 windows in openings with multi-coursed jack arches and cut stone sills. The upper story has three 12/12 windows, somewhat smaller than those below, with simple one-brick jack arches and cut stone sills. An elaborate gougework bed mold enriches the boxed cornice. The ground floor of the south facade is spanned by a broad porch resting on brick piers; Colonial Revival columns support the shed roof, which is enriched with a boxed cornice with bed and crown molds.

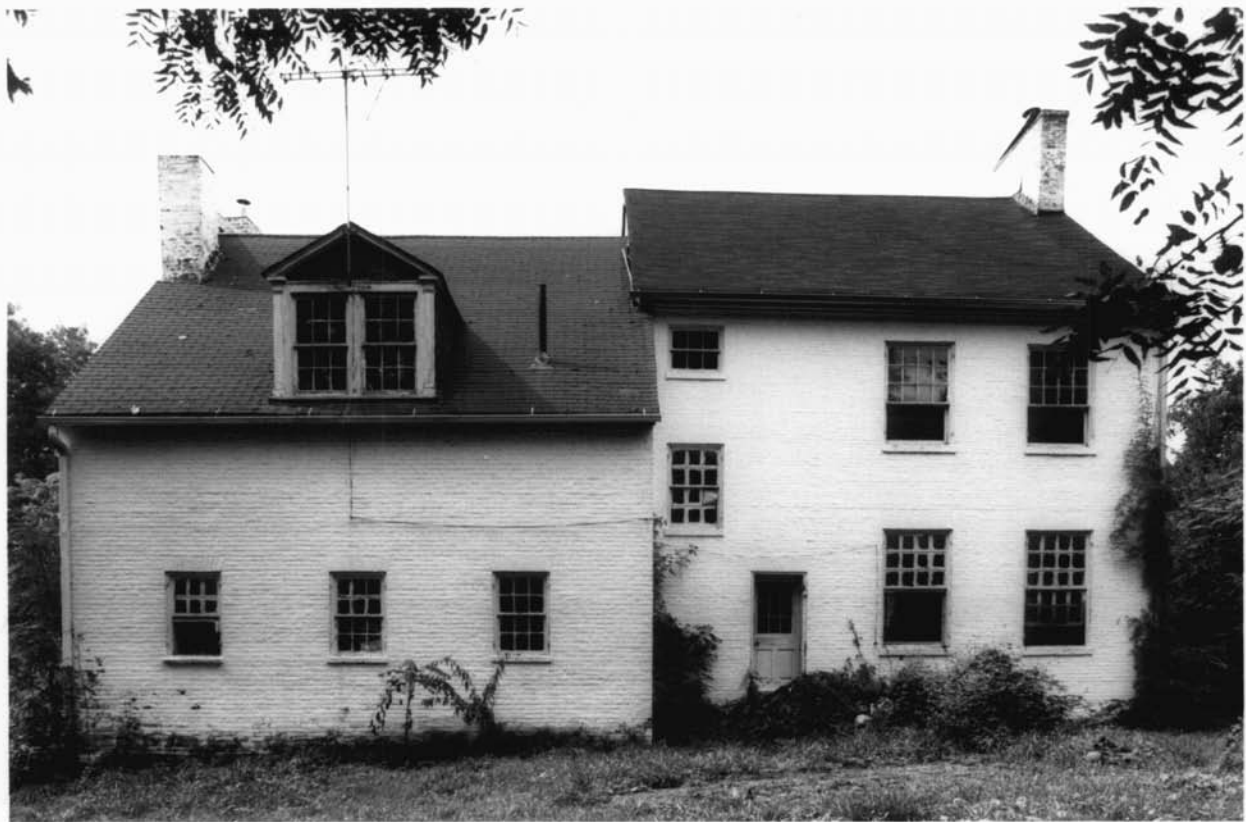
# 3 OF 7

NORTH ELEVATION

The north elevation of the main block is three bays wide, laid in five-course bond. There is an entrance in the east bay holding an unusual and apparently original door with two fielded panels below the lock rail and nine lights of glazing above. This door is set within a paneled jamb detailed in a manner similar to that of the front (south) entrance, but without the quarter-round cutouts in the corners of the panels. The remaining ground-floor bays (and the second-story bays above them) hold 12/12 sash in openings with single-brick jack arches and stone sills. The east bay has a 6/6 window at the level of the stair landing between the first and second stories, and a 3/3 sash at the landing between the second floor and the attic.

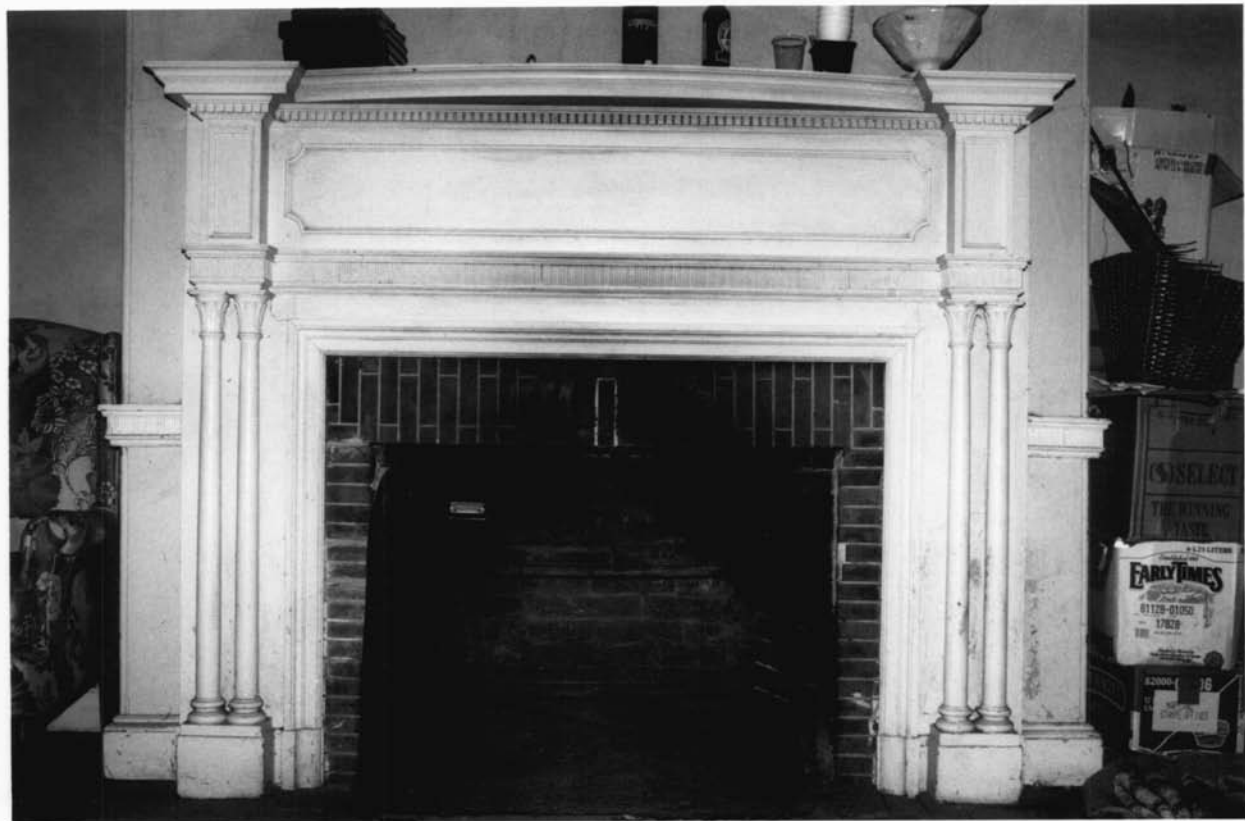
# 4 OF 7

MANTEL, SW ROOM

The southwest (front) room features decorative detailing comparable in quality and complexity to that of the stair passage. An elaborate molded plaster cornice, similar to that in the passage, encircles the ceiling. Six-panel doors have fielded panels with a cyma recta panel mold; they retain early hardware, including five-knuckle hinges and mortise locks. Architraves have a Greek ogee/astragal backband, broken field enriched with an ogee, and a torus at the edge; baseboards have Greek ogee/astragal caps; chair rail is identical to that in the passage. Windows are framed with paneled jambs, with panels below the sills. The focus of the room is an elaborate mantel on the west wall, featuring paired freestanding columns supporting paneled corner blocks and a bowed shelf. The columns have capitals with an abstracted foliate motif which is Egyptian in feeling. The edge of the shelf is treated with a cove/ogee molding; the bed molding is enriched with a row of dentils, with an ogee molding above and below. The frieze is decorated with applied molding, creating a rectangular panel with quarter-round cutout corners; a reeded band appears below the frieze. The fireplace opening is framed by cove/ovolo backband.

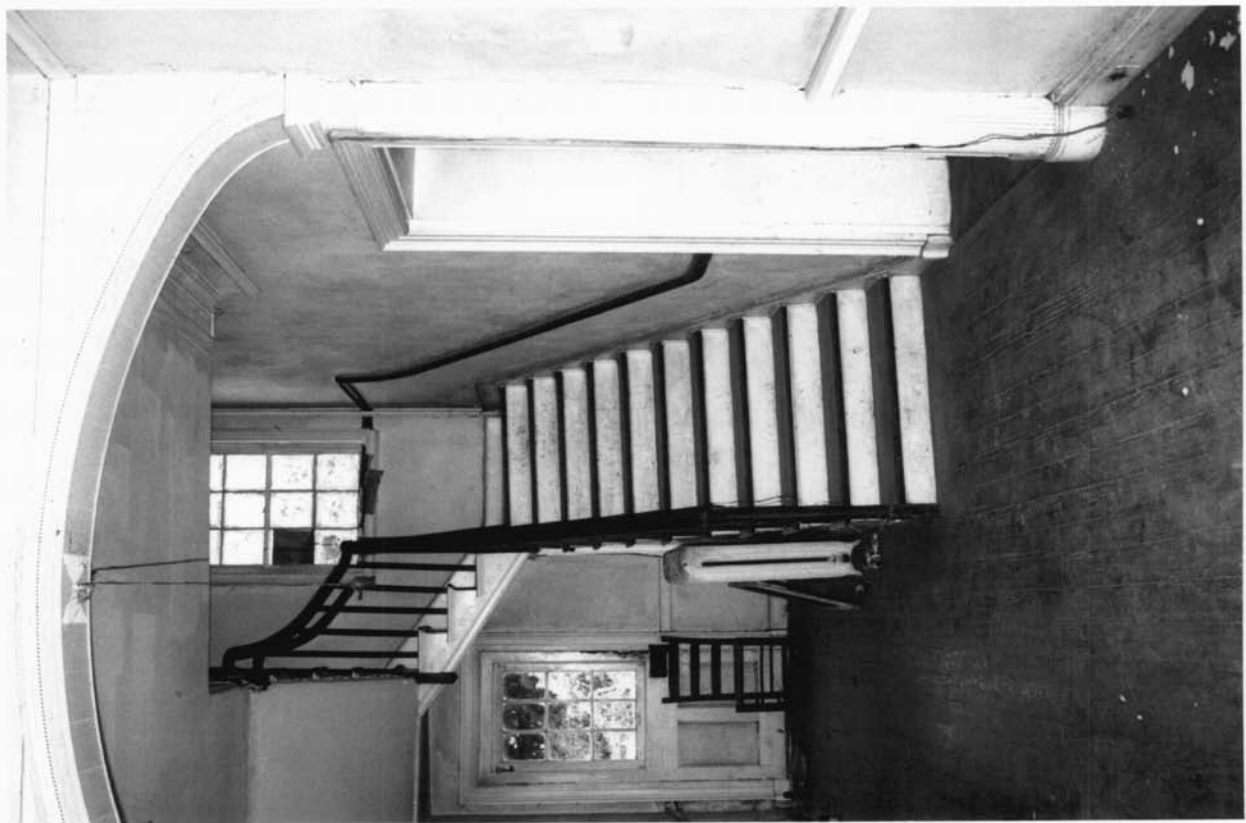
#5 OF 7

STAIR PASSAGE, VIEW FROM SOUTH

The south entrance opens into a formal stair passage which runs the full depth of the house. This space is richly detailed, with complex architrave, chair rail, and baseboard trim, a molded plaster cornice, and an outstanding central arch. The woodwork is exceptionally elaborate and well-crafted, and combines several molding profiles and elements associated with the Federal style. The architraves are enriched with a form of cove/astragal backband, a broken field with a small ogee at the transition, and a bold torus at the edge. The chair rail has an ogee/astragal shelf, a reeded field, and a Greek ogee/astragal base. Baseboards are capped with a cove molding above a torus. The central arch is supported on reeded columns; the column capitals and the fascia of the arch are detailed with punch- and gougework; the fascia is finished with a cove/astragal backband, and the soffit is reeded with a complex central panel. The three-flight, open-well stair rises against the east wall; it features a slender turned newel, rectangular balusters, and a mushroom-profile handrail (all of walnut or mahogany), scrolled step ends, and fielded paneling in the spandrel. A six-paneled door under the stair provides access to the basement.

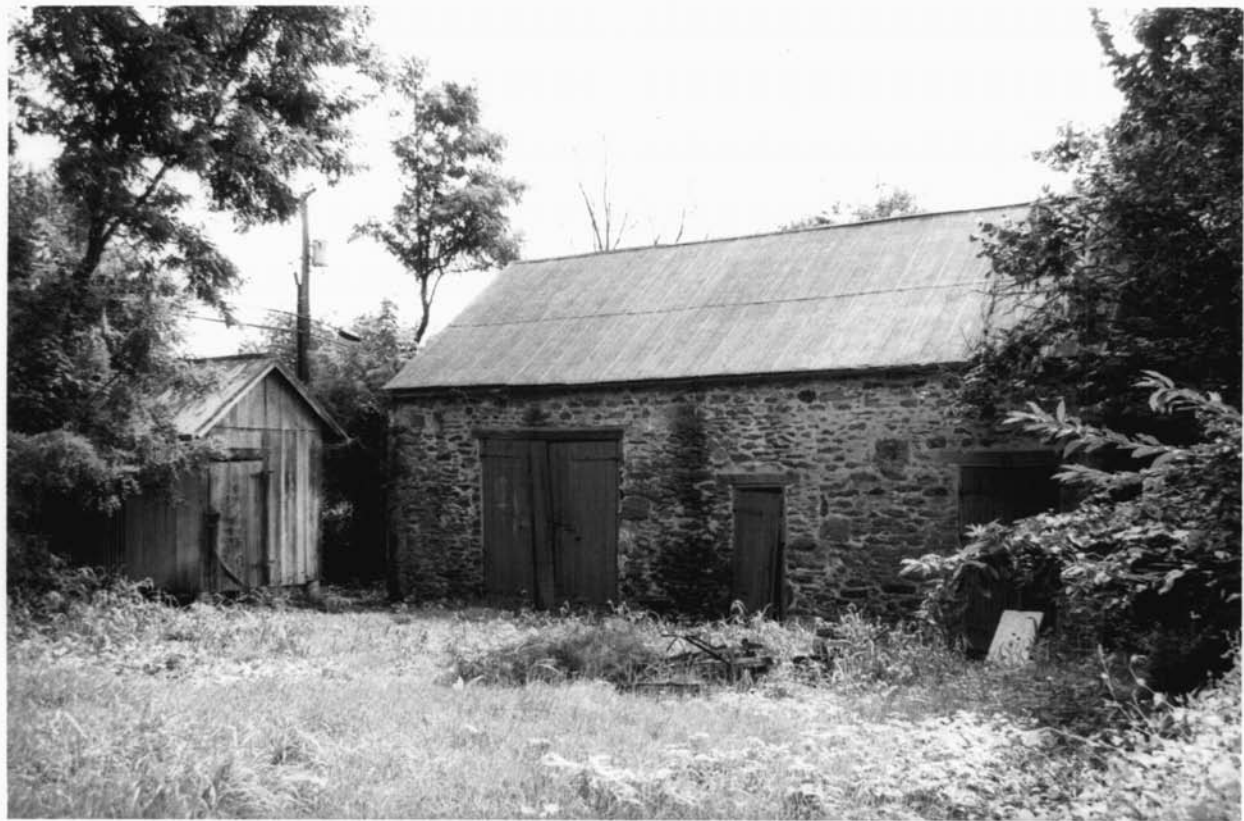
# 6 OF 7

STONE STABLE AND FRAME GRANARY | CORN CRIB  
VIEW FROM SW

The property retains several outbuildings, including a stone stable/carriage house located about 50 yards east of the dwelling; built of uncoursed rubble with prominent quoins, this building is probably contemporaneous with the house.

Three frame outbuildings of the late nineteenth or early twentieth century complete the grouping. Clad in circular-sawn board-and-batten siding secured with wire nails, these include a combination granary and corncrib adjacent to the stable, a garage or wagon shed near the northeast corner of the house, and a small gable-roofed shed northwest of the garage.
