Joseph and Virgile McAllister House
3675 College Avenue, Ellicott City
Private

Maryland Historical Trust Maryland Inventory of Historic Properties Form

Inventory No. HO-1003

historic Joseph & Virgile McAllister House

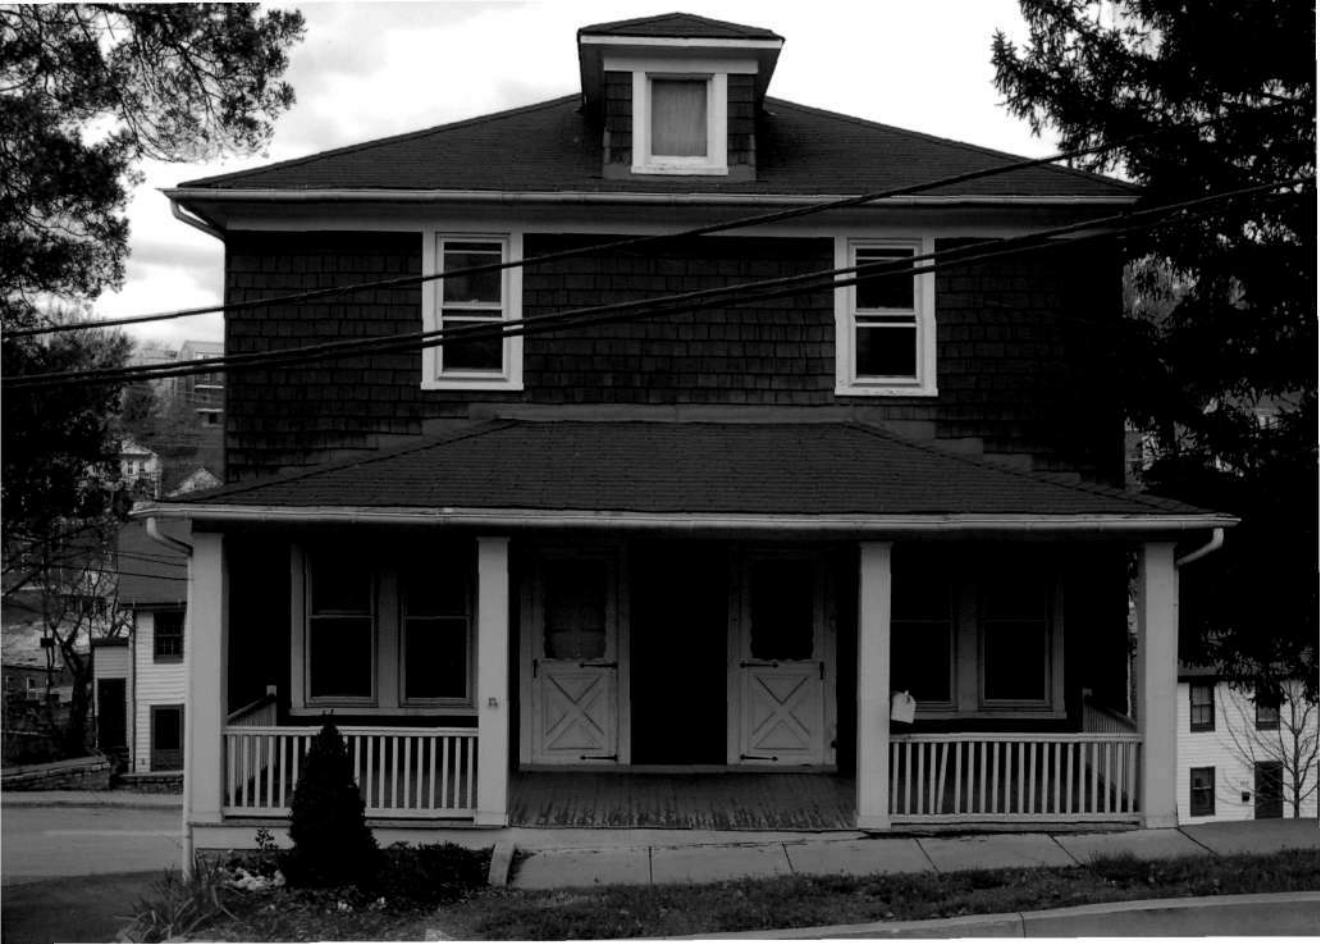
1/4

HO-1003_2009-12-03_01
South elevation

South Elevation

On the south elevation the first story has two center doors, neither one of which appears to be original, and they both have a fanlight of four lights at the top of the door and four panels below the fanlight. The bottom two panels are very tall. There are paired one-over-one double hung sash to each side of these doors. All of the openings on the house have head-cut trim. There is a one-story hipped-roof porch with four square boxed posts, with square balusters and a moulded handrail between the posts. The porch has a tongue-and-grooved wood deck and bead-board on the soffit. The second story has two one-over-one sash. There is a box cornice with a plain fascia board below it. There is a hipped-roof dormer that is covered with wood shingles and has a one-light sash. The east elevation, on the foundation, has a short boarded-up window in the south bay and a typical one-over-one sash in the north bay. The first story has a one-over-one sash in the south bay and just north of center is a patch in the wall with new shingles. This patch extends from the foundation to the first story ceiling and is approximately 5 feet wide. The second story also has a one-over-one sash in the south bay. The center and north bays have four three-light sash with jalousies outside of them. These sash are short and are set high on the wall.

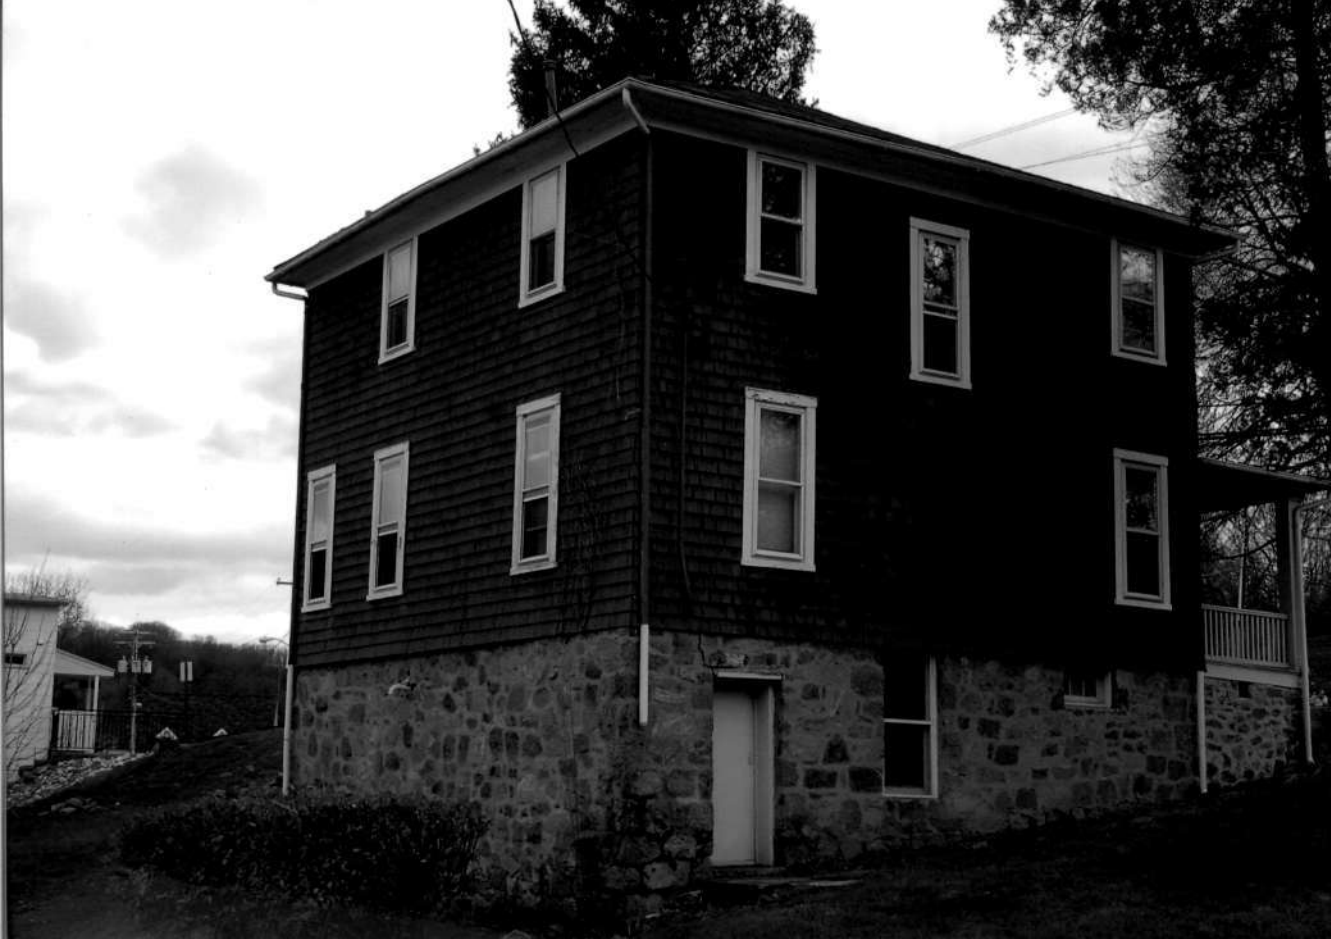
2/4

HO-1003_2009-12-03_02
North & west elevations

North & West Elevations

On the north elevation the foundation has no openings. The first story has a one-over-one sash in the east, east-center, and west bays. The second story has a similar sash in the east-center and west bays. On the west elevation the foundation has a flush door set in an original opening in the north bay. In the center is a large one-over-one sash, while the south bay has a three-light casement. The first and second stories each have a one-over-one sash in both the north and south bays. There is a one-over-one sash in the center, set between the first and second stories.

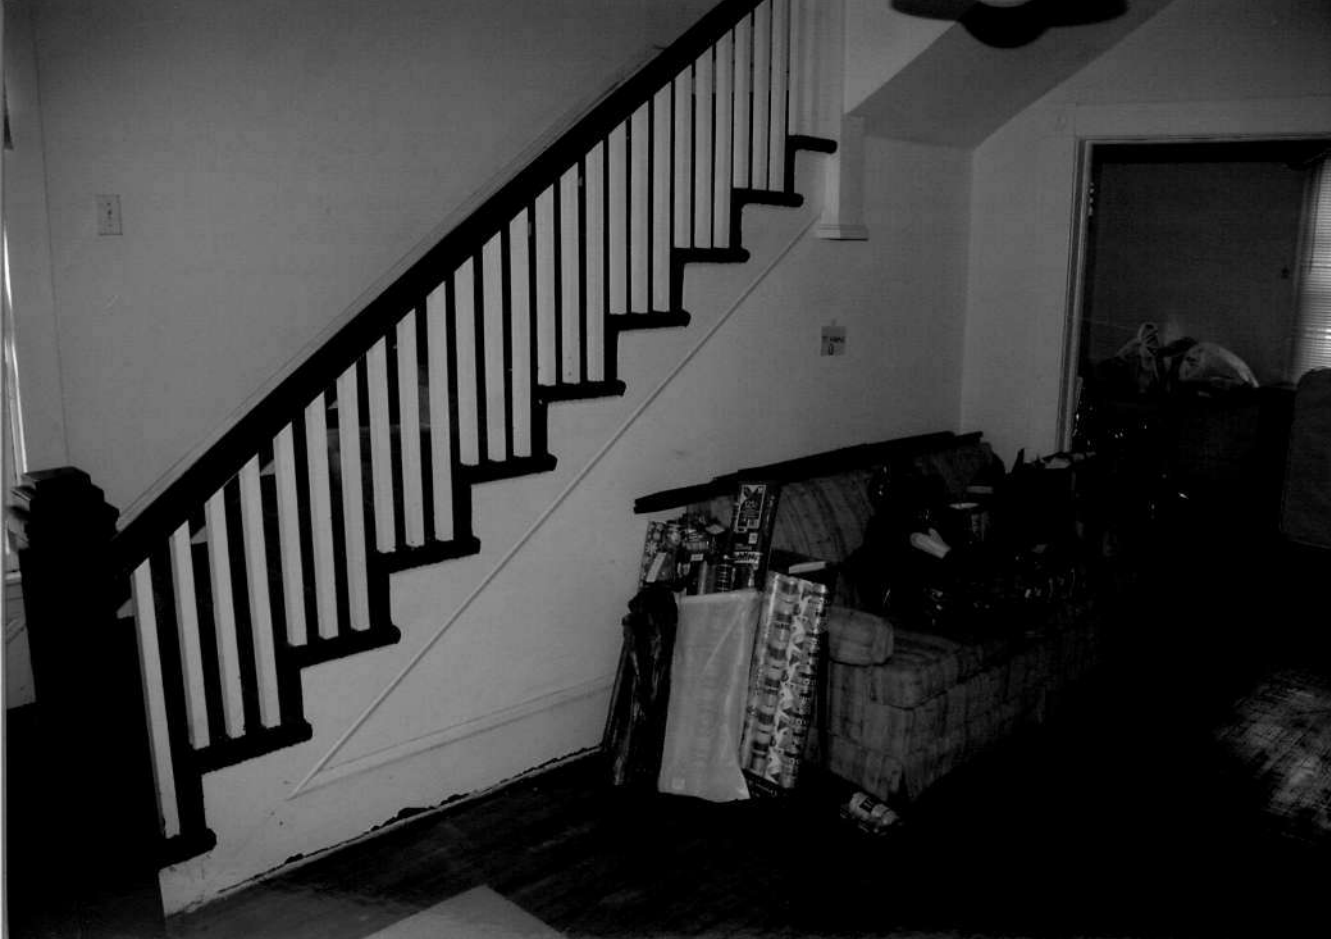
3/4

HO-1003_2009-12-03_03
Interior, southwest room, vw. northwest

Interior, Southwest room, view northwest

The first story has rooms in the northeast, northwest, southeast, and southwest corners, with two small rooms off the east side of the northeast room. The flooring throughout is 2 ½-inch tongue-and-grooved pine that runs north-south. The baseboard has a quirked ogee. The architrave is plain with bulls-eye corner blocks, and the trim was originally naturally varnished and was dark. The walls have plaster on lath. The southwest room has a dog-leg stair on the west side that ascends to the north. It has an open stringer and square newel post with stacked blocks on top of it. There is a moulded handrail that matches the porch railing, and similar square balusters. The north elevation has a wide opening for double doors that are now stored in the basement. These doors have fifteen lights each of pressed glass. There is also a doorway on the east elevation that leads to the southeast room. The northwest room has a doorway on the east that leads to the northeast room. The northeast room is a modern kitchen with a pantry and bathroom on the east side. The doors to these latter two rather small rooms have five lying panels. The rest of the doors are stored in the basement, but match these. The doors have butt hinges with ball finials and mortise locks. The southeast room has carpeting on top of a foam padding that is glued down to the floor. There is paneling on the walls, over top of dry wall. It appears that the lath and plaster have been removed from this wall. There are doors on the west and north elevations leading to the other rooms, and a door on the south to the exterior that appears to be an original opening.

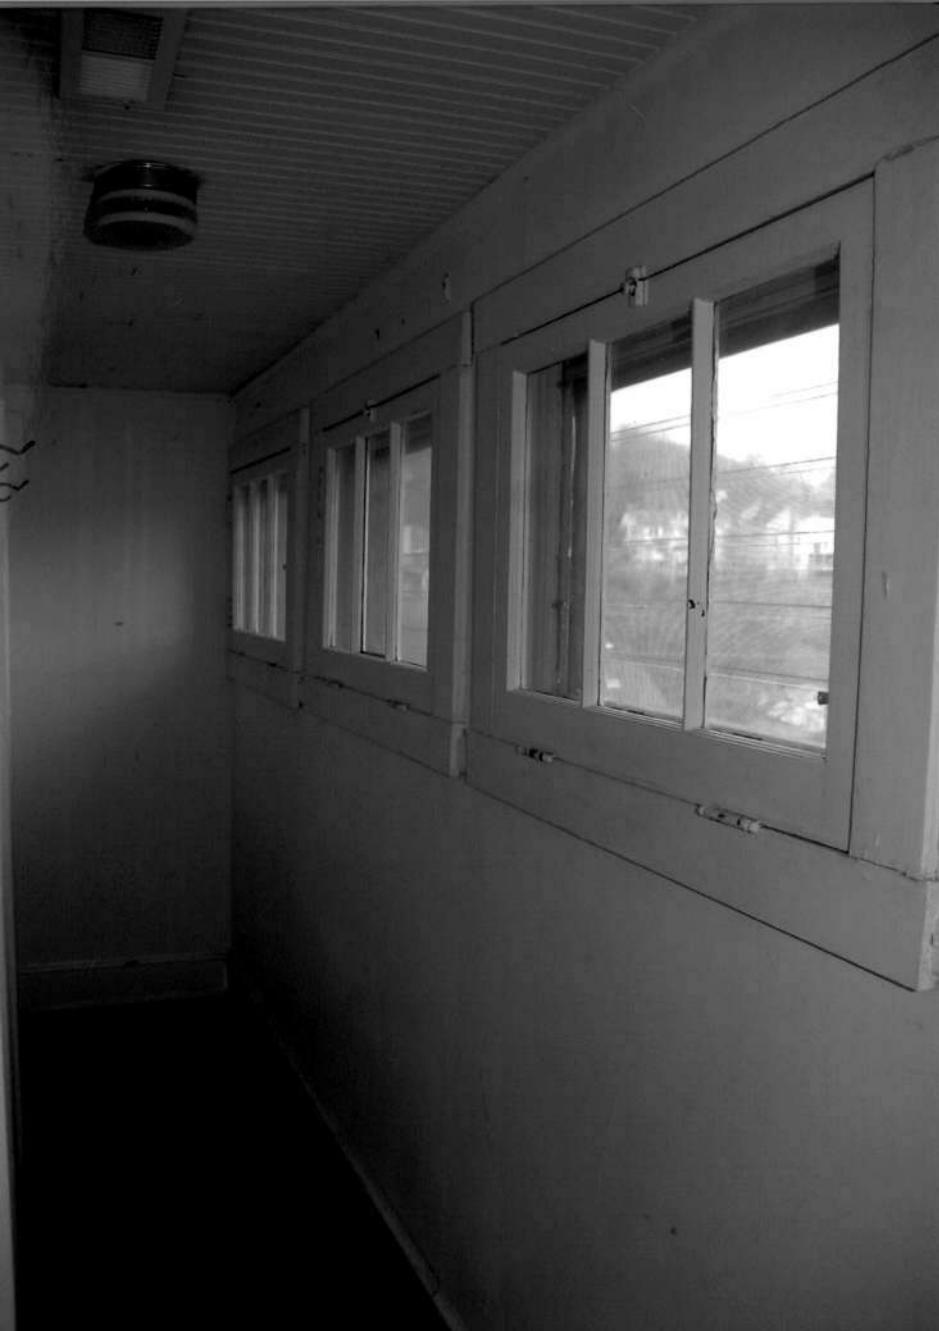
4/4

HO-1003_2009-12-03_04
Interior, northeast chamber, vw. north

Interior, northeast Chamber, view north

The second story has a passage that runs east-west, with two rooms to the south, one in the northwest corner, back-to-back bathrooms in the center, and a sleeping porch in the northeast corner. The trim and doors match those of the first story. The bathrooms have all new fixtures. There is a door at the east end of the passage, leading to the sleeping porch, that has one light of pebble glass over two lying panels. It is hung on butt hinges with ball finials and has a mortise lock that dates to the circa 1920s. This door appears to be original. The sleeping porch has four three-light casement windows on the east elevation, all of which were originally hinged at the bottom, but the end windows have now had their hinges shifted to the side. The ceiling is bead-board. The southeast end of the sleeping porch has 2 ½-

inch pine flooring that runs east-west. The northeast end has plywood infill on the floor beneath the carpet. The southeast chamber has a closet in the northeast that has a typical door. The southwest chamber has a closet on the west wall, over top of the stairs, also with a typical door. The northwest chamber does not have a closet, but connects to a bathroom on the east, at the north end. This bathroom has a full window on the north elevation. All of the window sash are hung on cords.
