HO-150  
The Lorenz House  
Elkridge  
Private

circa 1832

INVENTORY FORM FOR STATE HISTORIC SITES SURVEY

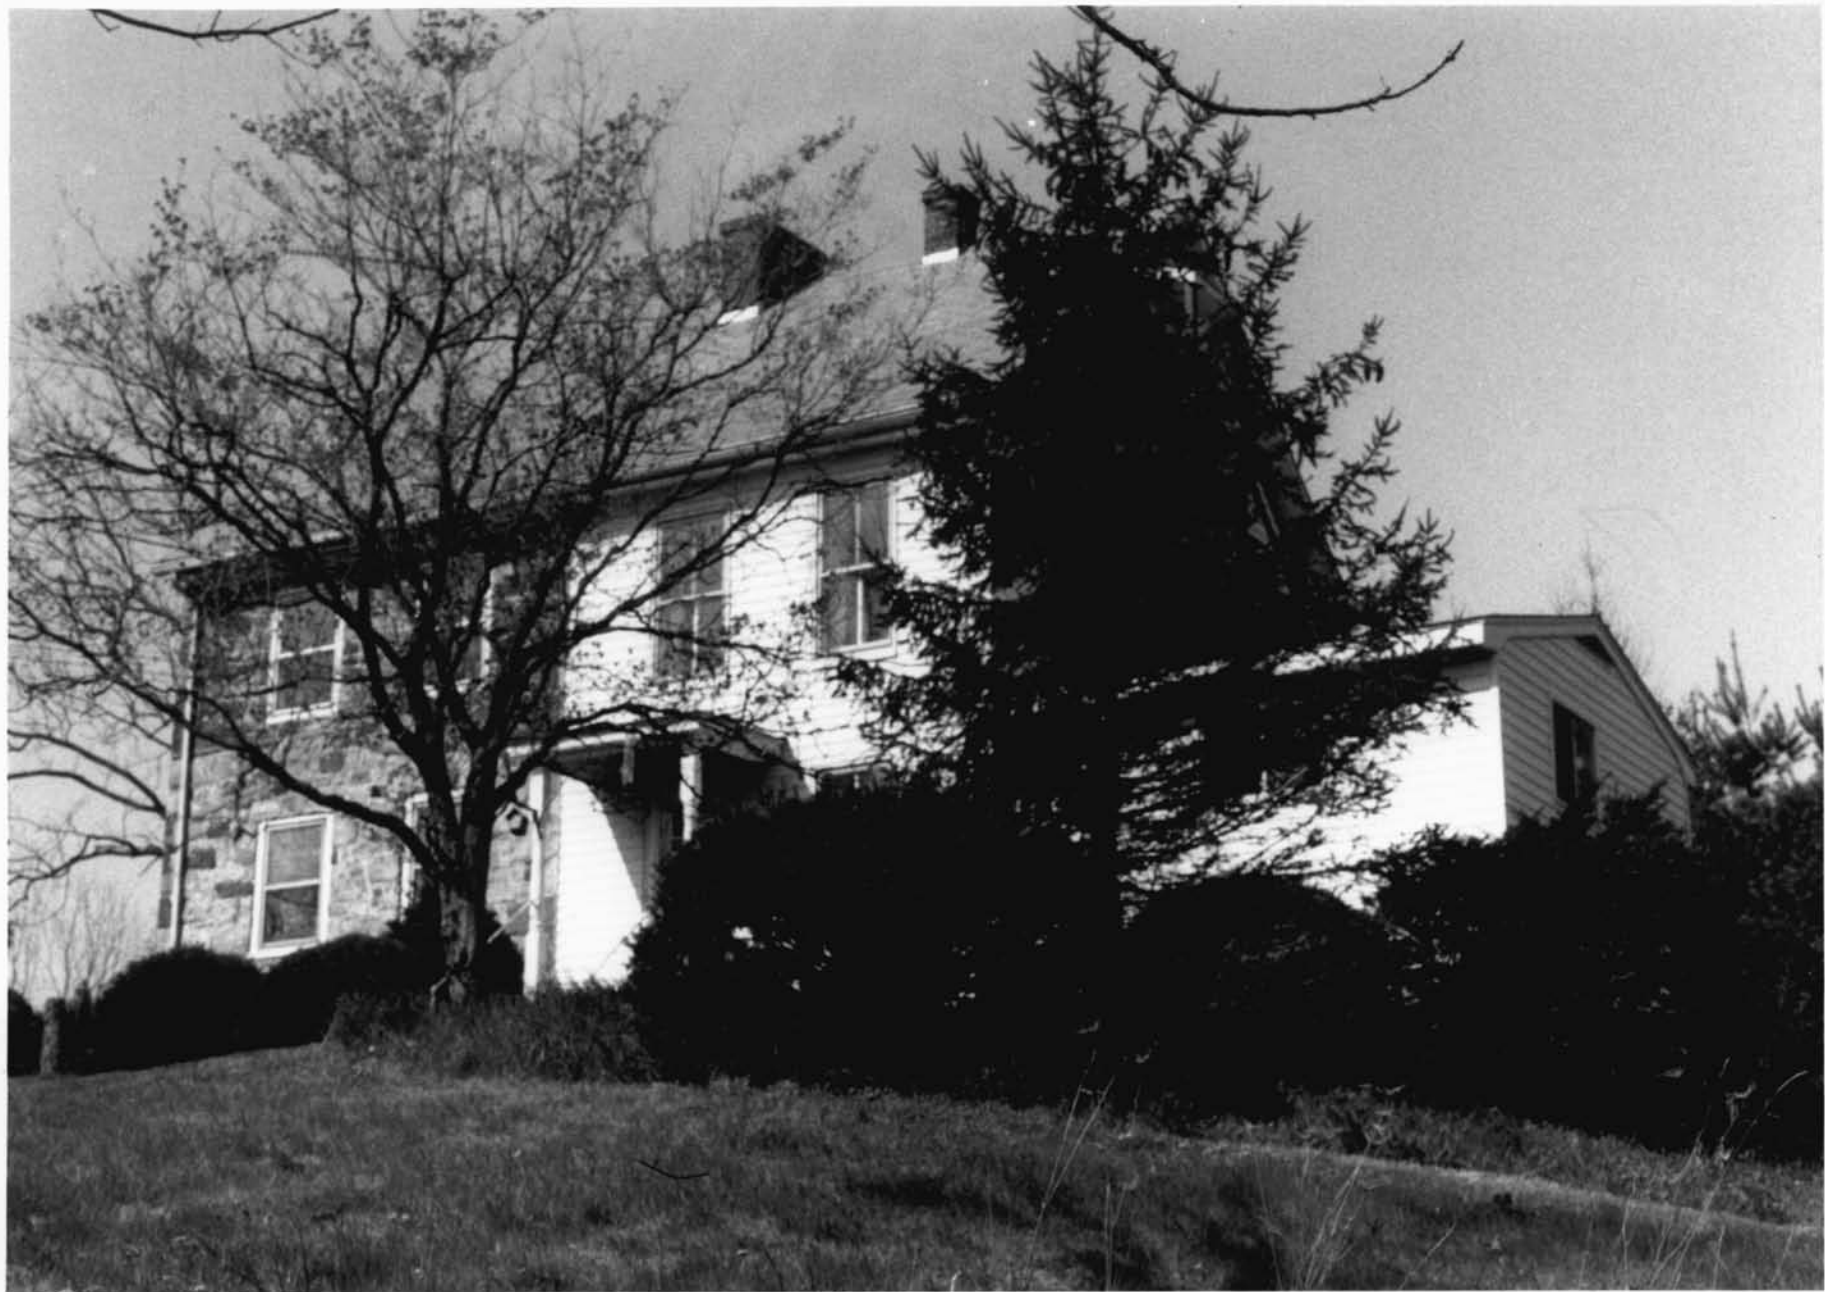
Hb-150  
The LORENZ HOUSE  
EAST

The original stone house is a two bay wide, one room deep, two story high, gabled roof (running north-south) fieldstone house, resting on a stone foundation, with wide brick chimney centered into its north wall. It features stone quoining and flat stone lintels with primitive keystones. A rectangular, one light entrance door is centered into its south wall, surmounted by a flat stone lintel with primitive Keystone. Two tall, rectangular attic windows rest above. The east and west elevations are almost identical, holding two first and second floor rectangular double-hung windows, holding six-over-one lights, except that the west elevation does not have a first floor north bay window.

A two bay wide, two bay deep, two story high, gabled roof (running north-south) frame addition, resting on a stone foundation and holding a square, brick, central chimney was constructed in 1907 along the north wall of the original stone dwelling house. It features a cross paneled, east entrance door in the south bay, fronted by a flat roofed stoop, composed of four poured-in-place concrete steps and landing.

Fenestration for this section of the house is vertically aligned and proportionally scaled. Windows are double-hung, holding two-over-two lights.
