HO-234

The Zubovic Farmhouse
Mount Airy
Private

INVENTORY FORM FOR STATE HISTORIC SITES SURVEY

The Zubovic Farm House

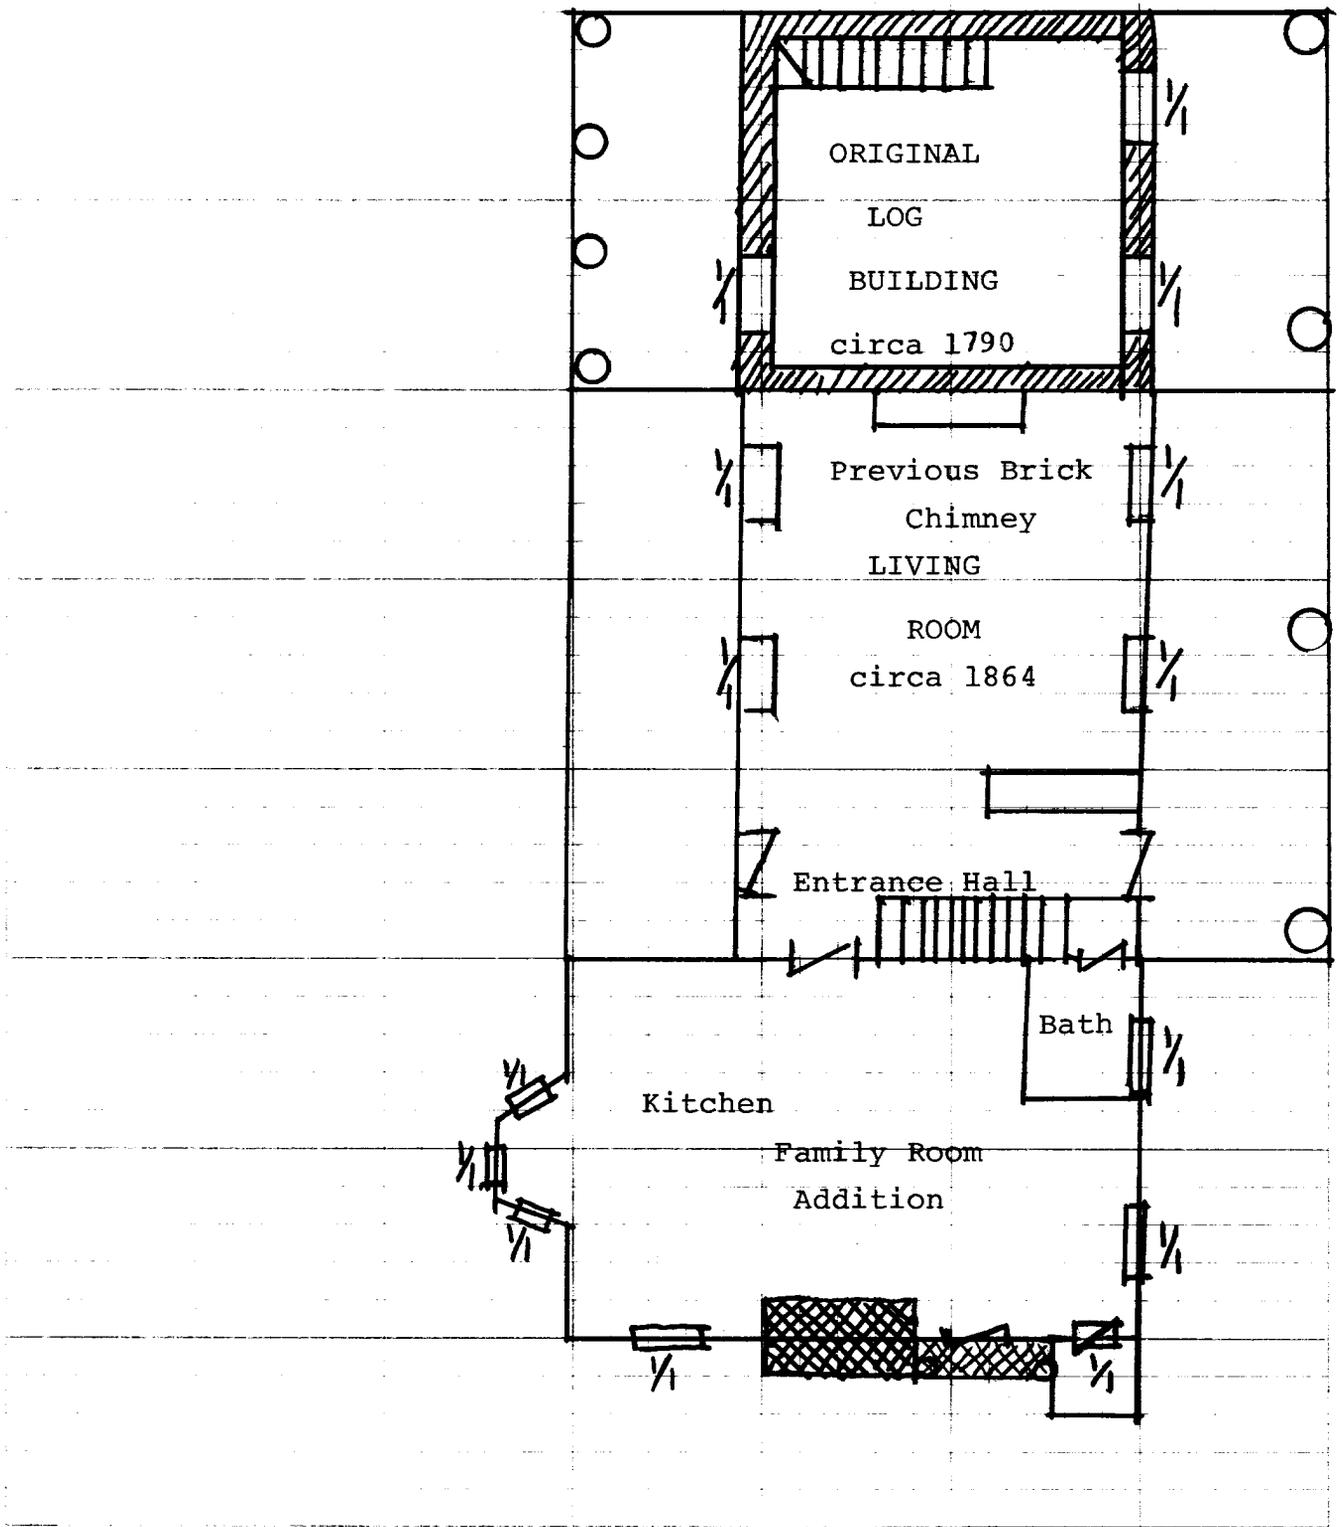
Figure 1
 HO-234
 The Zubovic Farmhouse
 First Floor Plan

The Central Section

One very wide brick chimney, centered on the south wall of the central section of the house was removed by Mr. Zubovic, since the bricks were soft and crumbling. This chimney held a fireplace to heat this central section. Wide, random width, six to eight inch floors are found throughout the first and second floors of the central section of the building, covered by modern hardwood floors.

The original floor plan for this section of the house is difficult to ascertain for several partitions were added by the Burdette family, during their hundred year tenure, chopping up this section of the house into several small rooms. When restoring and modernizing the house, the entire downstairs was opened up, creating one very large living room. The east and west, south bay entrances were replaced by rectangular, double-hung windows, matching those in the central bays of the east and west walls. This may very well have been the original floor plan for the house, with entrance hall occupying the north bay. The north bay, east and west entrances remain, with a closet partition wall constructed on the south side of the west entrance resulting in 1) Space for a coat closet and 2) An enclosed entrance hall area, which opens up into the spacious living room. The original staircase, running up the north wall of this section of the house was modernized by the creation of a large square, first floor, landing step, replacing previous triangular steps and the addition of a handsome, mid-nineteenth century, walnut knewel post and oak bannister, which runs up a short distance of the stairwell, until it becomes an enclosed staircase.

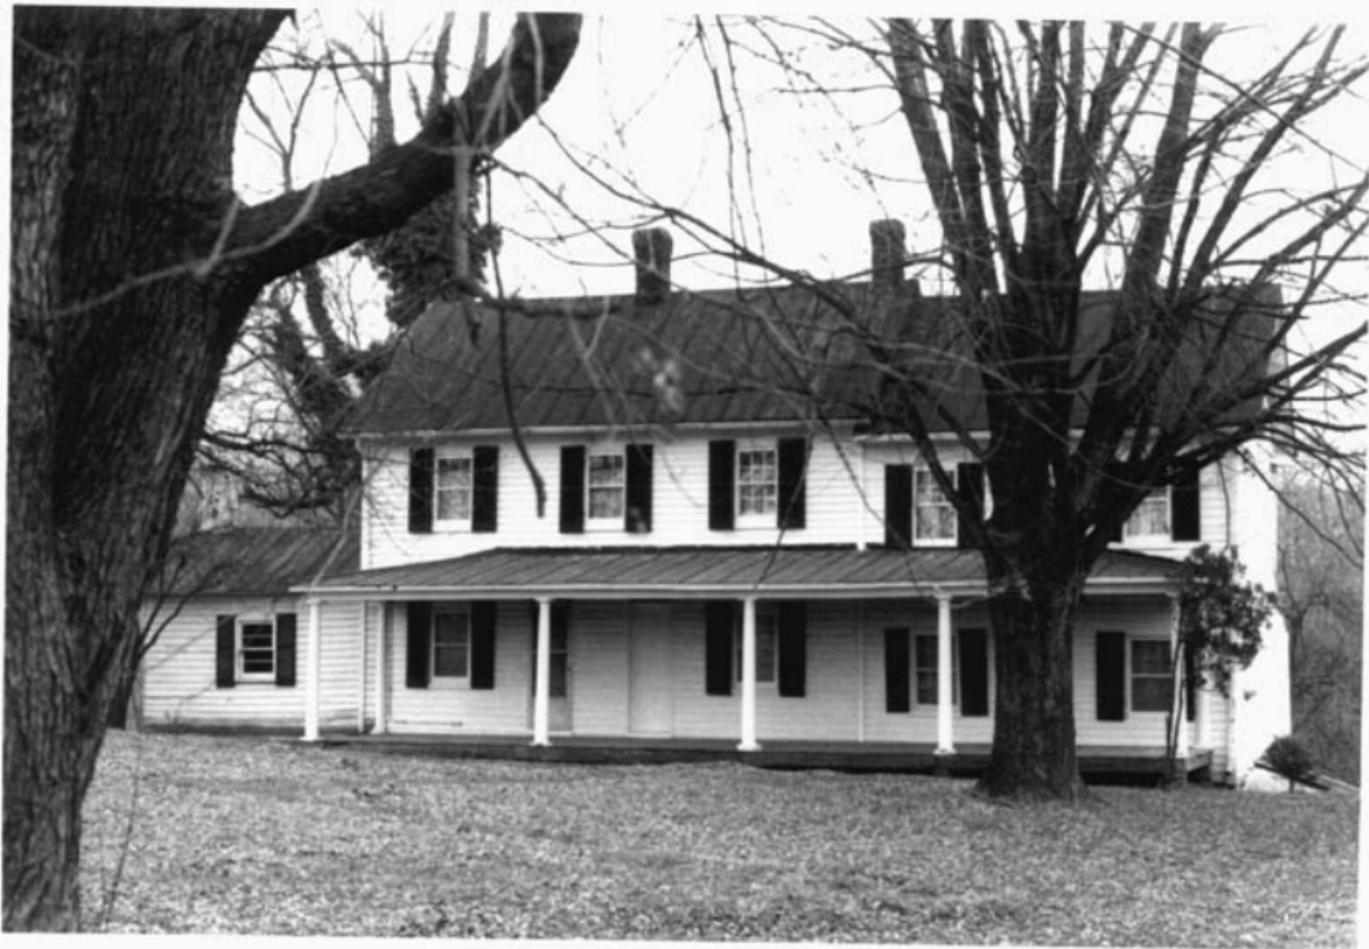
HO. 234

The frame clapboard farm house in three sections is oblong, facing west. The A-frame roof ridge line running north-south. The center section and the south section are two stories high, while a small north section, 1 bay by 1, is one story. The central section is 3 bays by 2, the south section 3 bays by 0. Eaves of the tin roof are wide. There are two chimneys rising from interior walls near the center of the house. A one-story porch shelters the first floor of the central and south sections.

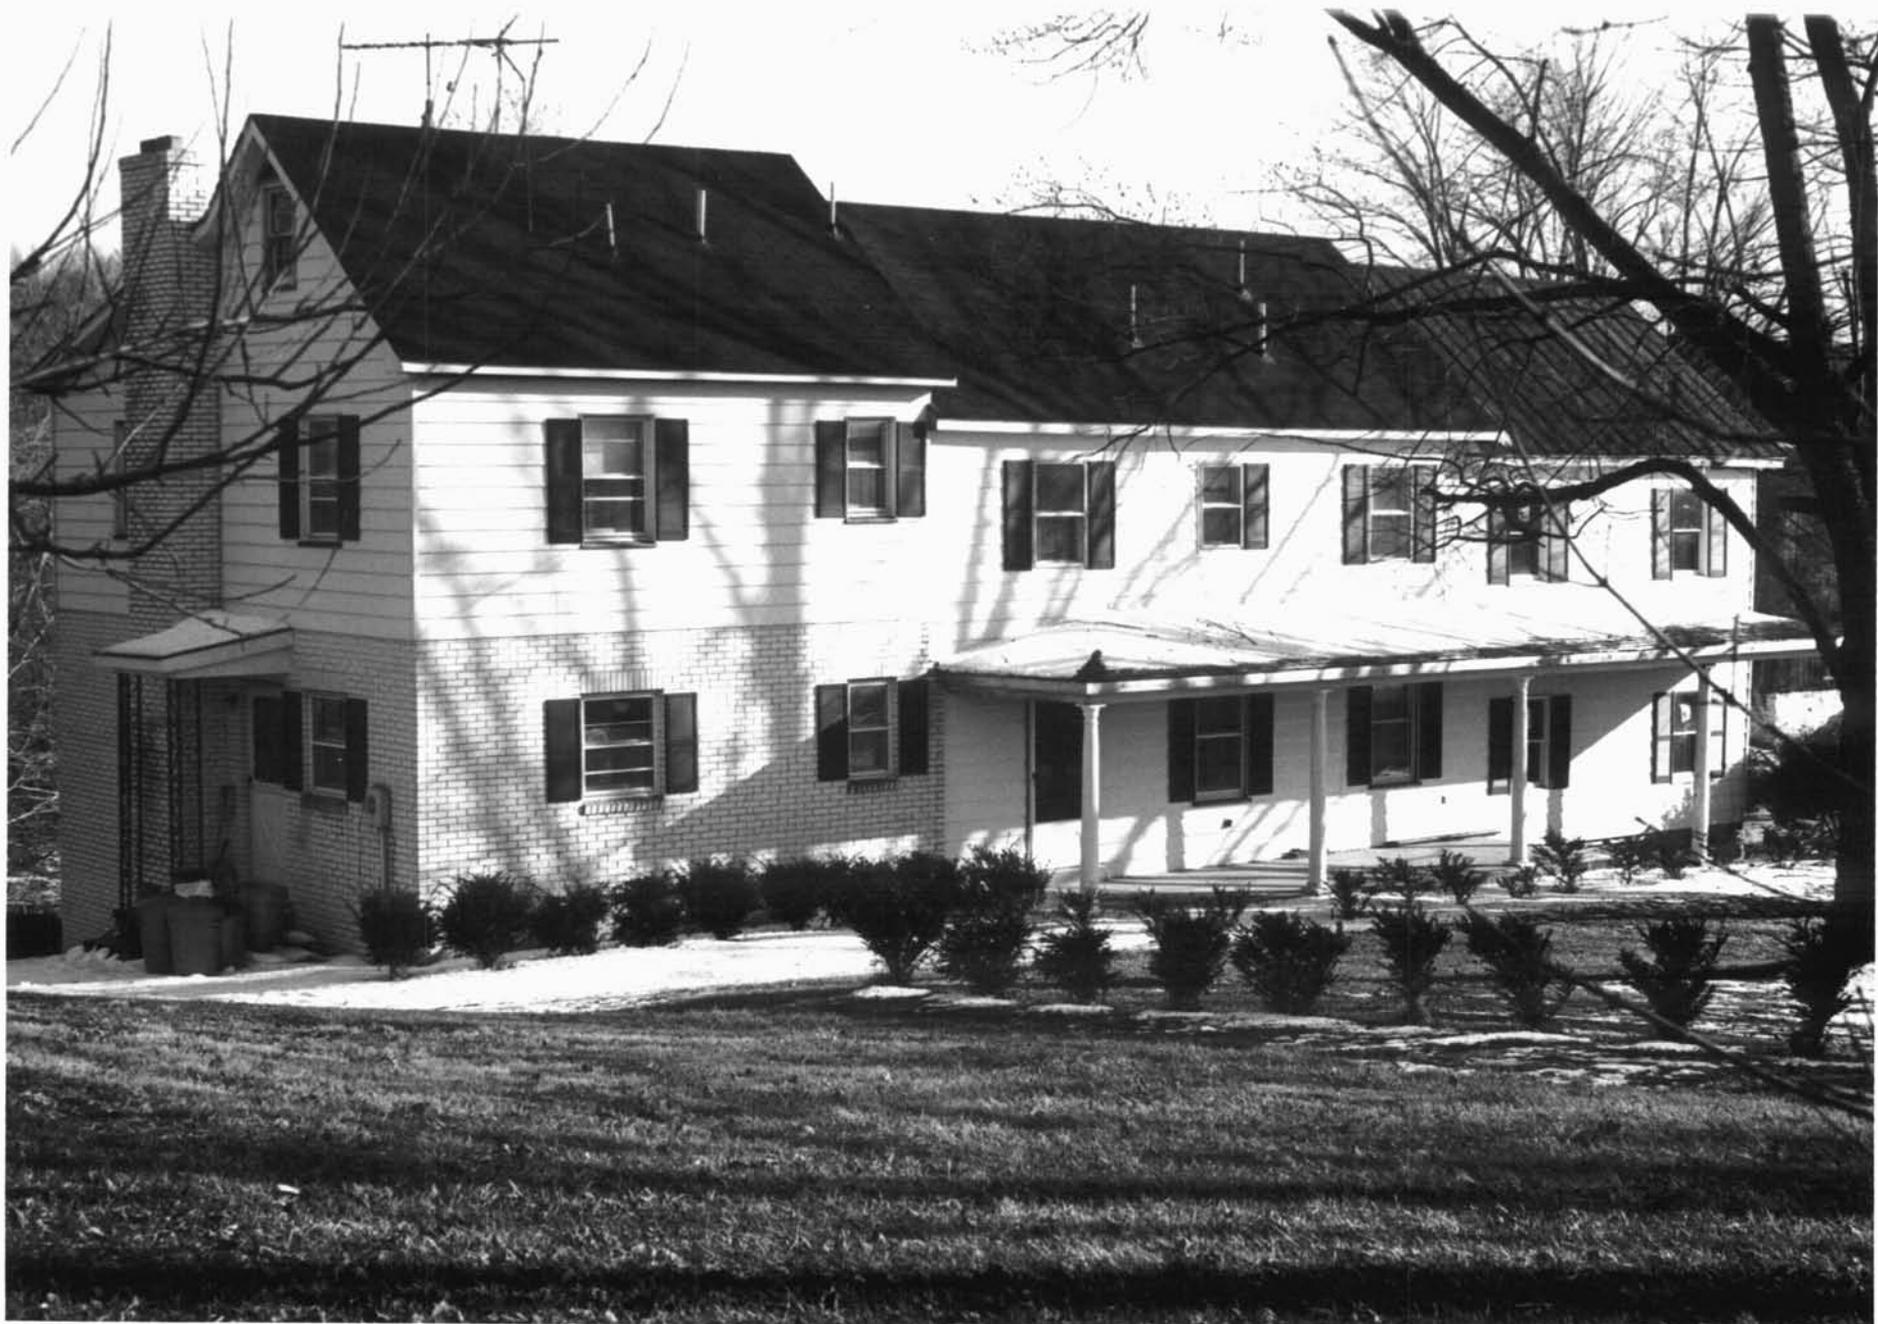
Name: HO-234
The Zubovic Farmhouse
Location: 1259 Route #27
Mt. Airy, Maryland
Photographer: Cleora B. Thompson, A.I.C.P.
Date of photograph: March, 1980
Negatives in possession of the Maryland Historical Trust
View: Northwest
Photographer looking: Southeast
Photograph number: 1 of 1

The Zubovic Farmhouse faces west on the east side of Ridge Road (Route 27), 0.2 miles north of the Howard County-Montgomery County boundary line. It is a good example of a telescope house, constructed in three sections. The central section, in existence in 1864, when Philip Burdette acquired the property, is a three bay wide, two bay deep, two story high, gabled roof (running north-south) frame clapboard section, resting on a stone foundation. The south section, which predates the central section and may have existed as early as 1790, is a two bay wide, one room deep, two story high, gabled roof (running north-south) log (covered by aluminum siding) south wing, originally resting on a stone foundation which has been reinforced by cinder block. The north wing is now a two bay wide, one bay deep, two story high, gabled roof (running north-south) brick first floor and frame second floor, north wing, to whose east wall has been added a two bay wide, one bay deep, shed roofed, frame (covered with aluminum siding) addition, featuring a central bay window on its east wall. A wide, brick, exterior chimney is centered on the north wall of this wing and its extension. This north wing replaces an earlier, one bay wide, one bay deep, one story, north wing, which, due to its dilapidated condition, was totally demolished and this new section added on by the present owners, Mr. and Mrs. Zubovic, to hold a large modern kitchen and family room. It rests on a full, cinder block foundation.

A one story high, hipped roof, open porch, supported by four wooden posts, runs along the entire west elevation of the central and south sections of the building, while a one story high, shed roofed, open porch supported by four iron posts, resting on a cinder block foundation runs along the entire east elevation of the south wing of the building. A three bay wide, one bay deep, one story high, shed roofed, screened in porch runs along the entire east wall of the central section of the house.

Fenestration for the house is often vertically aligned, and is almost entirely rectangular and double-hung, holding one-over-one lights.
