**MARYLAND HISTORICAL TRUST  
DETERMINATION OF ELIGIBILITY FORM**

Property Name: The Daisy Trading Post Inventory Number: HO- 258  
 Address: 15948 14948 Union Chapel Road City: Woodbine Zip Code: 21797  
 County: Howard County USGS Topographic Map: Woodbine Quad  
 Owner: Nicholas L. Andris Is the property being evaluated a district? \_\_\_yes  
 Tax Parcel Number: 72 Tax Map Number: 13 Tax Account ID Number: 313321  
 Project: Verizon - Daisy Cell Site Agency: FCC  
 Site visit by MHT Staff: \_\_\_no \_\_\_yes Name: \_\_\_\_\_ Date: \_\_\_\_\_  
 Is the property located within a historic district? \_\_\_yes X no

THE DAISY TRADING POST, <sup>15948</sup>~~14948~~ UNION CHAPEL ROAD.  
 HOWARD COUNTY, MARYLAND HO-258

INVENTORY FORM FOR STATE HISTORIC SITES SURVEY MAGI# 1402585611

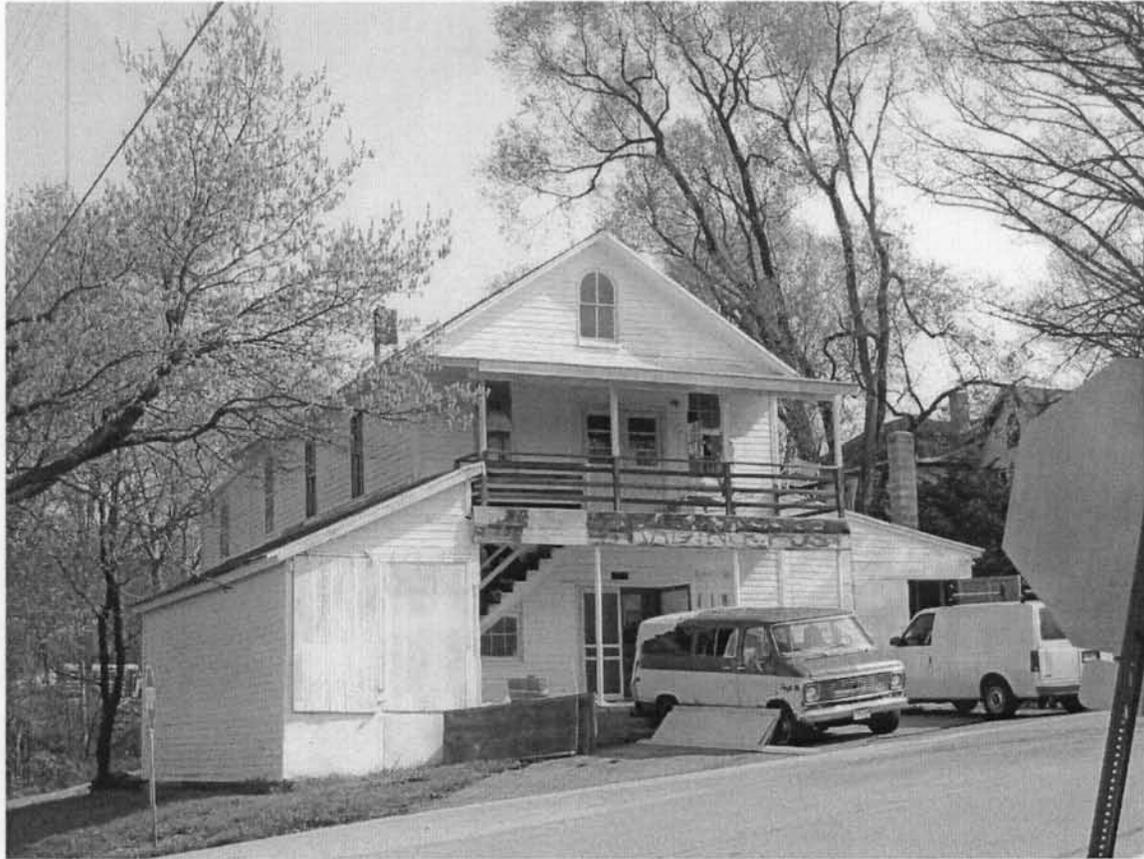
HO-258  
Daisy Trading Post  
15948 Union Chapel Road  
Woodbine  
Jennifer K. Cosham  
April 21, 2004  
Digital color photo on file at MHT

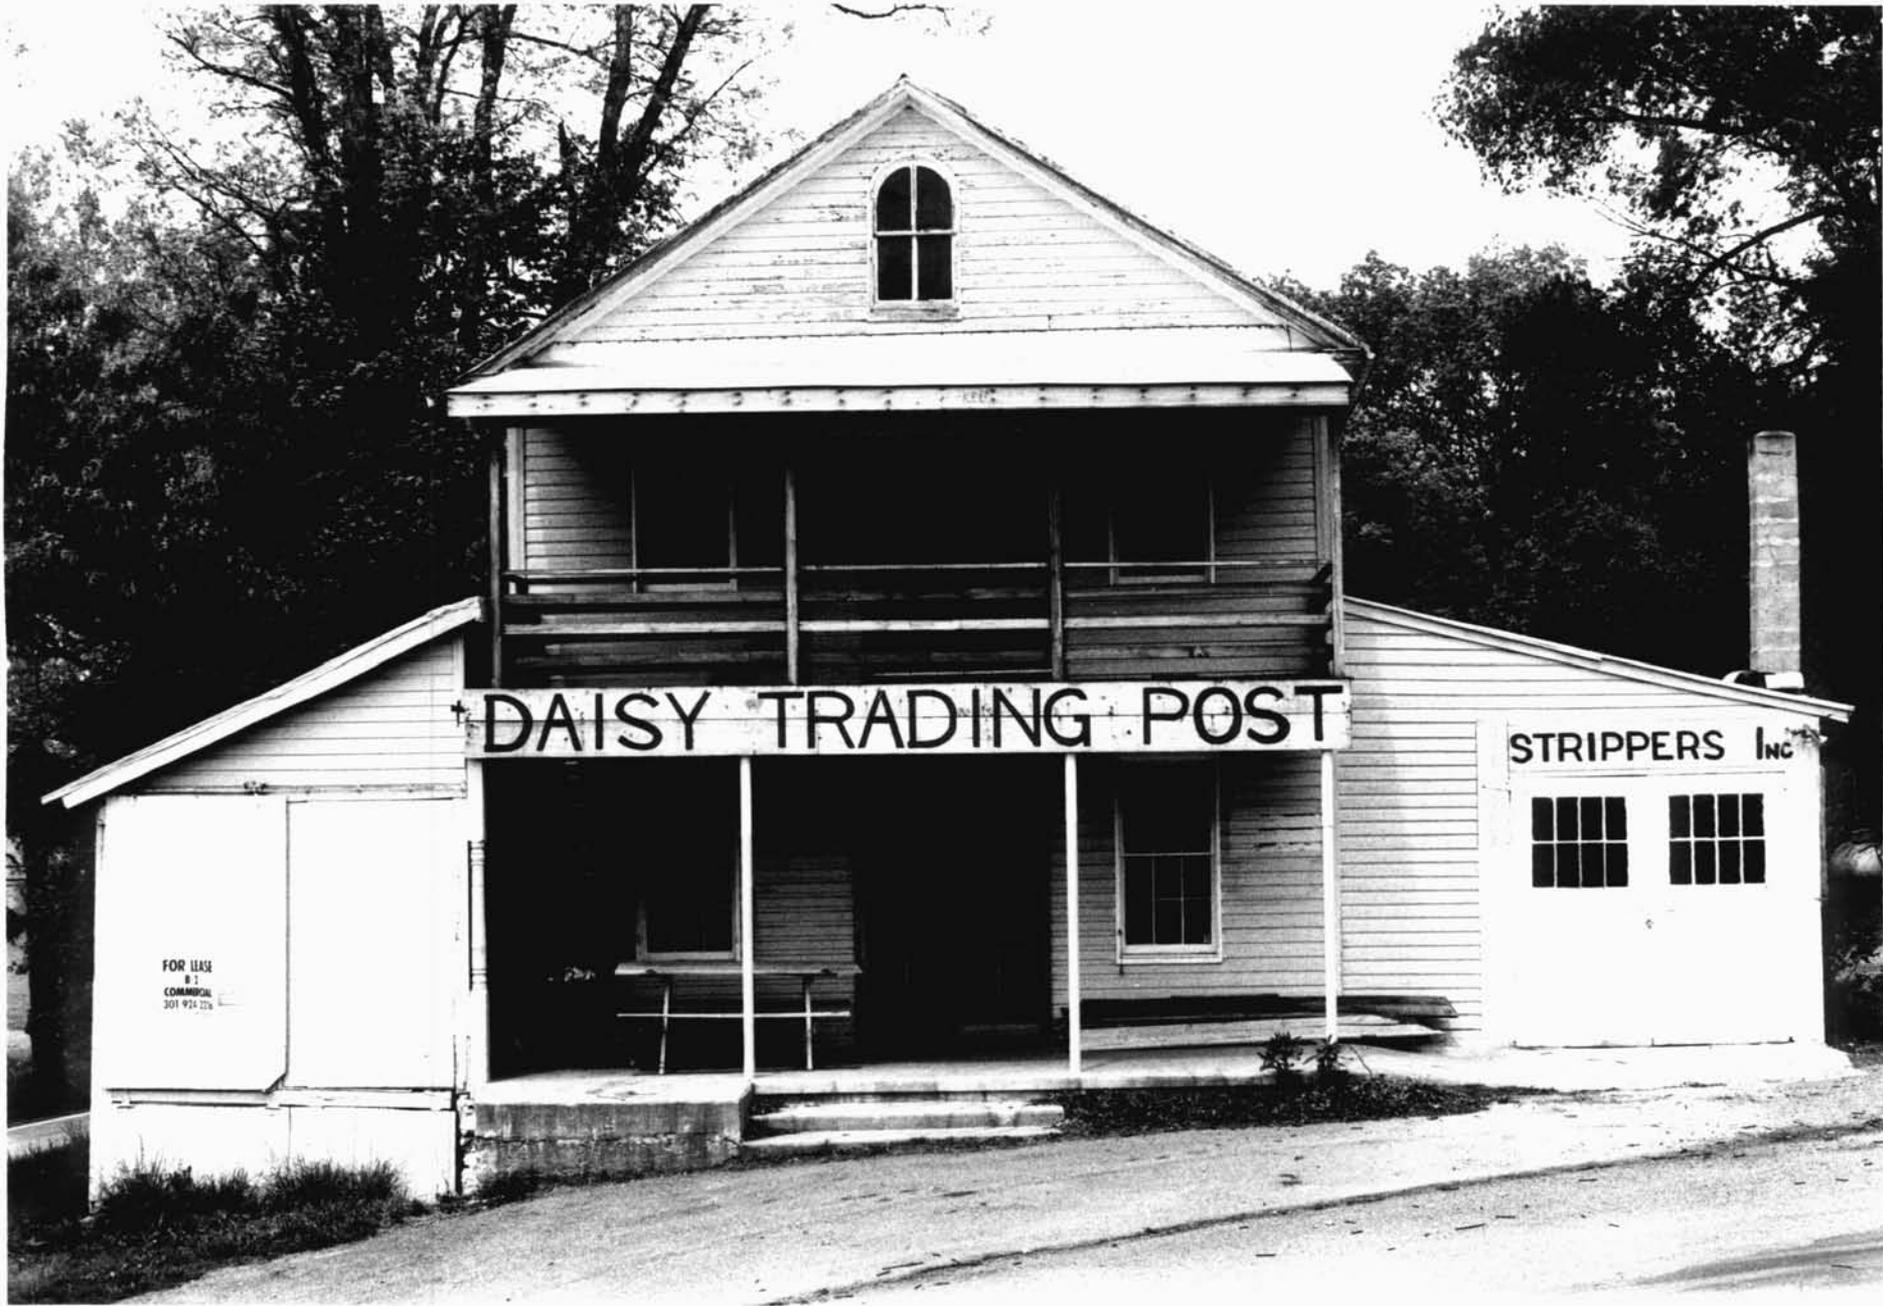
Name: HO-258  
Daisy Trading Post  
Location: 15948 Union Chapel Road  
Woodbine, Maryland  
Photographer: Cleora B. Thompson, A.I.C.P.  
Date of Photograph: May, 1980  
Negatives in possession of the Maryland Historical Trust  
View: South elevation  
Photographer looking: North  
Photograph number: 1 of 1
