Maryland Inventory of Historic Properties Number: HO-726

Name: Folly Quarter Rd over Middle Patuxent River

SHA Bridge No. HO 20 **Name:** Folly Quarter Road over Middle Patuxent River

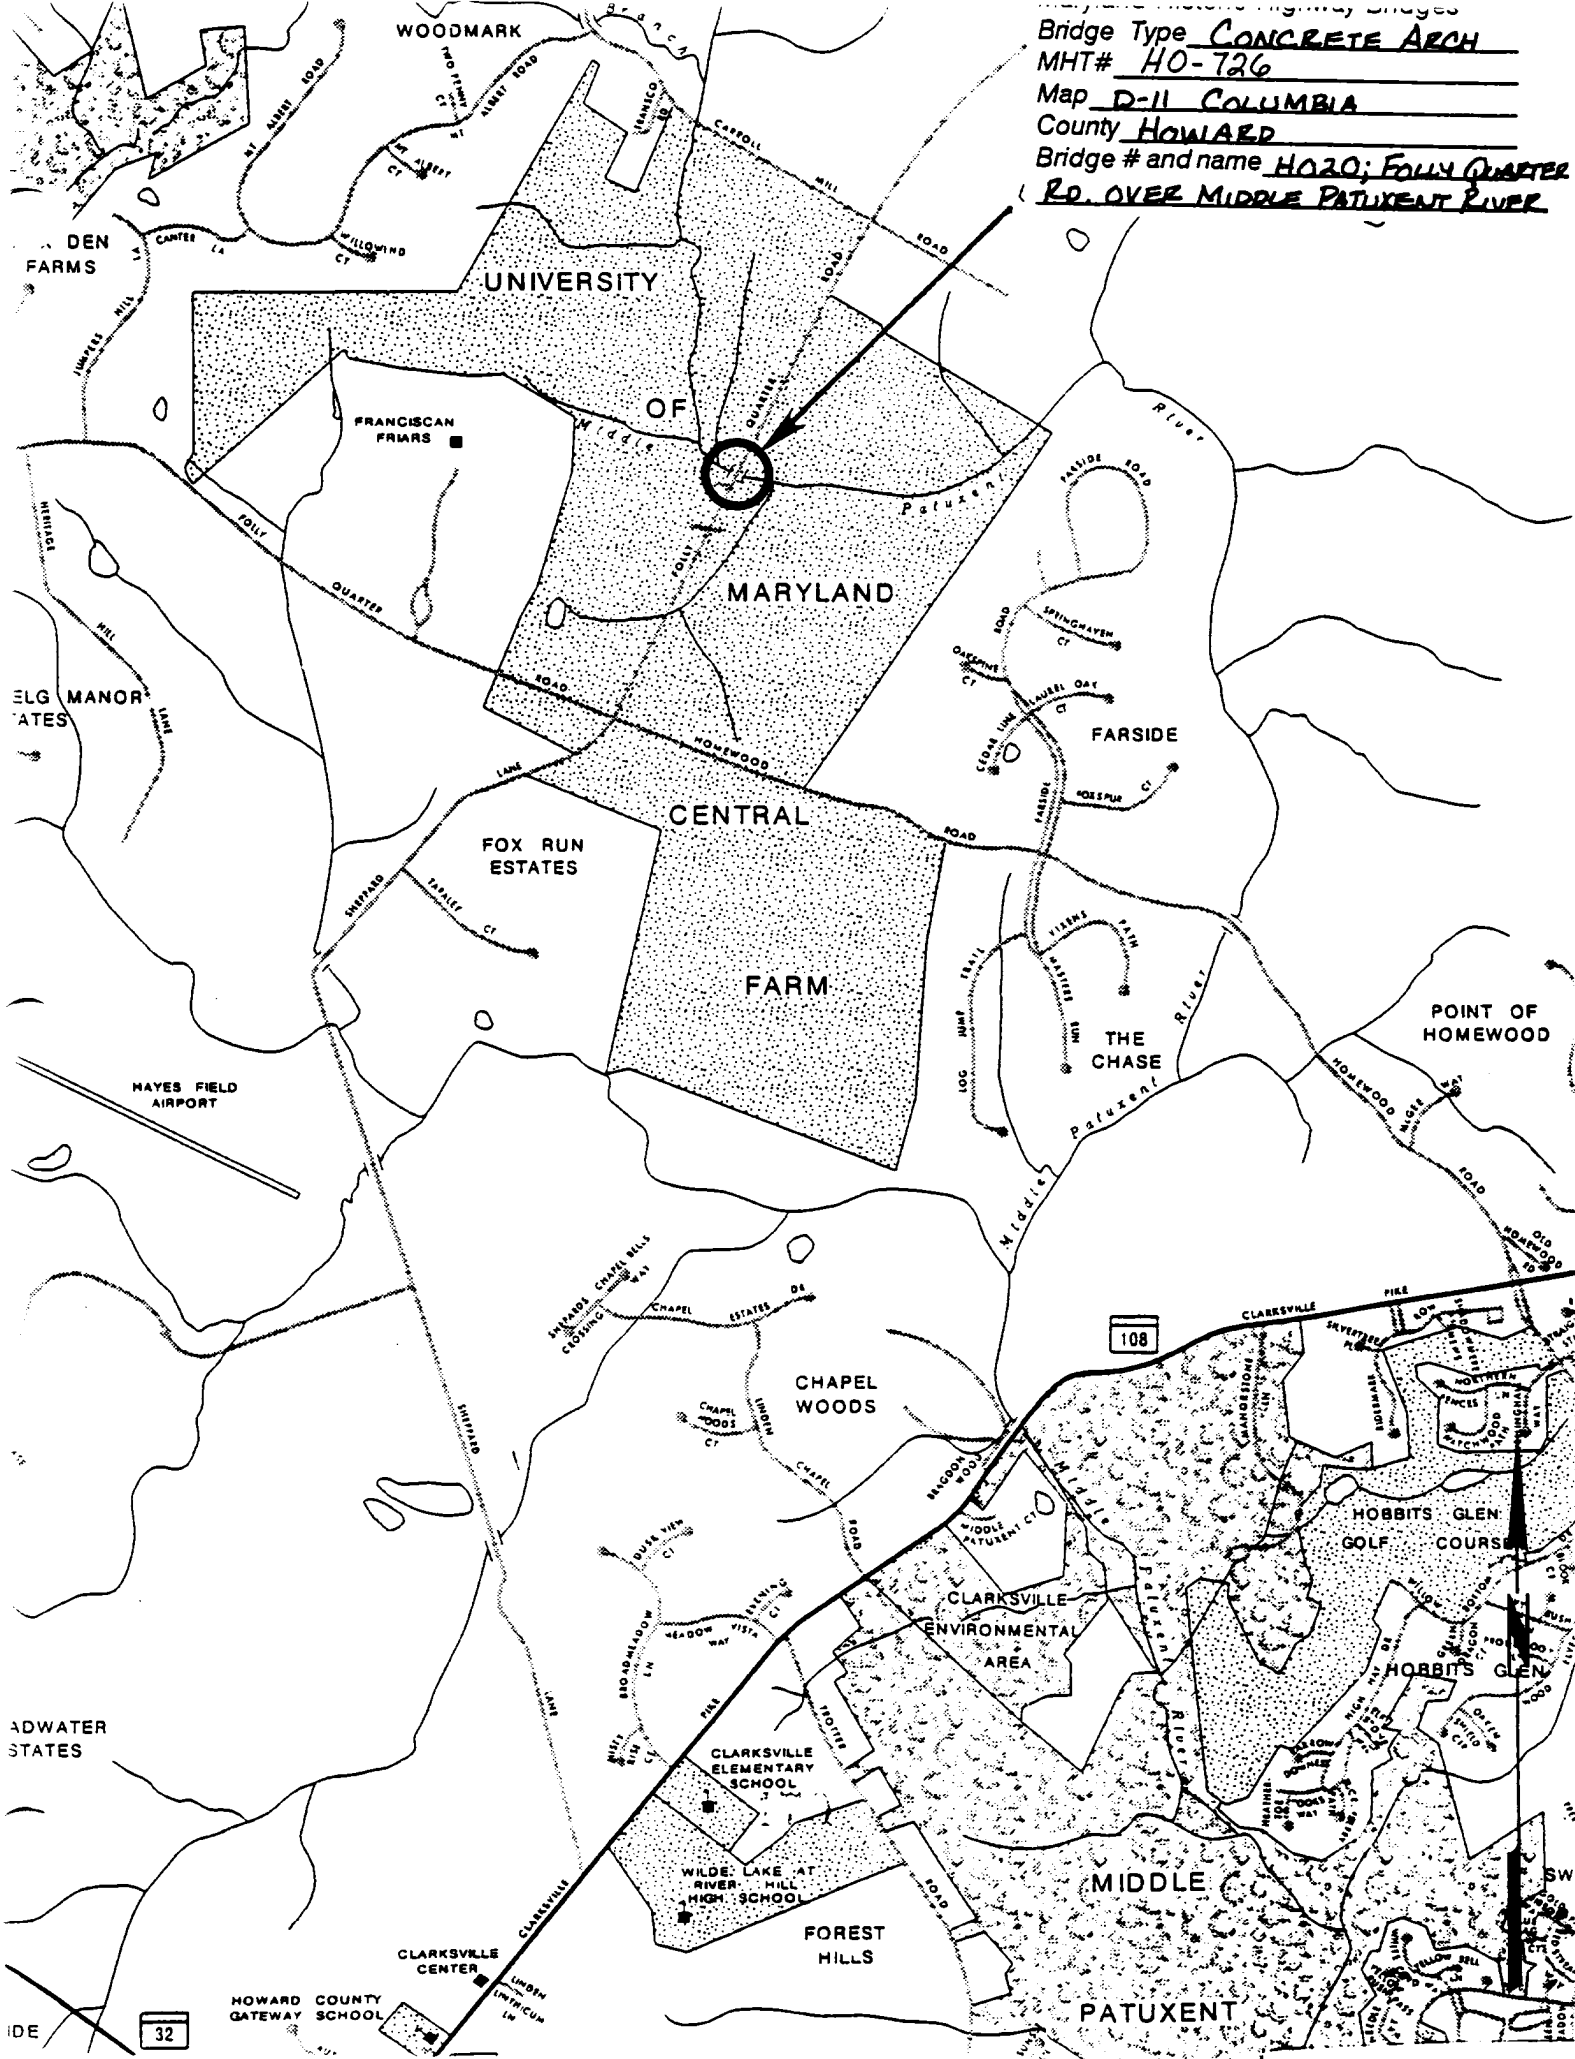
Bridge Type CONCRETE ARCH
MHT# HO-726
Map D-11 COLUMBIA
County HOWARD
Bridge # and name HO20; FOLLY QUARTER
RD. OVER MIDDLE PATUXENT RIVER

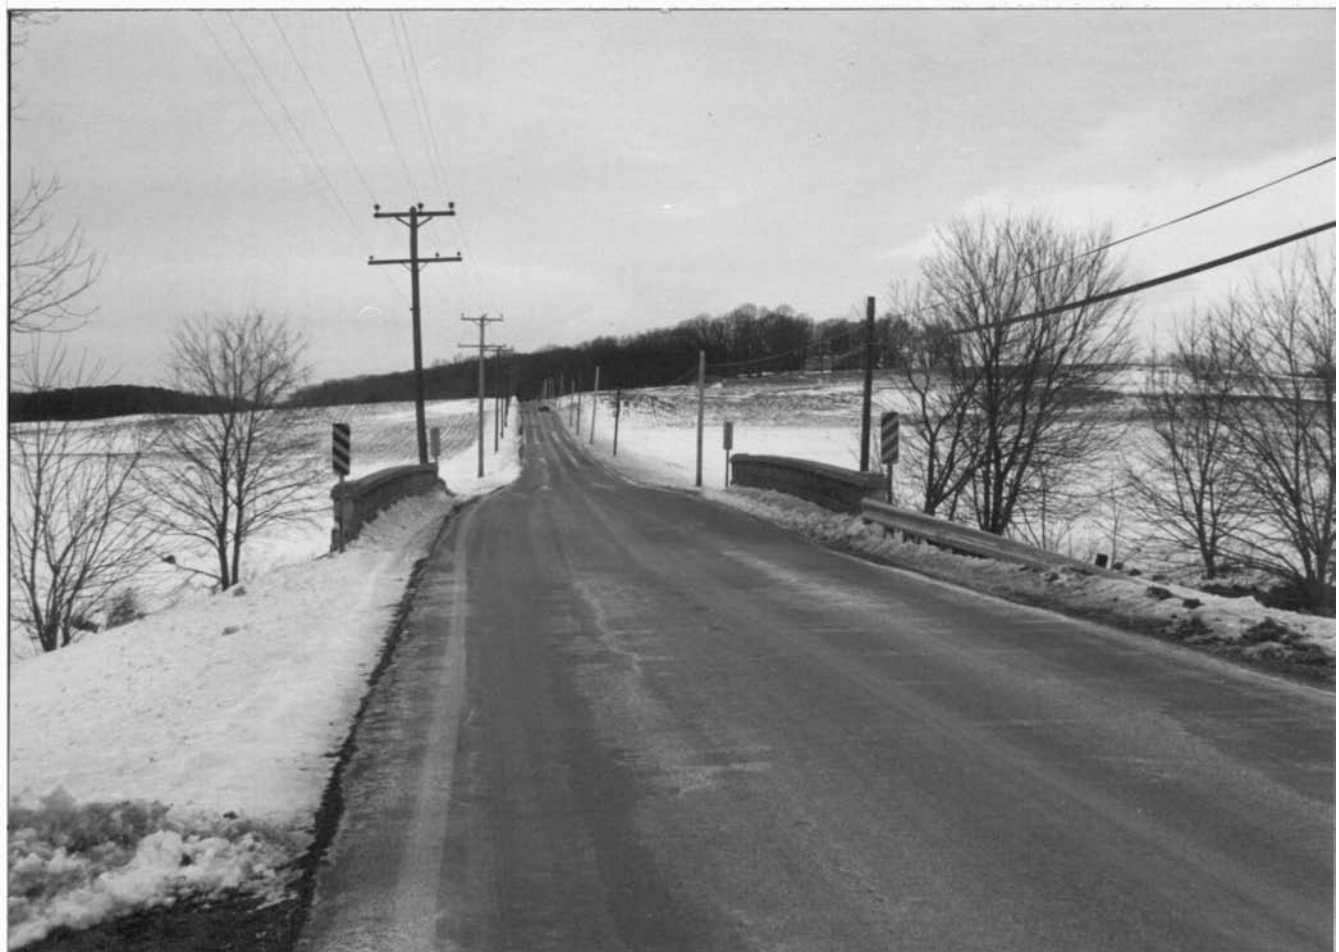
Number 16 of 33

Description SOUTH APPROACH LOOKING NORTH

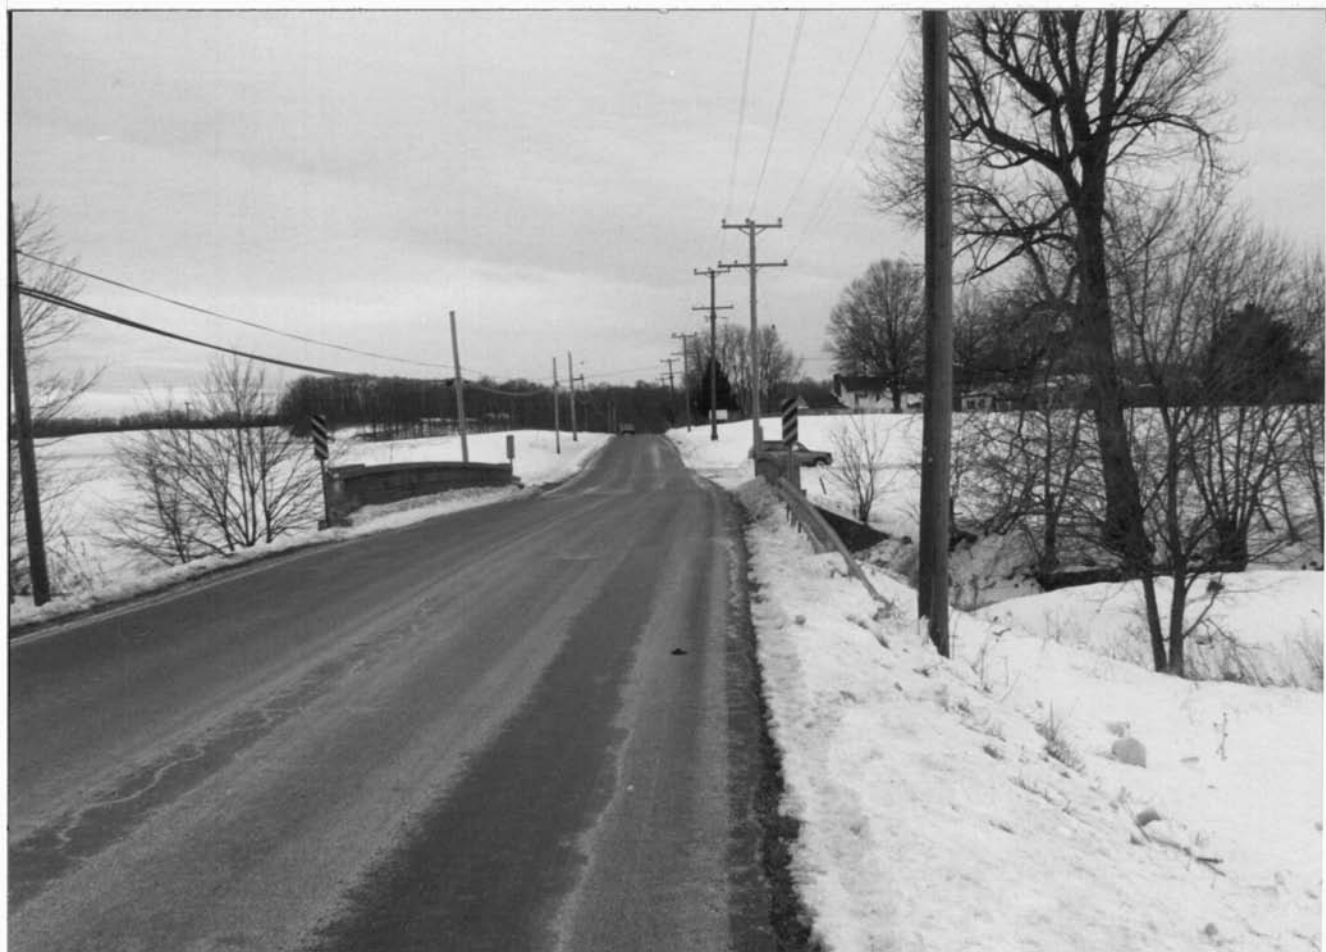
Number ² ₆ 34 of 33

Description NORTH APPROACH LOOKING

SOUTH

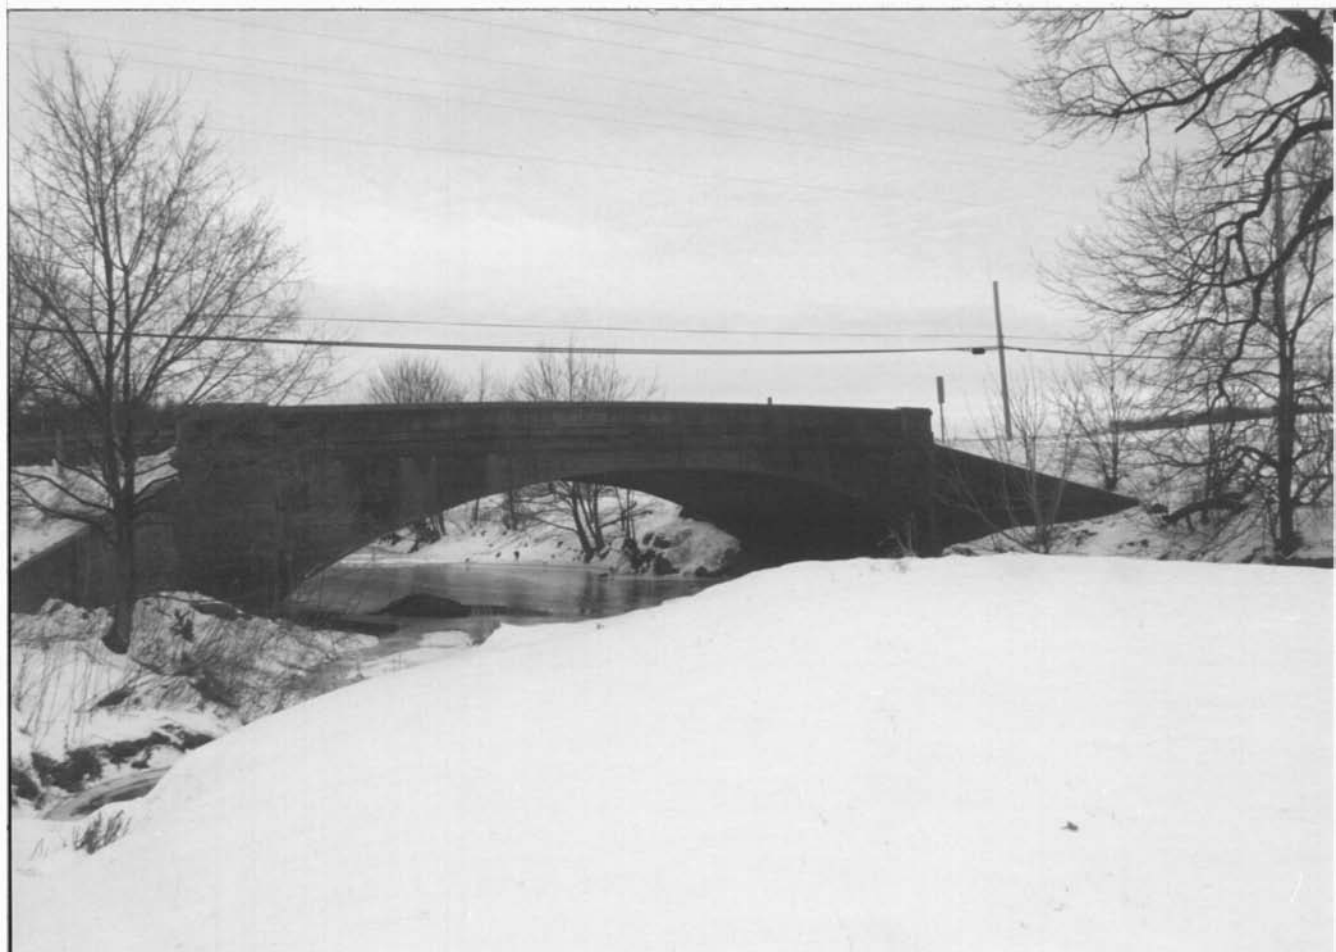
Number 3 of 6
28 of 35

Bridge HO-20 is a single span filled concrete arch bridge. The length of the bridge is 64 feet with a clear span measuring 60 feet at the spring line. The bridge has a rise of approximately 13 feet from springline to the crown. The rise to run ratio is 21 percent. The spandrel walls are approximately 14 feet by 8 feet. The wingwalls are approximately 10 feet by 8 feet. There is a clear roadway width of 24 feet, with an overall bridge width of 26 feet 8 inches. The spandrel walls have severe deterioration on the eastern slope. The arch ring has fine vertical cracking and some signs of efflorescence. According to a 1994 inspection report, the bridge is in satisfactory condition, with a sufficiency rating of 76.2.

Description WEST ELEVATION LOOKING
SOUTH EAST

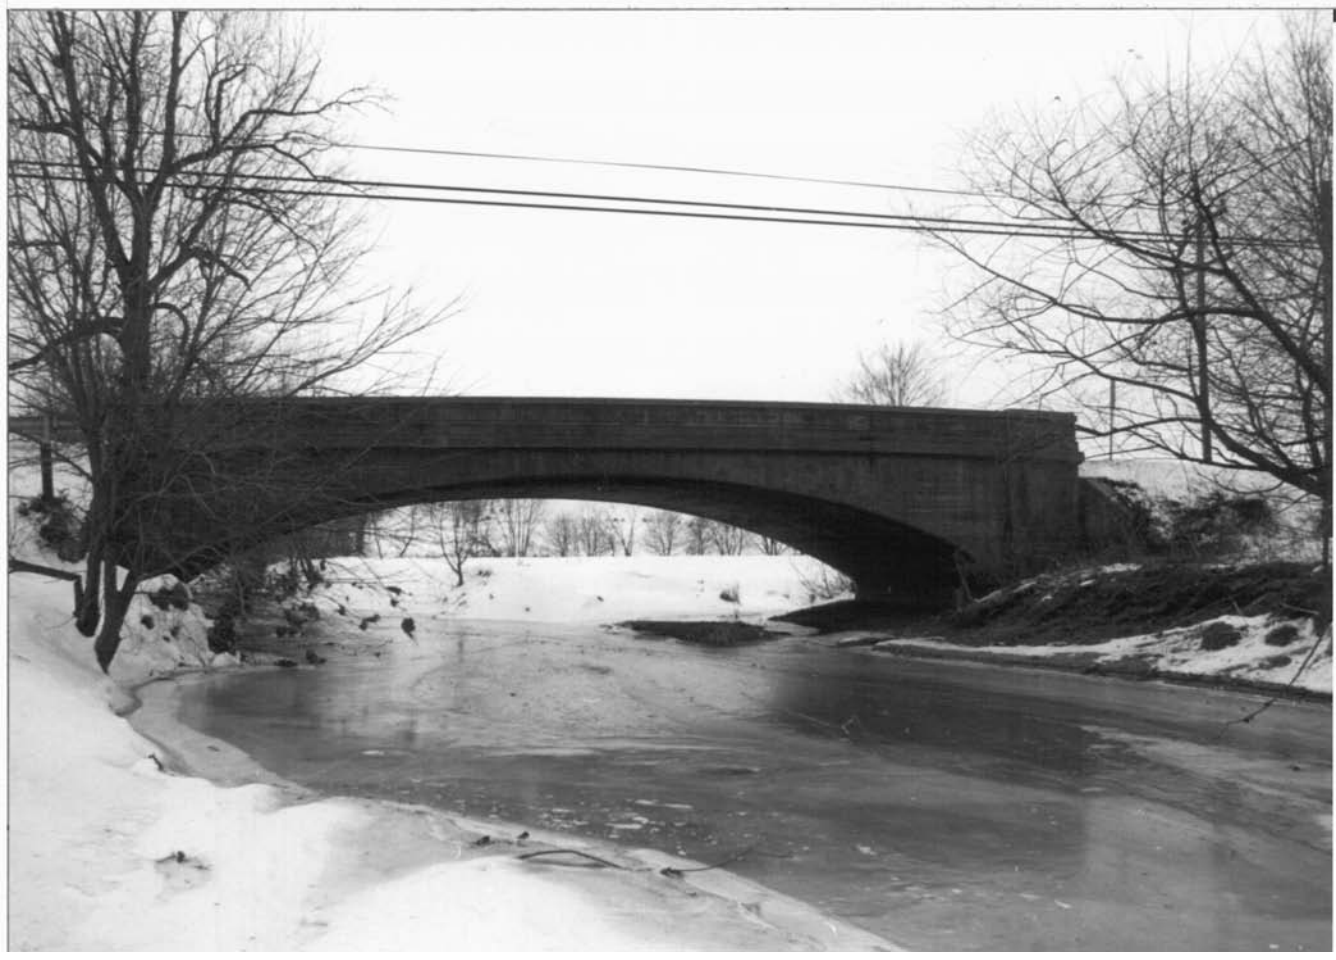
Number 4 of 6
26 of 35

Bridge HO-20 has its original parapets. The builders used a closed parapet design. This reinforced concrete parapet consists of vertical posts securely fastened by dowels to the structure, horizontal rails, and solid panels that fill the space between posts and the railings. The posts and rails were built in place. The panels are separated by solid paneled expansion joints. The parapets are in a single section and are in fair condition with moderate spalling at the construction joints.

Description EAST ELEVATION LOOKING
NORTHWEST
