Maryland Historical Trust Maryland Inventory of Historic Properties Form

Inventory No. HO-751

1. Name of Property South Branch Recreational Area Survey District

historic Sykes Mill, Howard Cotton Factory, B. F. Shriver Cannery
other Apple Butter Factory

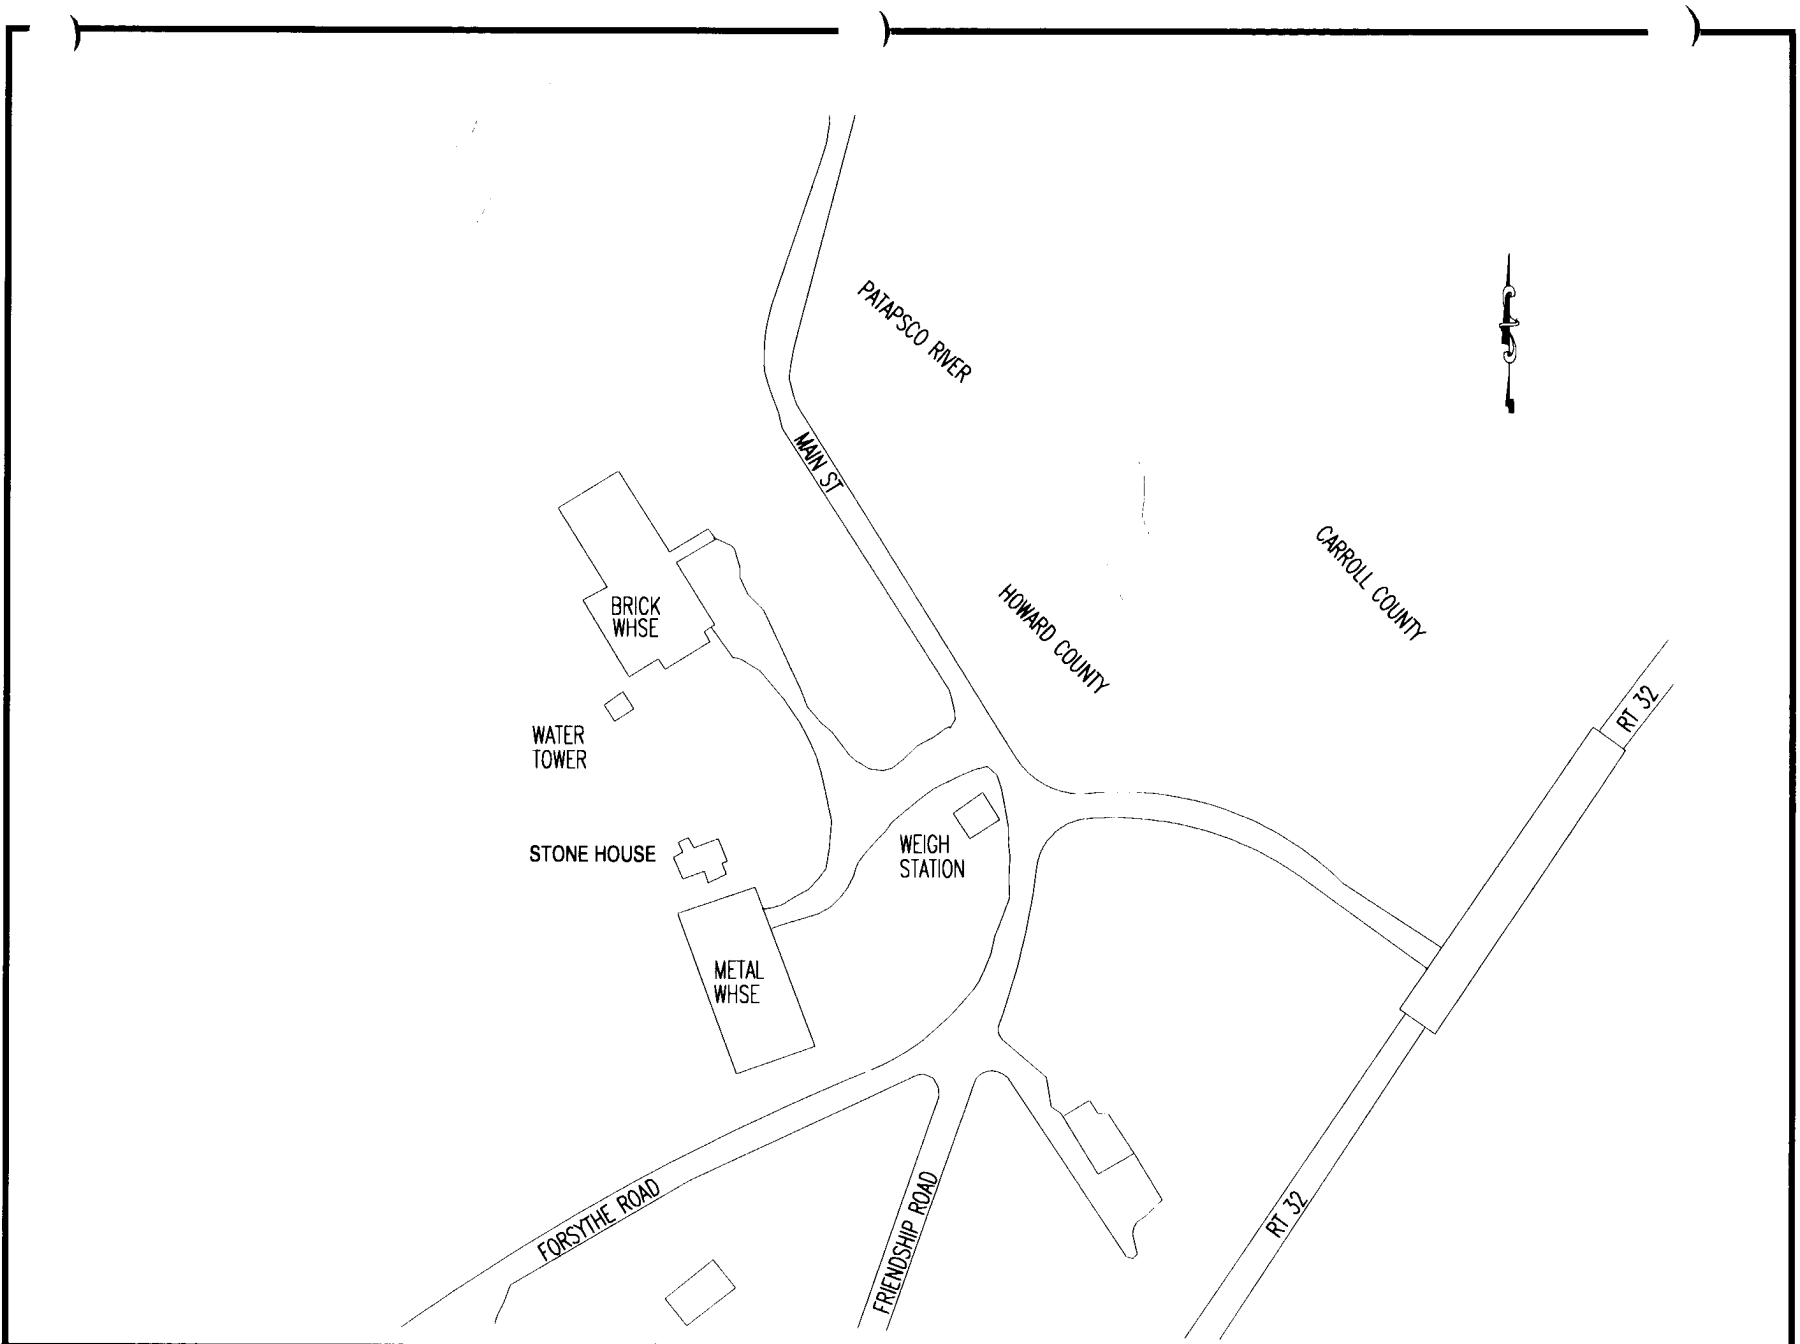
Site Plan of the South Branch Recreational Survey District	
URS	PROJ NO INVENTORY NUMBER HO-751

The South Branch Recreational Area Survey District is comprised of three contributing buildings, two contributing structures, and one non-contributing building. The buildings include a large brick warehouse, a truck weigh station, a small stone house, and a non-contributing metal warehouse. The structures are an elevated water tank and its partially subterranean pumphouse. The buildings and structures are spread across a 7.369 acre site on the south bank of the West Branch of the Patapsco River. They are located where Forsythe and West Friendship Roads join with Main Street to cross the river into downtown Sykesville. While the town is in Carroll County, the South Branch Recreational Area is in Howard County.

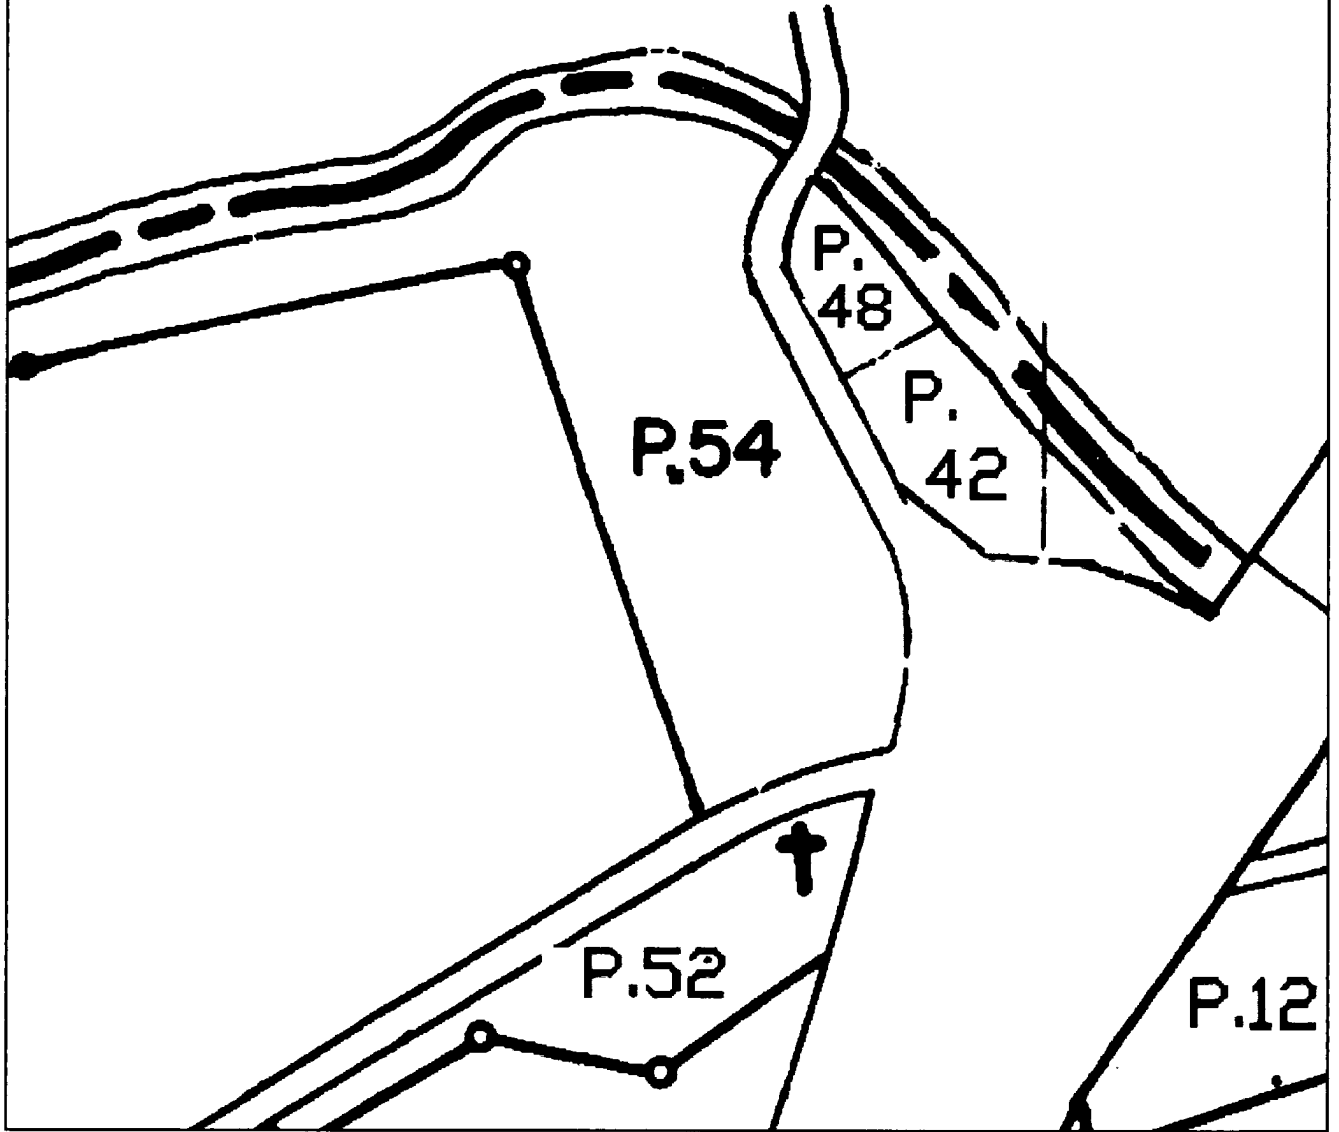
South Branch Recreational Area Survey District
Property Boundary - Tax map 4, parcel 54

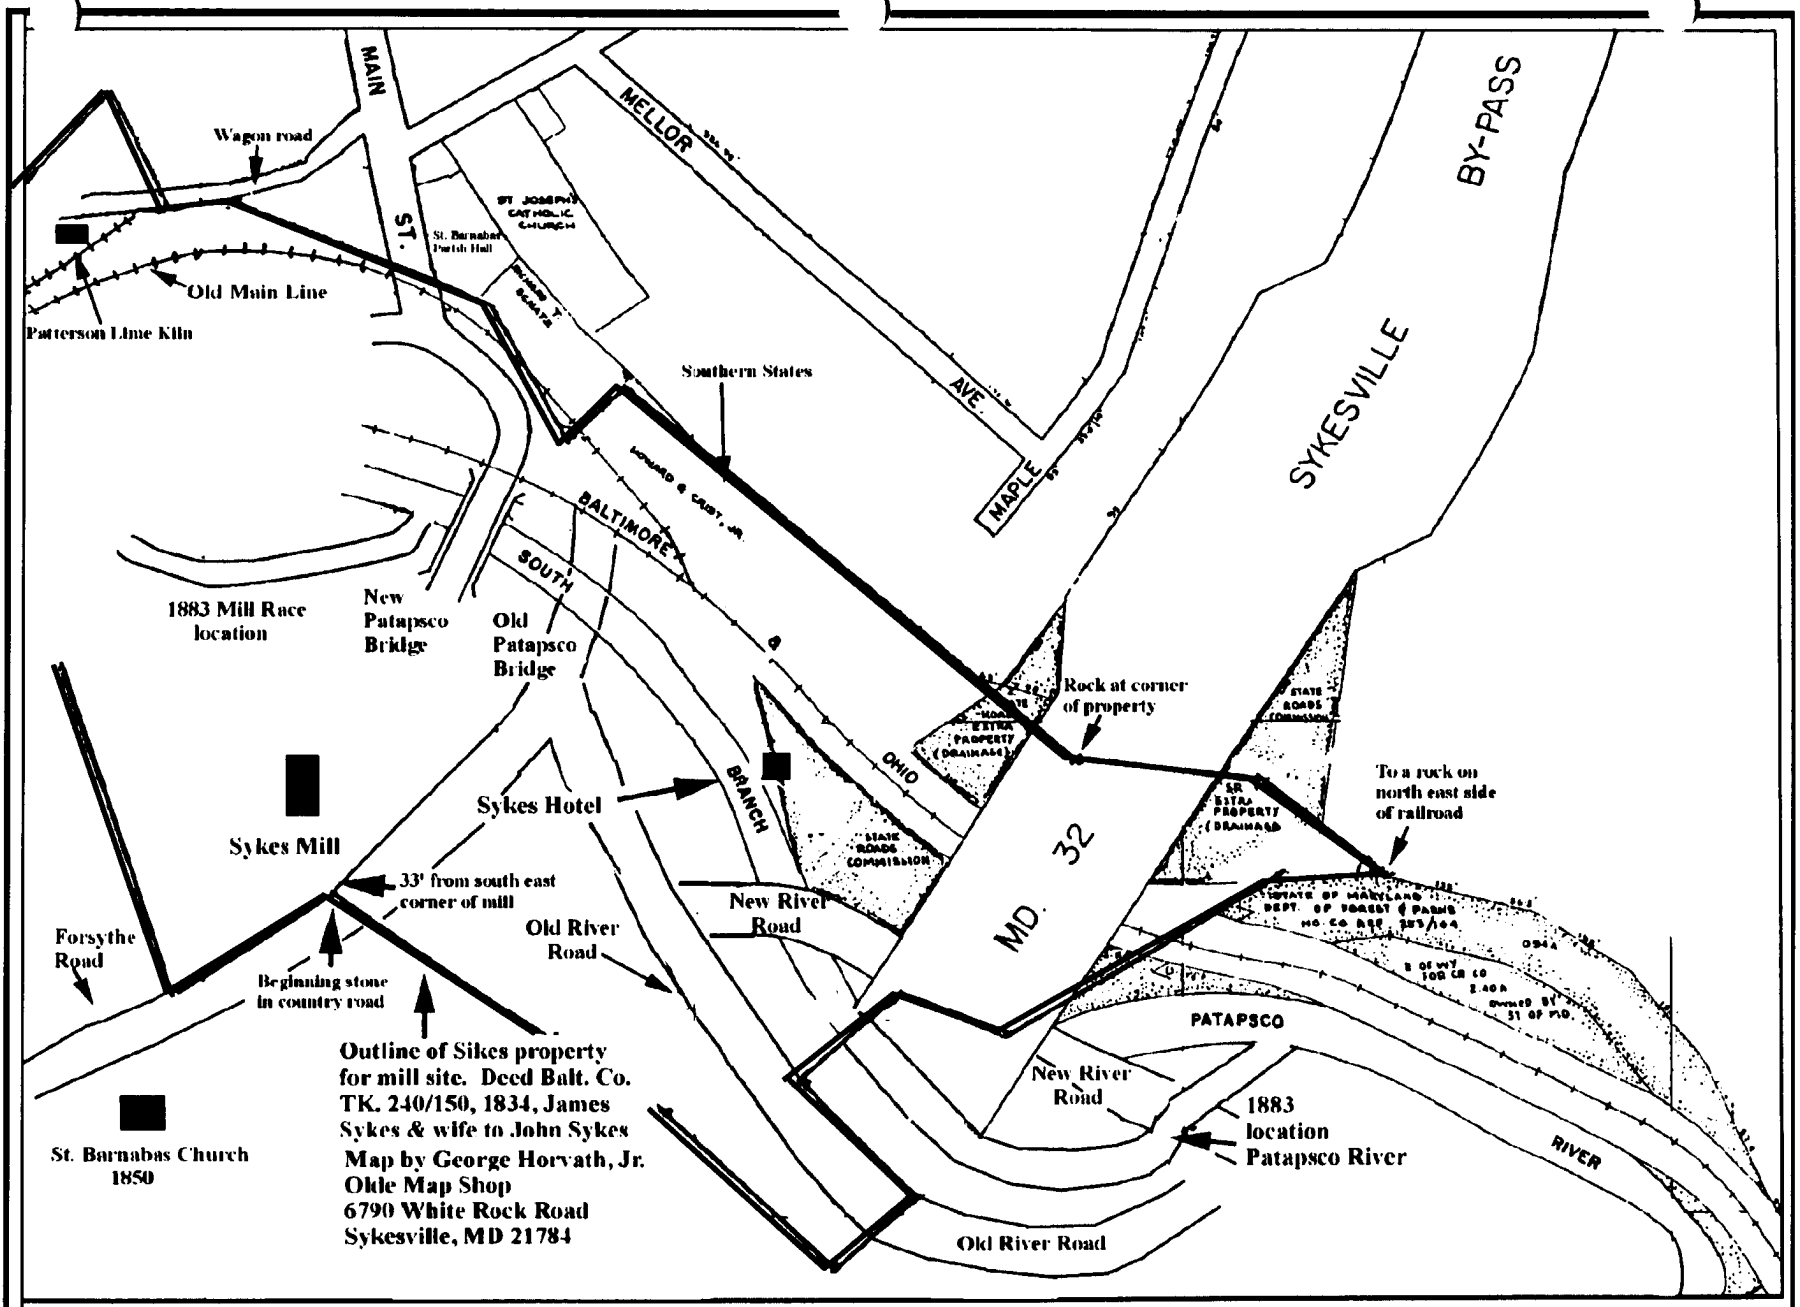
Map of the Original Sykes Mill Property	
URS	PROJ NO INVENTORY NUMBER HO-751

**Outline of Sikes property
 for mill site. Deed Balt. Co.
 TK. 240/150, 1834, James
 Sykes & wife to John Sykes
 Map by George Horvath, Jr.
 Okle Map Shop
 6790 White Rock Road
 Sykesville, MD 21784**
