HO – 823
The Cornelius W. Pickett Property (Garage)
8802 Washington Boulevard
Jessup, vicinity

Maryland Historical Trust Maryland Inventory of Historic Properties Form

Inventory No. HO - 823

historic The (Cornelius W.) Pickett Property (Garage)

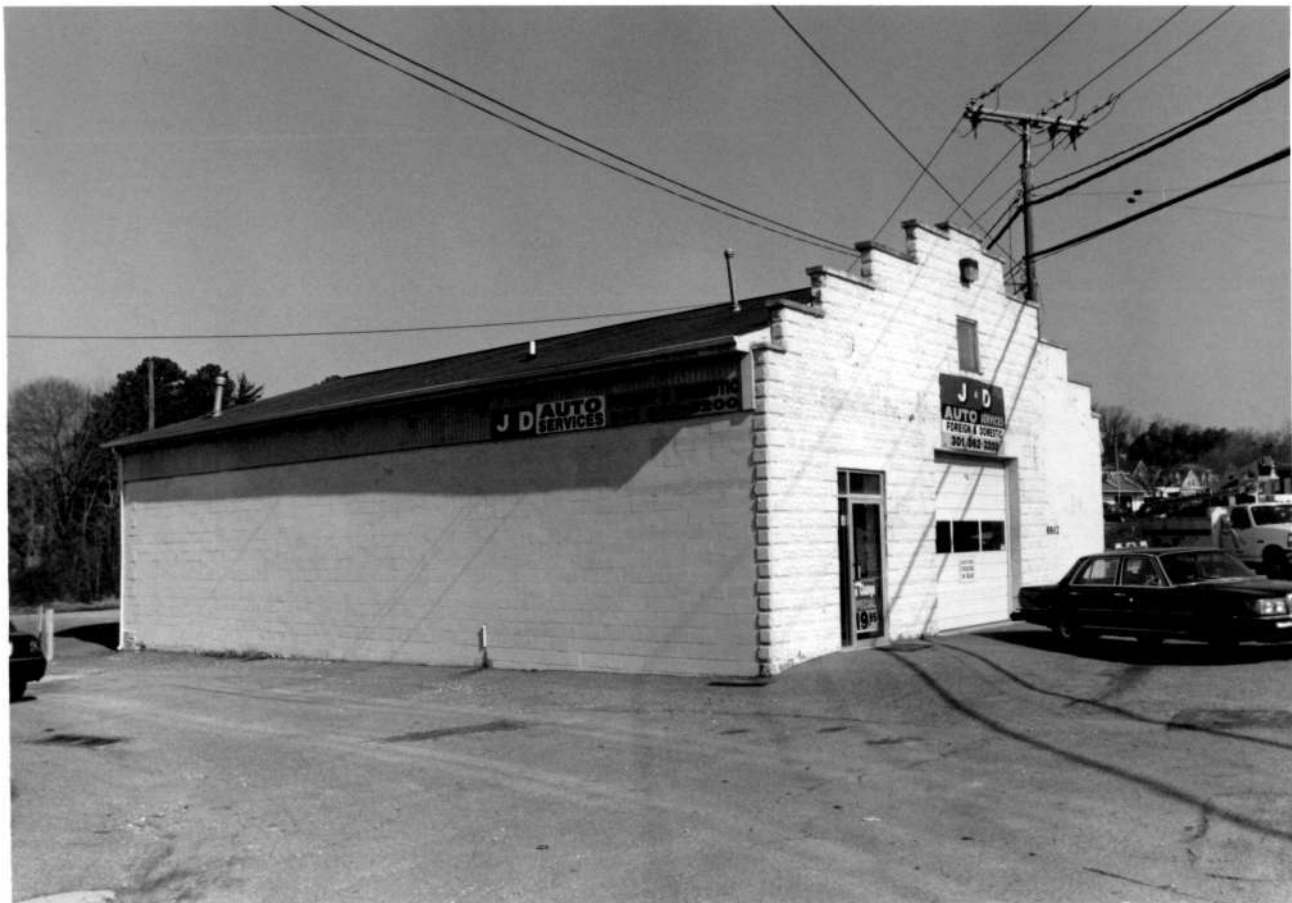
1 OF 3

The **East (front) façade** is composed around three bays with a centrally located garage opening. The walls are mostly constructed of a rusticated concrete block. The wall face extends above the gable roof eaves as a simple, stepped parapet structure. There are five (5) steps that are laid out symmetrically on both sides of the centerline of the façade. Along the horizontal runs of these parapet steps, there is a concrete capstone that projects slightly from the wall plane, and extends each length. While the metal garage door at the center of the façade is clearly a replacement door, this opening appears to be historic otherwise. There are smooth concrete masonry quoins that step along the vertical sides of this opening and the historic, smooth stone or concrete lintel remains above the opening. Currently, above this opening is a large sign promoting the business, "J&D Auto Service." Above this sign is a vertically oriented window opening. The window appears to have a wooden frame and to be boarded with plywood. The masonry surround is similar to other surrounds at some of the openings at the building and is composed of a smooth concrete block, laid as masonry quoins along both sides of the opening. Above this window opening there is a small surface mounted lamp for exterior lighting.

The **North (side) façade** currently has no fenestration or doors. The wall material is a mixture of materials. There is evidence of earlier fenestration along this face when one studies the wall surface. At the north east corner of the building the wall begins with the historic rusticated block. There is evidence of a single door having been near this location. The opening appears to now be boarded, blocked in part and puttied over in places to no longer function as an opening to the building. There are smooth, concrete block quoins that frame the area where the door once would have been. There is a evidence of a smooth stone or concrete lintel above the previous opening. Above the remaining lintel and on the west side of this wall area, there is more of the historic rusticated block. It extends to another vertical line of staggered block quoins, indicating another opening of some sort in this location. The size of this opening is not clear from this façade. The masonry quoins seem to match the ones adjacent for the door implying it was some form of doorway. A larger area of the wall has been reworked adjacent to this area. Evidence of the lintel is not in place, and a fairly large

HO-823
PICKETT PROPERTY
HOWARD COUNTY
VIEW LOOKING NORTHWEST

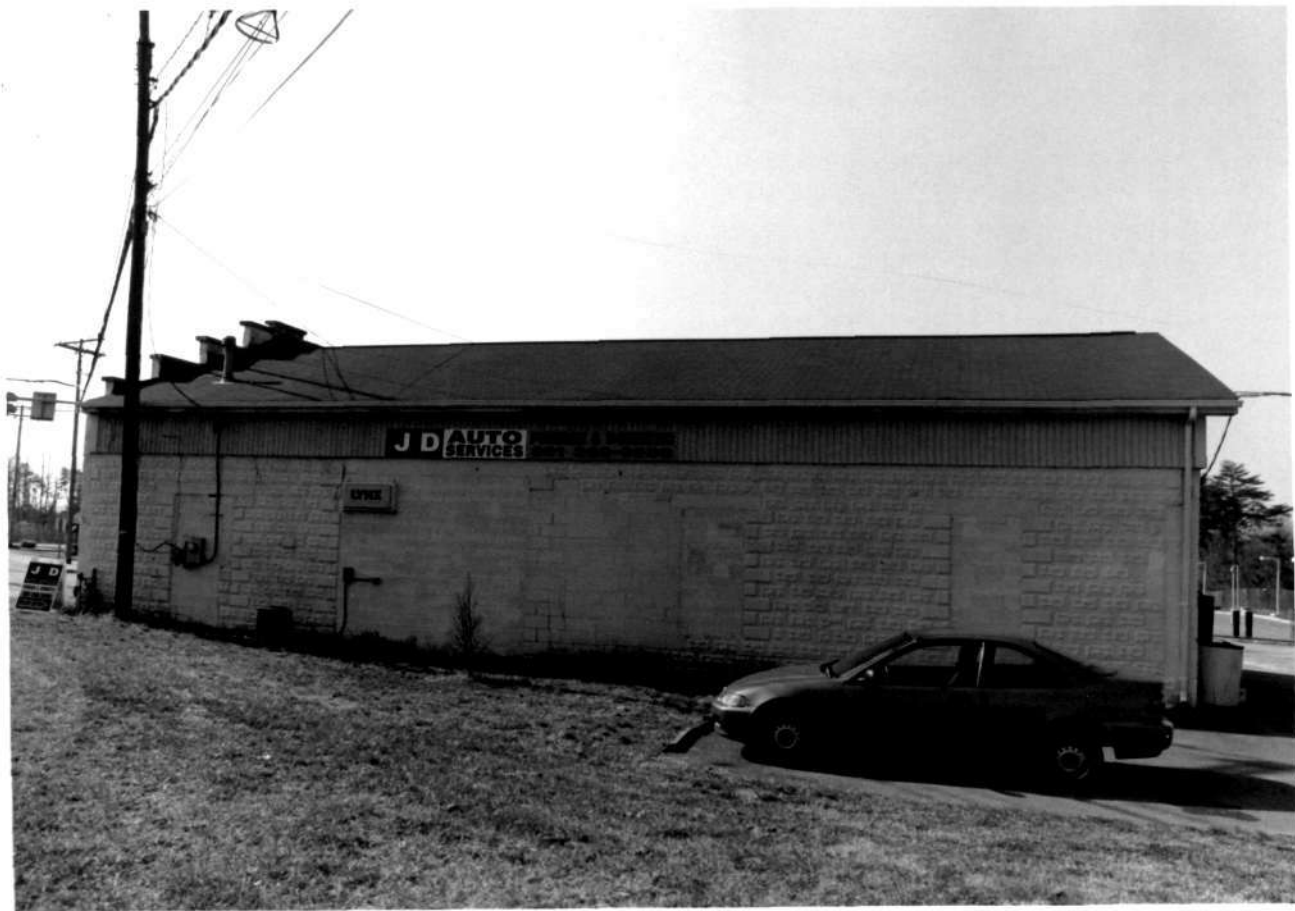
2 OF 3

The **South (side) façade** is a mostly smooth finished concrete block wall. There is no rusticated finished block on this secondary façade. At the eastern most corner of the building there is evidence the rusticated concrete finish was possibly cut off. The masonry quoins that frame both sides of the east façade are interrupted around the corner at this location. The roof also awkwardly extends beyond the parapet wall at this corner. The cornice level has an applied board material, possibly T-111 similar to the north façade. There is another painted sign advertising "J&D Auto Services." There is a single downspout at the far western corner of the building. There is also evidence of the earlier masonry quoin configuration along the vertical corner with the west façade.

HO-823
PICKETT PROPERTY
HOWARD COUNTY
VIEW LOOKING SOUTHWEST

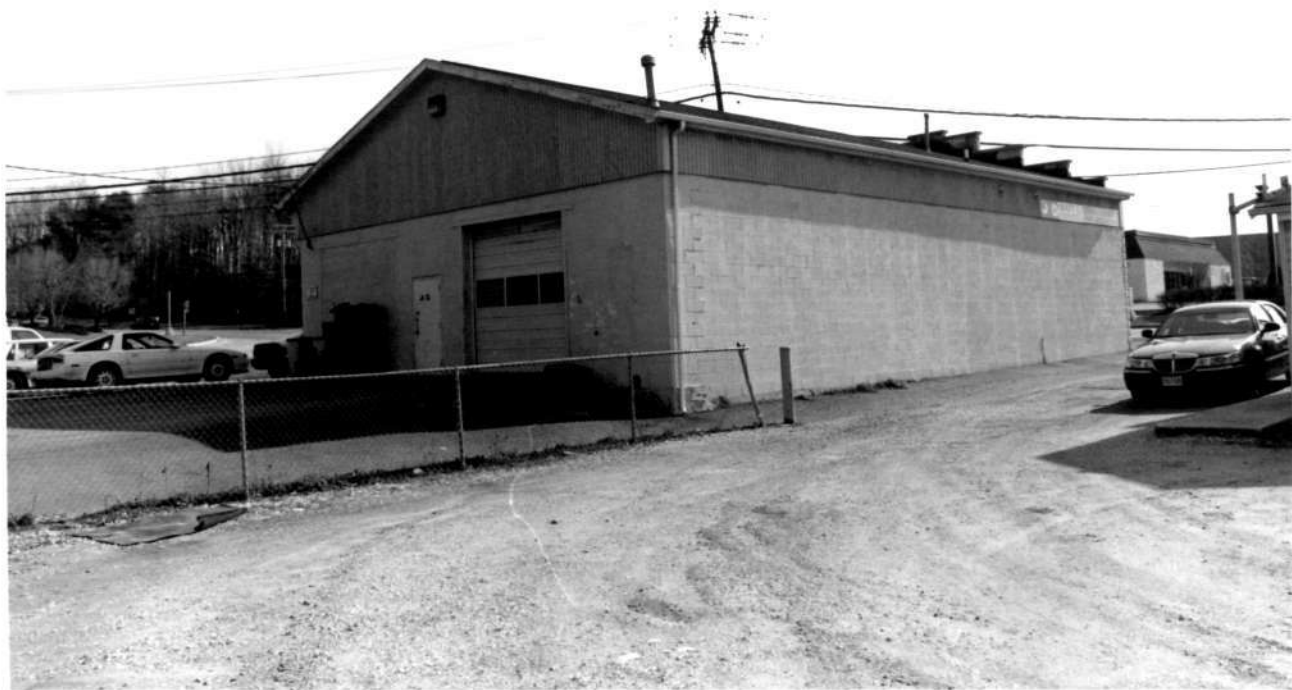
3 OF 3

The **West (rear) façade** is similar to the Southern façade and is also of a secondary nature to the building. The gable end of the structure is (similarly to the east façade) configured as three bays, although not symmetrically arranged. The wall material is a smooth concrete block, different than the rusticated finishes seen on the east and north facades. The gable end above the cornice level is covered with the T-111 type boarding arranged in vertical installation. At the peak of the gable end is a small exterior lamp that matches the front façade. Currently there is one garage door on the right side of this façade. The opening does not appear to be historic. The opening does not have characteristics similar to the openings on the other facades. There is a large rolling metal garage door with three windows. Near the middle of the façade is a single leaf metal door with the letters "J&D" noted. To the left or north of this doorway, there is what appears to be a larger garage like entrance that has been in-filled with concrete block. There are not quoins on the sides of this opening. There is a narrow lintel above the opening. It is not clear when this door was possibly added or in-filled. Current conditions at the building are fair.

HO-823
PICKETT PROPERTY
HOWARD COUNTY
VIEW LOOKING EAST
