HO-870 Caleb Shipley, Jr. Farm 2400 Pfefferkorn Road West Friendship vicinity Howard County, Maryland Private c. 1850s

# Maryland Historical Trust Maryland Inventory of Historic Properties Form

## HO-870 CALEB SHIPLEY, JR. FARM 2400 PFEFFERKORN ROAD

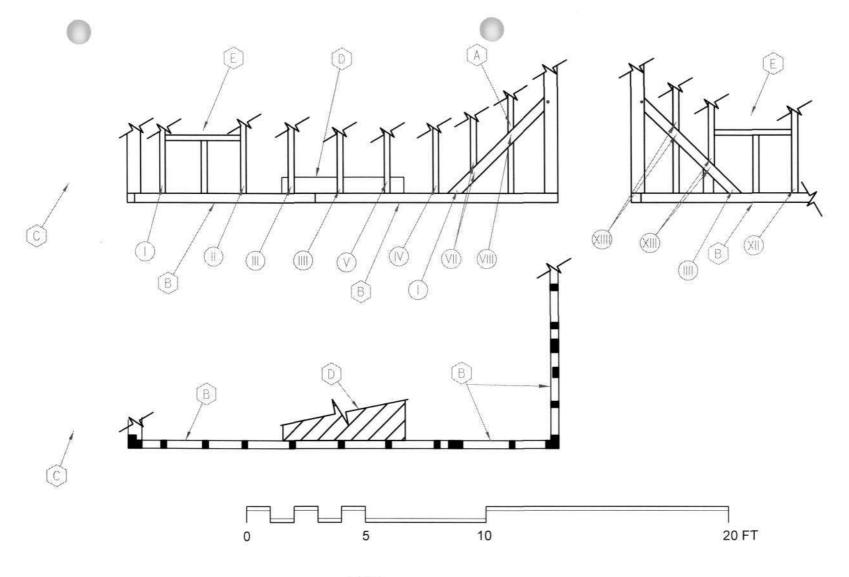
- A. FRAMING ROTTEN, MARRIAGE MARK LOST.
- B. SILLS REPLACED.
- C. ADDITION NOT SHOWN.
- D. BRICK FIREPLACE EXPOSED BEHIND LATH AND BASEBOARD.
- E. WINDOW OPENINGS

PARTIAL ELEVATION AND PLAN OF NORTHWEST AND SOUTHWEST ELEVATIONS SHOWING MARRIAGE MARKS
FRAMING EXPOSED BY STEVE ROLLS AND KEN SHORT -- MEASURED AND DRAWN BY KEN SHORT -- SEPTEMBER 2007

Some of the walls were opened up to examine the construction of the building. The siding is sash-sawn, with a 3/4-inch half-lap at the bottom of each board, and the siding is fastened with cut nails. The bottom two boards of the siding match the rest, but have modern cut nails holding them in place that do not match the cut nails used in the rest of the siding. The southwest and northwest sills have been replaces with 4 3/4-inch square circular-sawn timber, and it is set on bricks laid in Portland cement with shims on the exterior face of the sill, at the bottom of the sill, to push out the bottom piece of siding so that it sits over the foundation wall. The studs are toe-nailed to the sills now with a combination of cut and wire nails. The west corner post is hewn and is guttered, and is 6 1/4 inches by 6 1/2 inches, with a 2 1/2-inch gutter. There are down braces that are mortised and tenoned and pegged to the corner posts, and they are sash-sawn. The braces have marriage marks where the studs meet them, and the studs have the same marks. The full-height studs also have marriage marks at the foot. The studs are sash-sawn and are toe-nailed to the brace with cut nails. The studs are 3 inches by 4 inches. There is sash-sawn lath fastened to the studs. The northwest wall is constructed the same way, and the wall was lathed and plastered before the brick fireplace was built. The baseboard does not go behind the fireplace, however, and the back of the baseboard is sash-sawn. The braces are halved on their ends and set into center mortises and pegged. The northeast sill is much rotted and appears to be the original, suggesting that the northeast addition was built before the sills were replaced.

The northeast addition construction also has circular-sawn sills that are replacements. The corner posts are hewn and are 4 inches by 6 1/2 inches, and are not guttered. The studs are sash-sawn, are 3 inches by 4 inches, and are spaced 24 inches on centers. The down braces are also sash-sawn. The northeast elevation, north down brace appears to have a number one on it. The stud feet on this elevation are numbered from north to east, but only the full height studs, as is done on the main block; the short studs beneath the windowsills were not given marriage marks. The short pieces of studs beneath the down braces also were not given marriage marks, while the longer pieces of studs on top of the braces were.

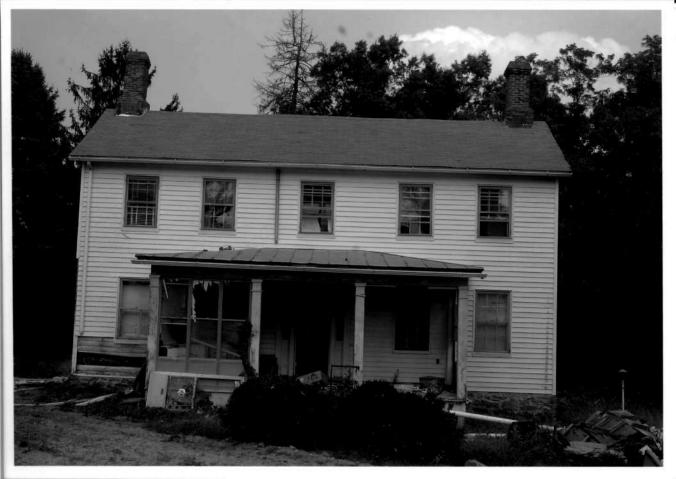
HD - 870 Caleb Shipley , Jr. Farm 2400 Pfefferkorn Rd Howard County, MD Ken Short Sept. 2007 mo stpd Southwest Elevation

On the southwest elevation the first story has a center entrance with a new door, a five-light transom, and three-light sidelights set over single panels. The panels have sunken fields and quirked ogee and bevel panel moulds. There is new reeded trim added to the side light mullions and transom bar. The muntins are all mortised and tenoned and pinned. The architrave is symmetrical, with a quirked Greek ogee to each side and plain corner blocks. Flanking either side of the doorway are two windows with six-over-six double hung sash in beaded-interior-edge frames that are mitered at the corners and have shutter hinges. There is a three-bay, one-story porch set on CMU piers, with a tongue-and-grooved wood deck, squared boxed wood posts, a plain frieze, a boxed eave, and a bead-board soffit. The porch is centered on the house and has a half-hip roof with standing-seam metal. The second story has five typical six-over-six sash and a wood box cornice with returns.

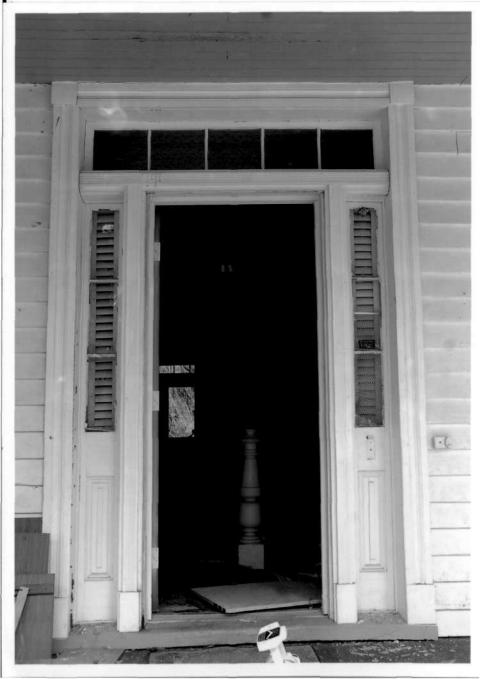
Southwest elevation, Doorway

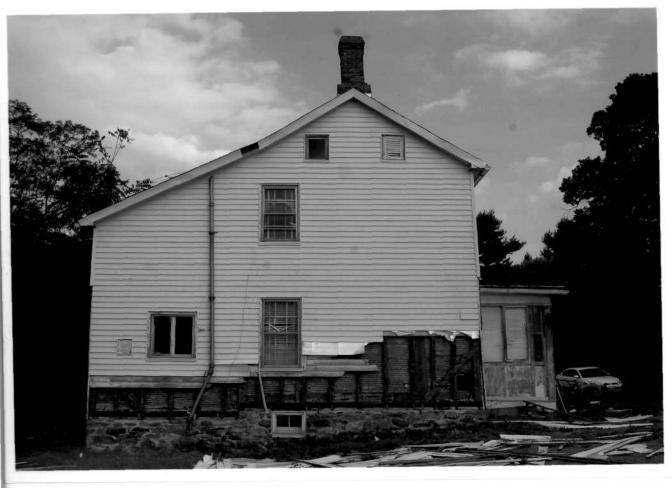
HO-870 Caleb Shipley, Jr. Farm 2400 Pfefferkorn Rd. Howard County, MD Ken Short Sept. 2007 mo stro Northwest Elevation

On the northwest elevation the north bay is an addition and the center and west bays are the main block. The weatherboards extend across the main block and addition, and must have been put on when the addition was, replacing the original siding. There is a two-light sash in the center bay of the foundation. The first story has two one-light casements in the north bay, a six-over-six sash in the center bay, and no opening in the west bay. The second story has no openings in the north and west bays, and a six-over-six sash in the center. The gable end has two small window openings, one of them converted to a vent.

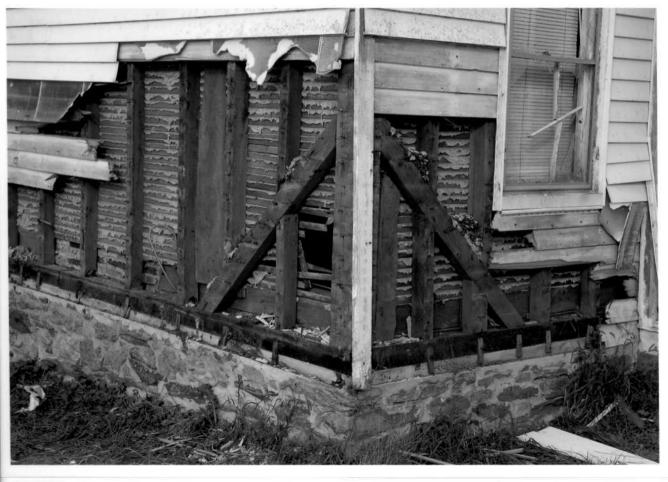
HO-870 Caleb Shipky, Jr. Farm 2400 Pfefferkorn Rd. Howard County, MD Kenshort Sept. 2007 mp SHPS West corner framing

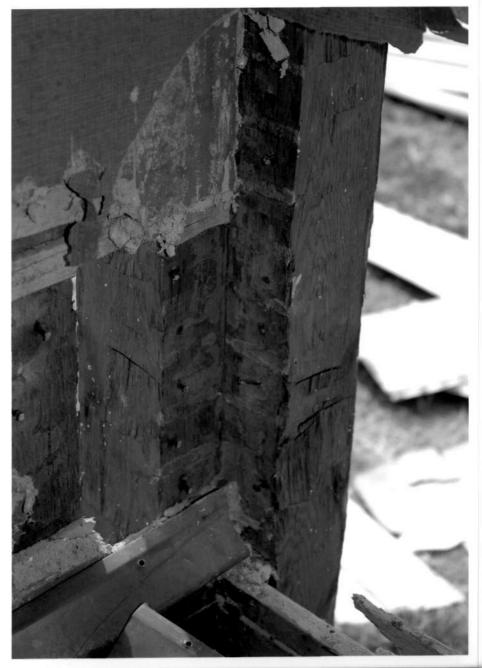
HO-870 Coleb Shipley, Jr Farm 2400 Pfefferkorn Rd. Howard County, MD Ken Short Sept. 2007 MD SHPO West Corner Past, view from Interior

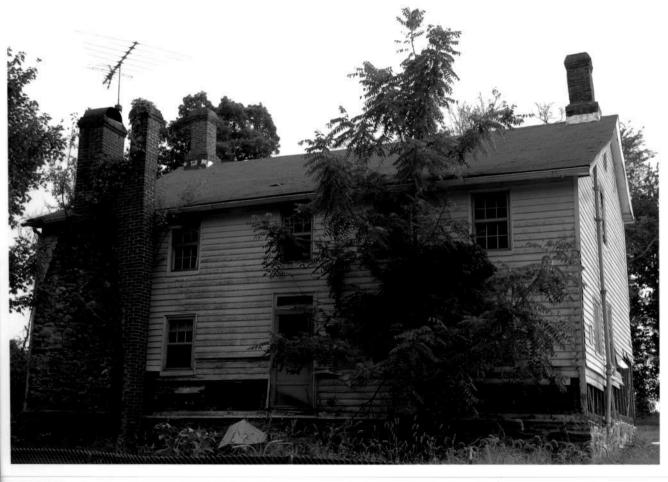
Caleb Shipley, Jr. Farm 2400 Pfefferkorn Rd. Howard County, MD Kon Short Sept. 2007 md shpo Northeast Elevation

The northeast elevation has an exterior rubble stone chimney on the east bay that tapers in on three sides, with a rebuilt brick chimney on top that was done when a new brick chimney was added to the northwest side. The east-center, north-center, and north bays have six-over-six sash on the first and second stories. The center bay has a beaded-edge vertical-board door on the first story and a six-over-six sash on the second story. There is a wood box cornice.

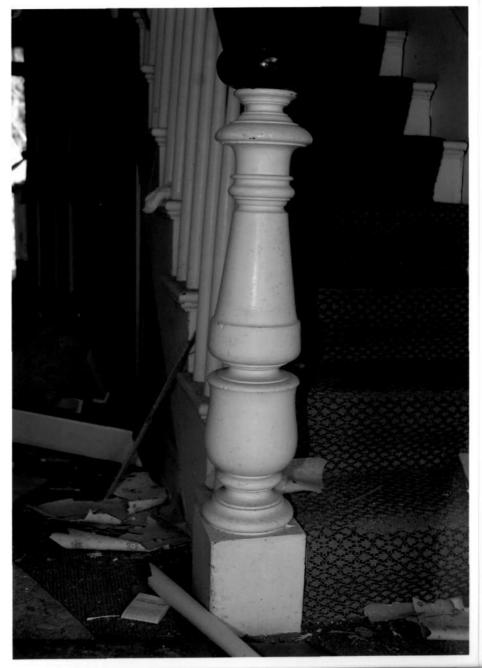
HO-870 Caleb Shipley, Jr. Farm 2400 Pfefferkorn Rd Howard County, HD Ken Short Sept. 2007 MD SHPO Stair Newel

The house is a center-passage, single-pile plan with a center-passage, single-pile addition on the rear, creating a double-pile plan. The front passage has an open-stringer stairway on the southeast with a turned newel that has a vasiform bottom. There are turned, tapered balusters which have tool marks that indicate that they were shaved by hand. There is a three-quarter-round ramped handrail that appears to be walnut. The stringer is plain. The baseboard has a broken field at the top, the architrave is symmetrical with quirked Greek ovolos, and there are plain corner blocks. There is plain peg rail board on the northwest wall. The doors have four panels with sunken fields and quirked ogee and bevel panel moulds, and identical panels are beneath the side lights. There is a four-panel door at the rear, and another beneath the stairway, leading to a closet. The floor and the joists beneath it are seriously deteriorated in this location, with large holes.

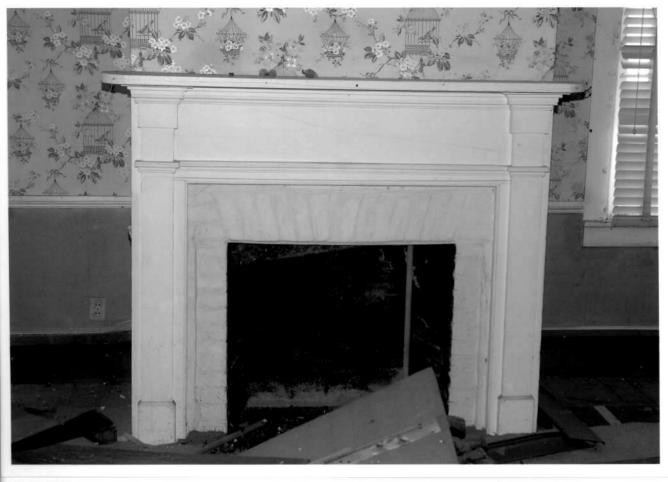
Caleb Shipley, Jr. Farm 2400 Pfefforkorn Rd Howard County, MD Ken Short Sept. 2007 MD SHRO Northwest room fireplace

The northwest room has trim that is fastened with cut nails. The baseboard matches that in the passage and the architrave matches that in the southeast room. There is a fireplace on the northeast elevation, with splayed brick jambs, and a wood mantel that is sash-sawn and fastened with cut nails. The mantel has plain pilasters, a plain frieze, and broken impost blocks. The bed mould has a bead at the top, two fillets beneath it, and a quirked Greek ogee and bead at the bottom. A chair rail has been added to this room, with a quirked ogee and bevel moulding, and it is fastened with wire nails. The window sash have ovolo muntins and are mortised and tenoned and pinned at the corners, and also where the muntins meet the top, bottom, and meeting rails. There are no parting beads and plain meeting rails, with no spring latches or weights for the sash.

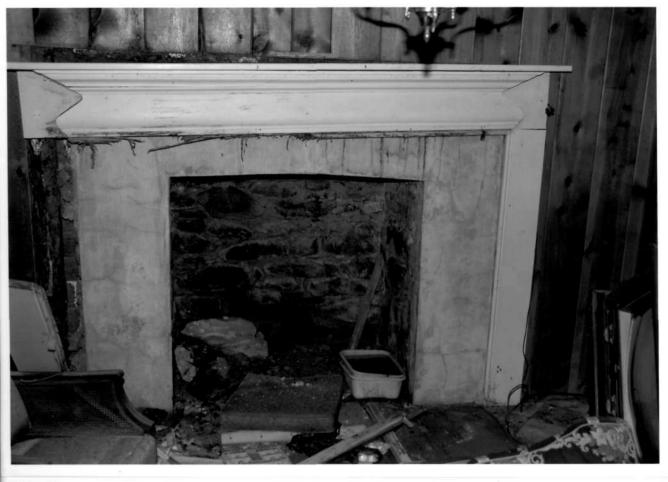
Caleb Shipky, Ir Farm 2400 Ffefferkorn Rd Howard County, MD Ken Short MD SHPO Addition Southeast room, fireplace on Northeast Elevation Richard Shipley Farm HO-870 2400 Pfefferkorn Road, West Friendship Howard County ca. 1863 Private

fireplace on the northeast elevation that has straight stone jambs and a slightly arched top. Some of the stones were pulled out of the top northwest jamb, probably when a crane was removed. There is a wood mantel shelf made with wire nails that appears to be a reproduction. On the southwest elevation is a doorway with a beaded-interior-edge architrave that is mitered at the corners. The wall on the northwest was built out into this room at the north half to enlarge the bathroom beneath the stairs, and there were doors here leading to that bathroom.

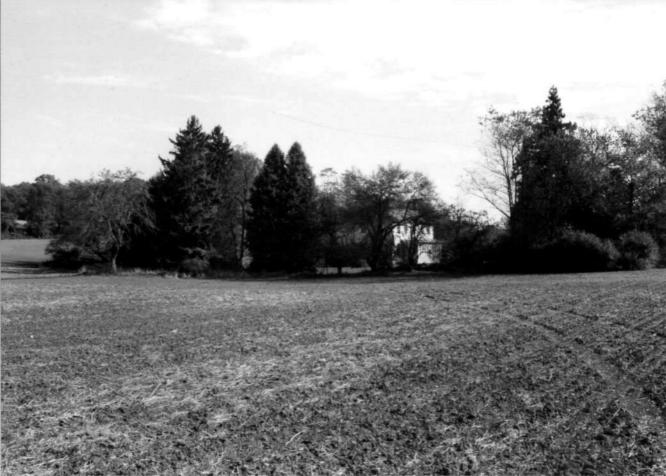
HO-870 Richard Shipley Form Howard County , ND Jennifer Goold October, 2004 MD SHPO Shows farmhouse in setting from fields south of house. Viewnorth 10617

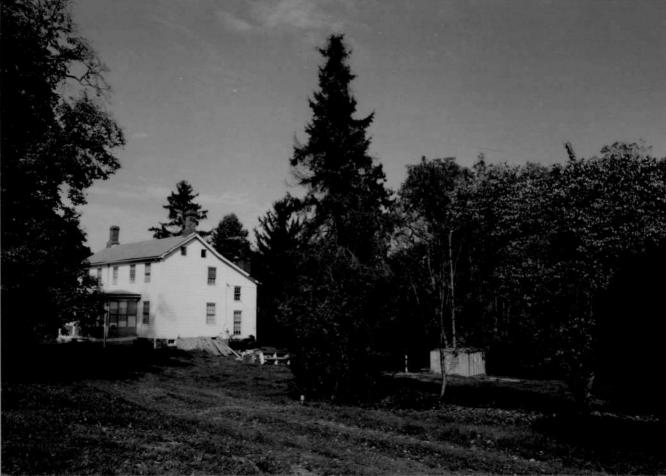
Richard Shipley Farm Howard County, MD Jenviller 6001d October, 2004 MD SAPO View west. Shows Farmhouse in setting from yard. 208 17

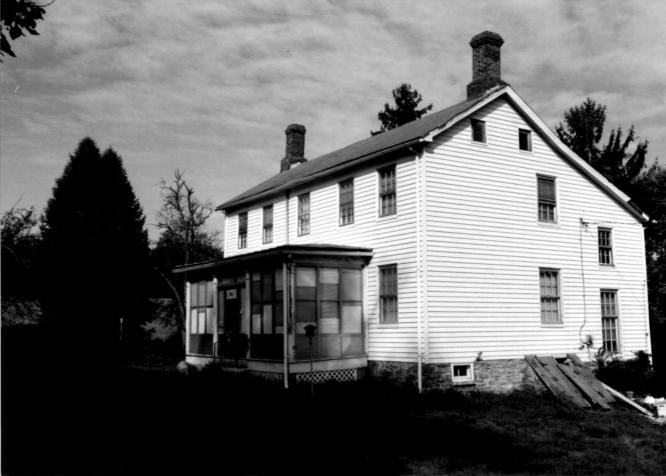
HO-870 Richard Shipley Farm Howard County, MD Sennifer Good October, 2004 MD SHPO

View west. Chows Farmhouse.

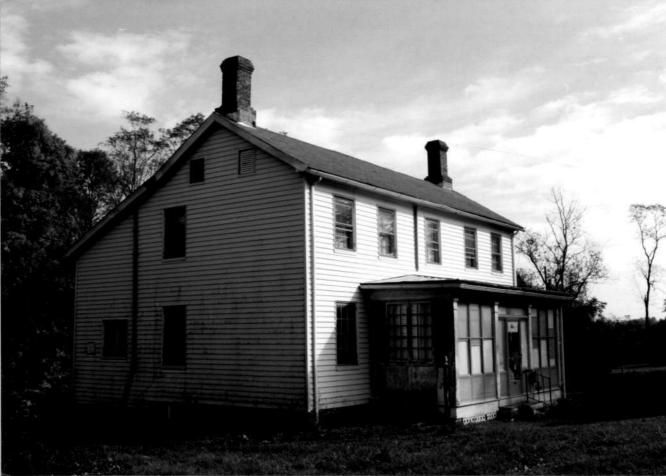
HO-870 Richard Onipley Farm Howard County, MD Vennifer Goo'd October, 2004 MO SAPO View east. Shows farm house

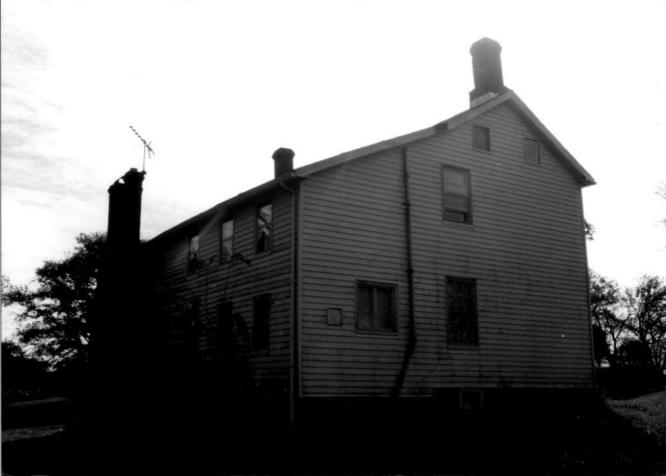
HO- 870 Richard Shipley Farm Howard County, MD Jennifer Goold October, 2004 MD SHPO

View south. Shows Farmhouse.

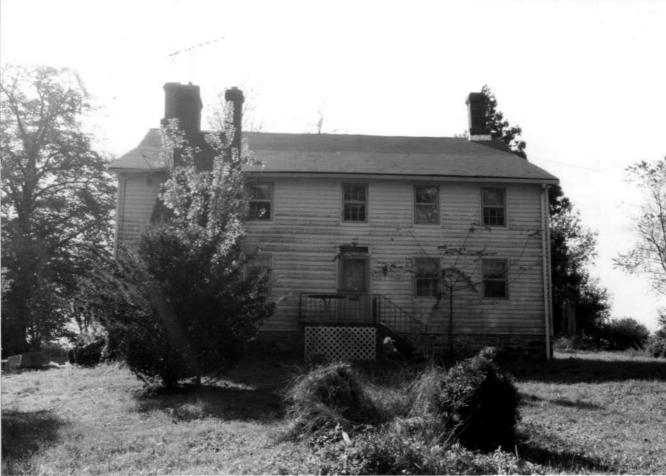
40-870 Richard Shipley Farm Howard County, MD Jennifer Goold October, 2004 MD SHPG View south, Shows formhouse. 60 06 M

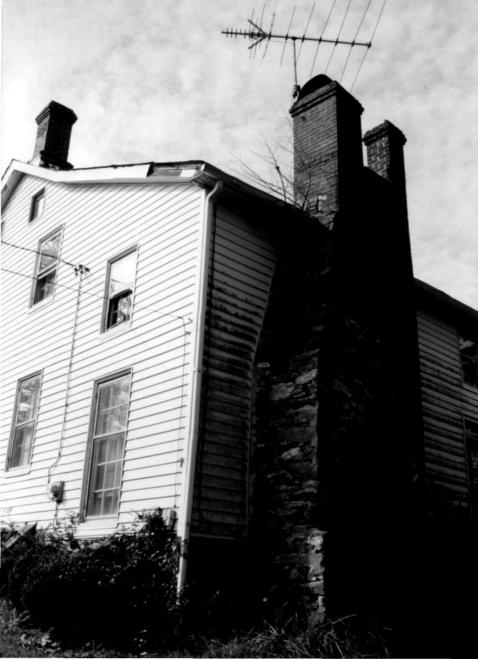
View southwest. Shows detail of kitchen chimney.

The rear (north) facade has four bays. The elevation is asymmetrically arranged with three bays located in the western half of the facade and one bay and the massive kitchen chimney located in the eastern half. Window openings are vertically aligned and are the same size. There are no cellar openings in the stone foundation. A small, recent, metal back porch projects from the rear facade outside the back door. The stone kitchen chimney has two brick stacks; presumably the larger stack is the fireplace stack and the smaller is the stove stack.

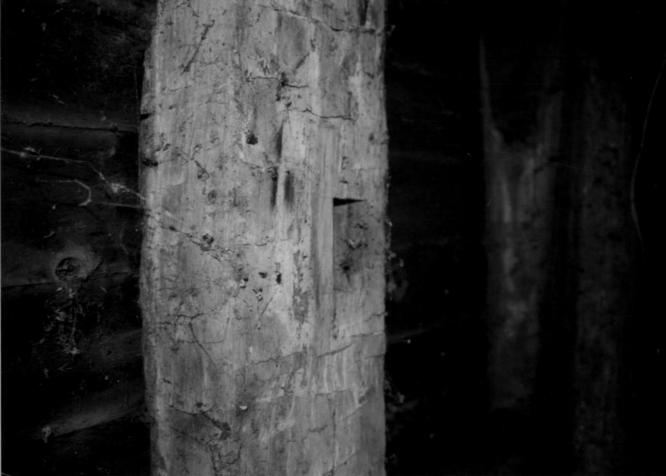
HO-870 Richard Shipley Farm Howard County, MD Jenniker Goold October, 2004 640< SZ:0N> 119Z-13U MD SHPO View northeast . Shows detail of hand-heun joists in cellar. 100h M

Only the cellar interior was accessible; the house was, until recently, heavily infested with termites and the building is structurally unsound. A brief look into the 1st floor indicated that the house has a center passage, hall and parlor plan in the main section of the house with a shed extension across the back of the house. The 1st floor joists are hewn and appear to have been reused from an earlier structure: joints from the earlier use are visible.

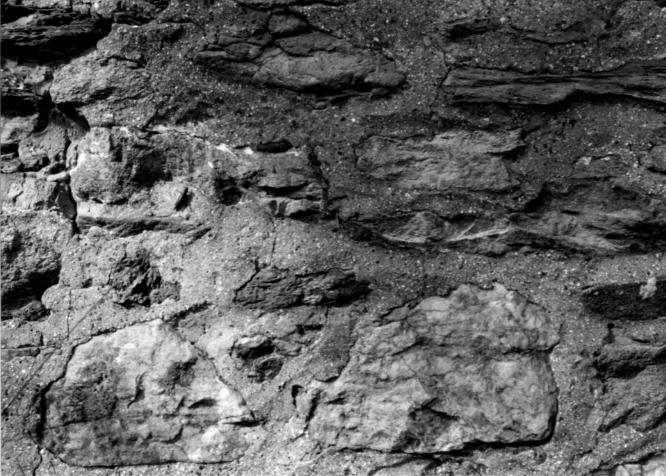
40-870 Richard Shipley form Howard County, MD Jennifer Goold October, 2004 ③(\*\*b0) 98 \$\Omega - N N I = 2121 16\$ MD SHPO View northwest. Shows detail of foundation stonework, 906 17

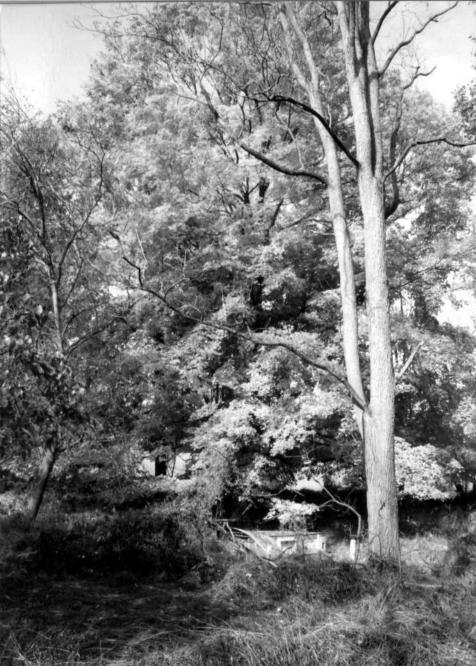
The remnants of a dry-laid stone foundation is located northeast of the house. A spring rises through the ground in the center of the foundation. Although this feature cannot be dated through construction technology, Robert Matthews, the most recent long-term owner of the farm, posted a sign on the foundation labeled "Spring c. 1795", which may have been derived from oral sources.

HO- 870 Richard Shipley Farm Howard County, MD Jennifer Goold October, 2004 0(440) tl t-N N I- ZIZI I6S 081-2611 < No.33 >865 MD SHPO View northeast. Shows spring house in setting 12 06 17

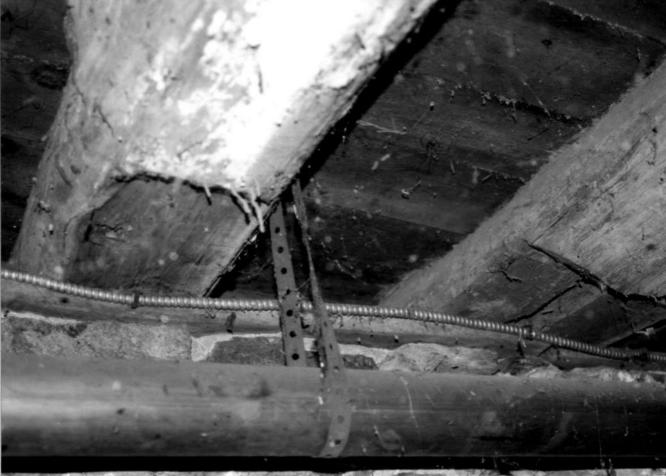
HO- 870 Richard Shipley Farm Howard County, MD Jenni Rev Goold October, 2004 MP SHPO View north. Snows detail of hand hewn joists incellar 11 300 17

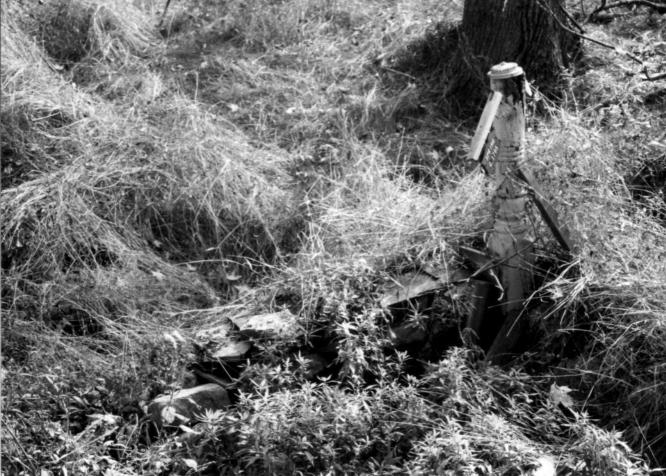
HO-870 Richard Shipley Form Howard Gunty, MD Jennifer Goold. October 2004 MP SHPO View east. Snows stone springhouse foundation. Note sign - "Spring co. 1795." 1300 17

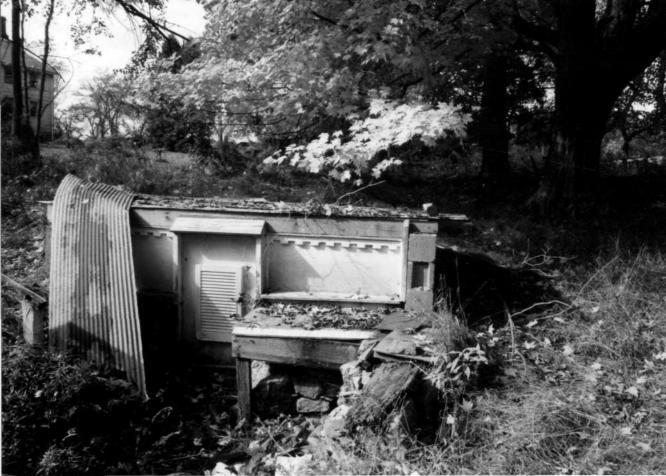
HO-870 Richard Shipley Farm Howard County, MD Jerrifer Goold. October 2004 MD SHPD View west. Come modern springhouse adjacent to Etone foundation. 1400 M

A CMU springhouse, that appears to have been constructed by Robert Matthews, is located immediately northwest of the older stone springhouse foundation. The springhouse has a roof of corrugated metal sheets and encloses a cylindrical, concrete cistern.

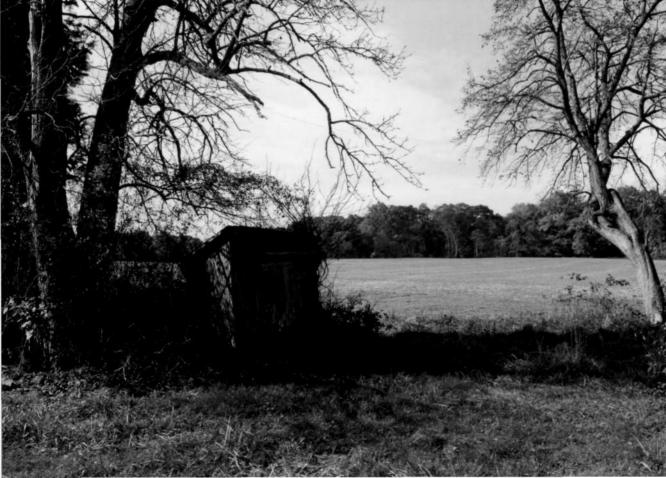
A small, wood shed-roofed structure is located northwest of the house at the edge of the yard. The structure has the size and form of an outhouse, but is not set on a foundation and was last used for storage.

HO-870 Richard Shiple Farm Howard County UD Jennifor 500 J. October 2004 MD SHPO View west. Shows offices! / Eled. 1506 17
