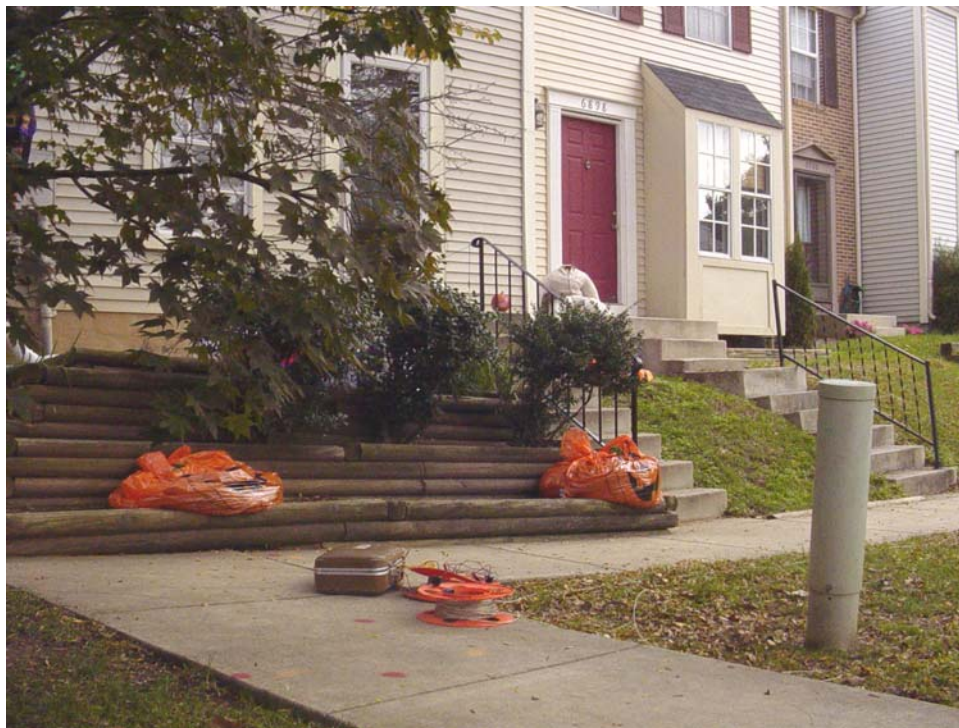
Figure 44 - Stray Current Testing in Marble Hill (Branch A)

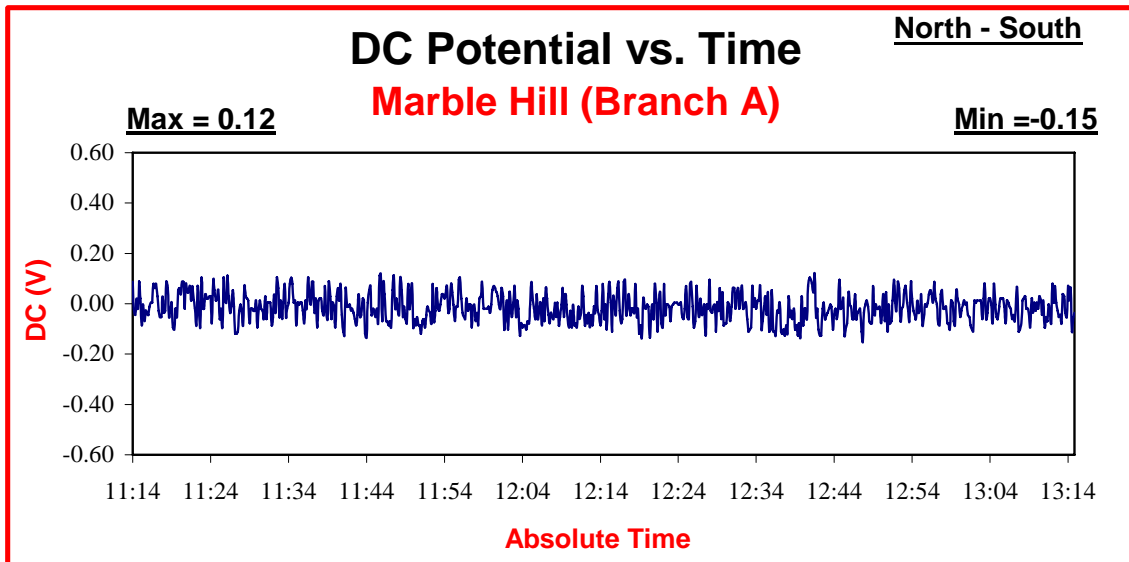
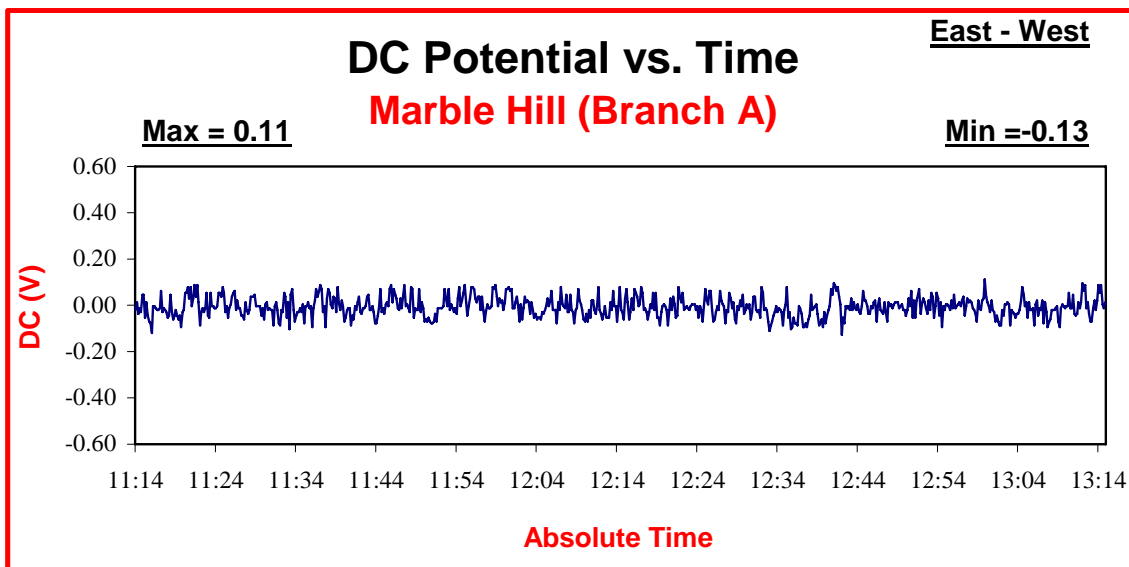
Location:	Marble Hill, near Ducketts Lane 6892 & 6896	
GPS Location:	N 39° 11.975', W 76° 44.708'	
	North-South	East-West
Date:	11/1/2006	11/1/2006
Time:	11:14:26	11:14:26
Maximum (V):	0.12	0.11
Minimum (V):	-0.15	-0.13
DC Potential Shifts (V):	0.27	0.24

Figure 45 - Stray Current Result for Marble Hill (Branch A)
